# Star Home Inspection Services

## *Home Inspection Report*

**475 E 55th St, Kansas City, MO 64113**

**Report Number: 09242009-2A**

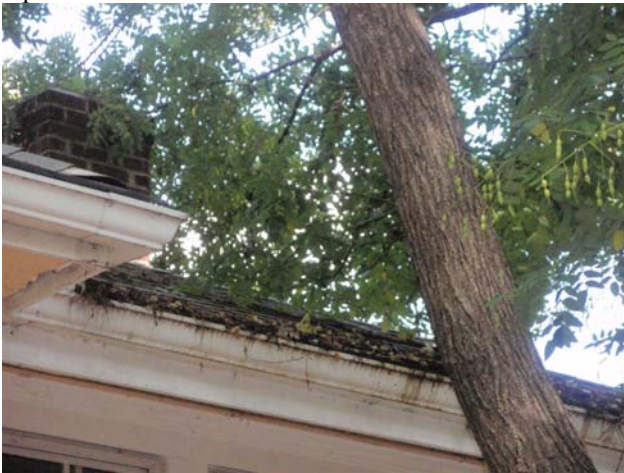
- **Improve:** Debris should be removed from the roofing to reduce risk of leaks and early roof wear.
- **Repair:** Vines growing on garage roof should be removed. Damaged roofing material which is uncovered should be repaired.

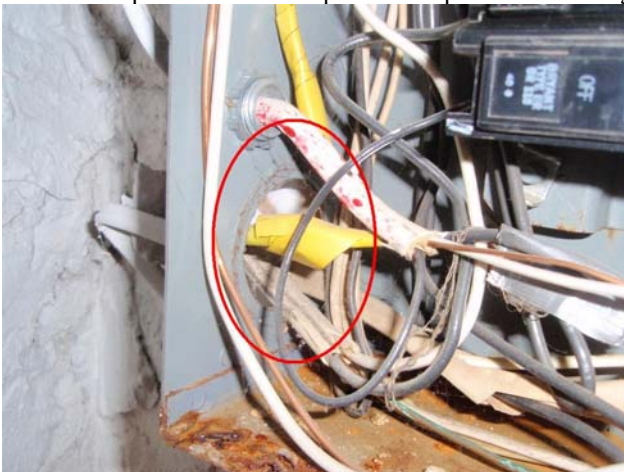
- **Repair:** Cable clamps (sometimes referred to as bushings or grommets) are required where wiring passes into the main distribution panel. Cable clamps serve to protect the wiring from the metal edges of the panel openings.

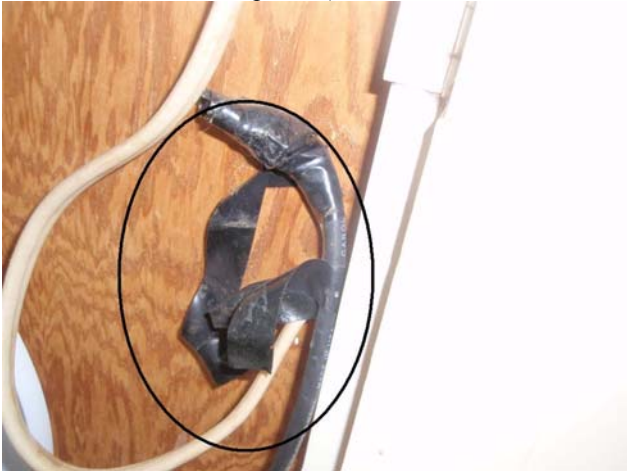
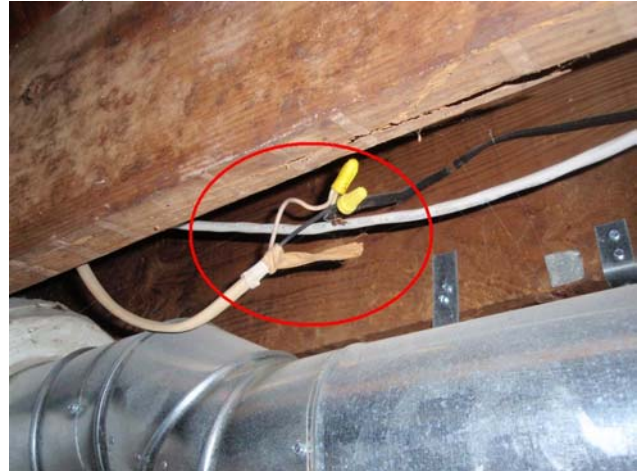
- **Repair:** Loose cable wiring in the basement should be secured.
- **Repair:** Improper electrical connections should be repaired. All electrical connections should be made inside junction boxes fitted with cover plates (i.e. basement and under kitchen sink).

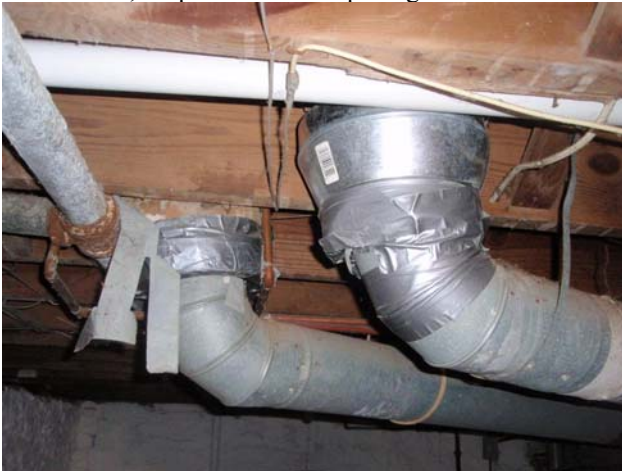
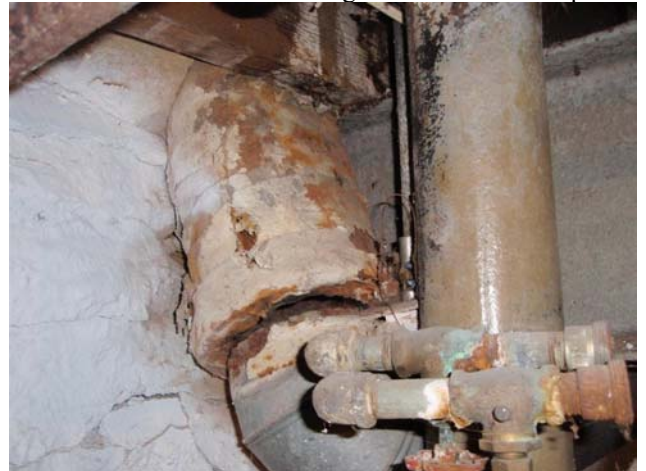
- **Repair:** Loose fitting joints and/or openings in the ductwork should be improved. Duct tape should not be used for duct connections, despite its name. Openings at the duct in the basement should be sealed. Damaged duct should be repaired.

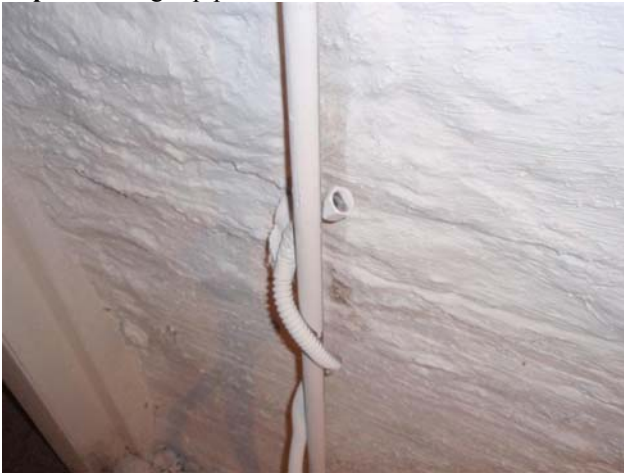
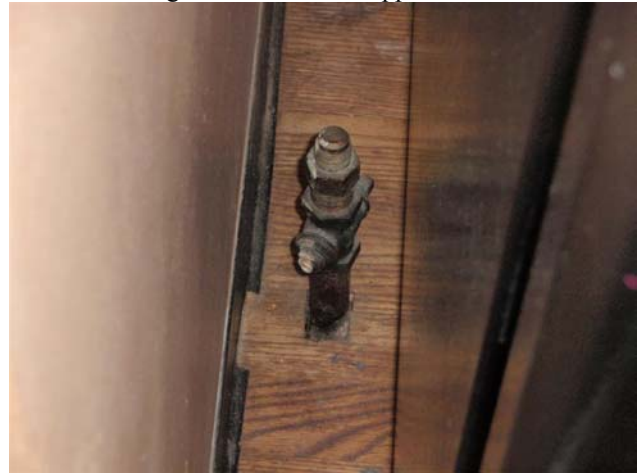
- **Repair:** The gas pipe at the back wall of the basement and behind the refrigerator should be capped when not in use.
