Star Home Inspection Services

Home Inspection Report

4774 Black Swan Dr, Shawnee, KS 66216

Inspection Date: 9/11/2007

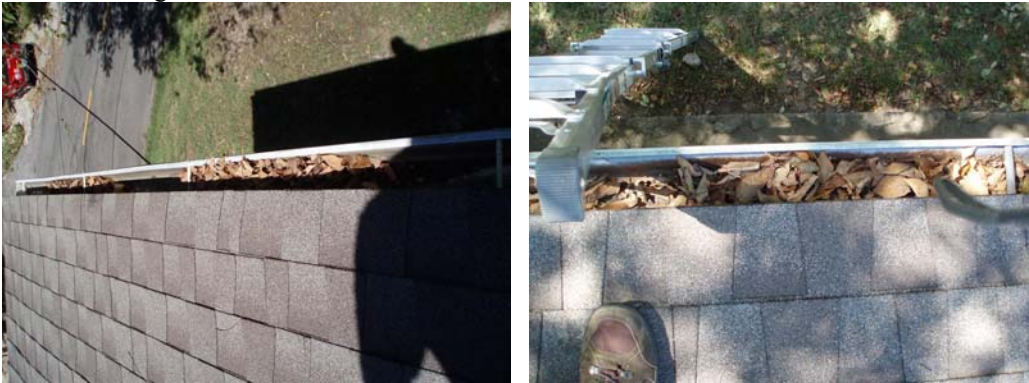
- **Repair:** The gutters require cleaning to avoid spilling roof runoff around the building – a potential source of water entry or water damage.
