# Star Home Inspection Services

## *Home Inspection Report*

**4910 W 69th Terr, Prairie Village, KS 66208**

**Inspection Date: 2/23/2009**

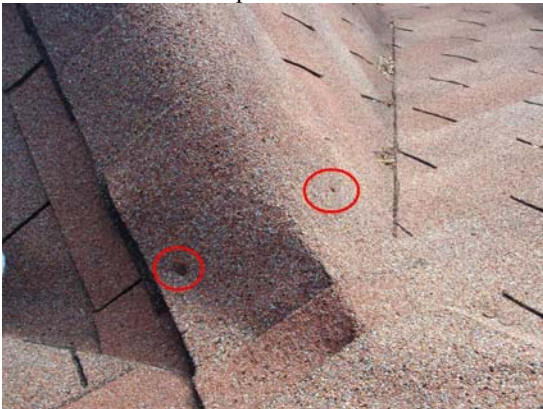
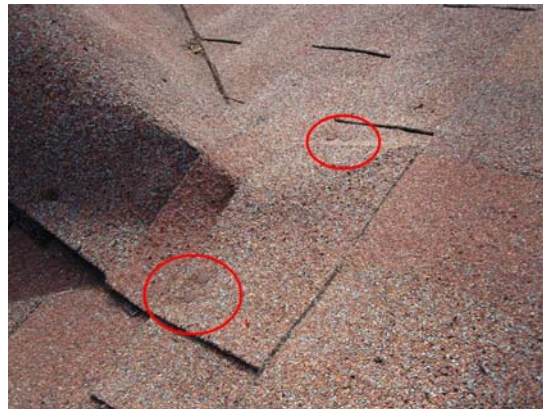
- **Repair:** Exposed nail heads were observed in the roofing shingles and/or ridge caps. All exposed nail heads should be caulked to reduce the potential of leaks.

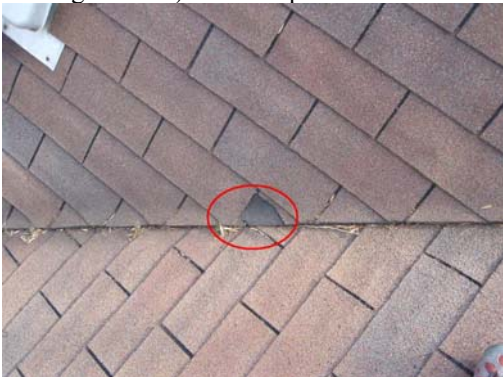
- **Repair:** Minor repairs to the roofing are needed. Damaged or missing roofing material should be repaired (example at missing roof tab). All roof penetrations should be examined and sealed as necessary.

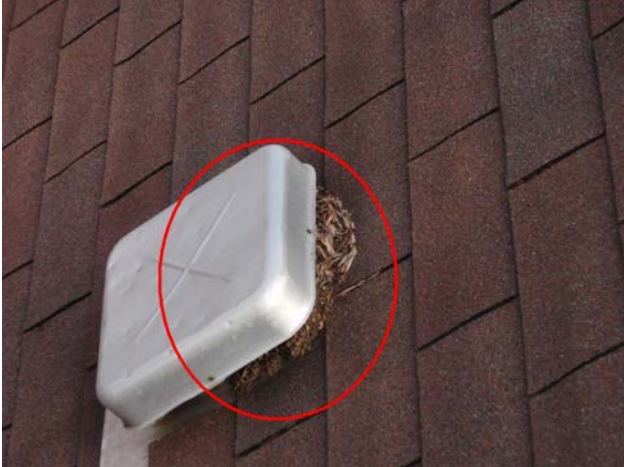
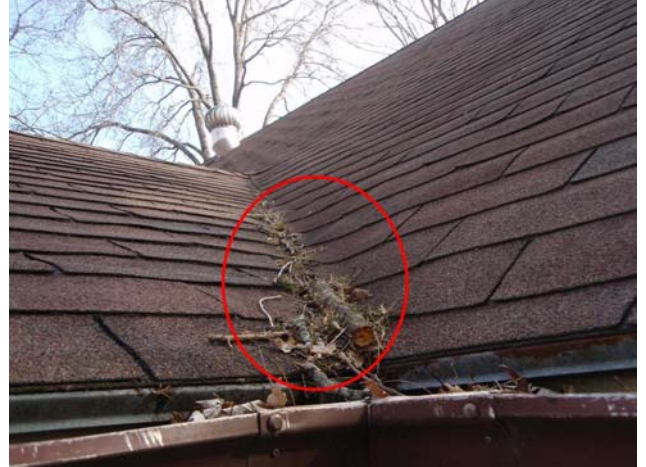
- **Repair:** The roofing at northwest room at back of house is near the end of its life. Minor repairs might be possible to extend the roof life and to defer leaks. Expect to replace the roof soon. Older roofs are, by their nature, a high maintenance roof. Annual inspection and repair should be anticipated. In addition, the older flashings should be monitored. In some cases, a deteriorated flashing can result in expensive repairs, because sections of the roofing have to be removed. As a rule of thumb, replacement of the entire roof covering may be logical if more than ten percent of the roof requires repair. Roofing over the rest of the house appears to have years of life remaining.
- **Improve:** Debris should be removed from the roofing to reduce risk of leaks and early roof wear.

- It is recommended that the present layers of roofing materials be removed prior to re-roofing. This adds cost of demolition and debris removal to the re-roof cost.

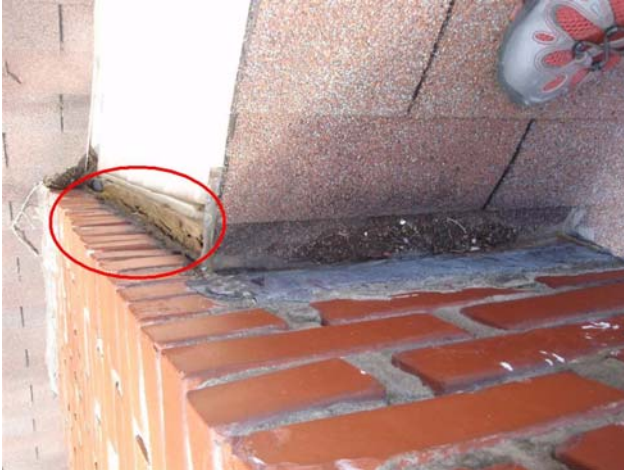
- **Repair:** The chimney flashing should be caulked to avoid leaks and the rotted chimney flashing wood replaced.

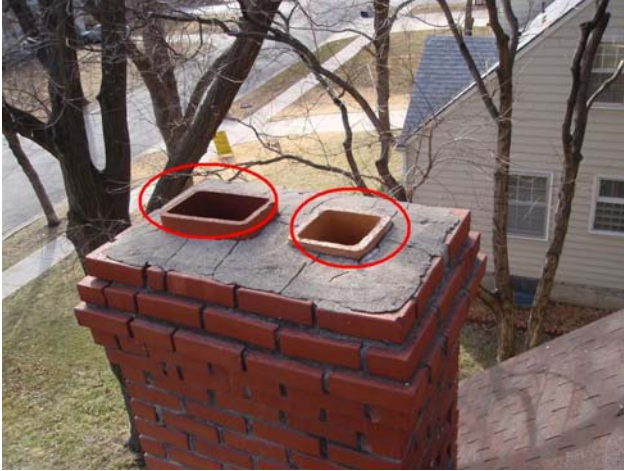
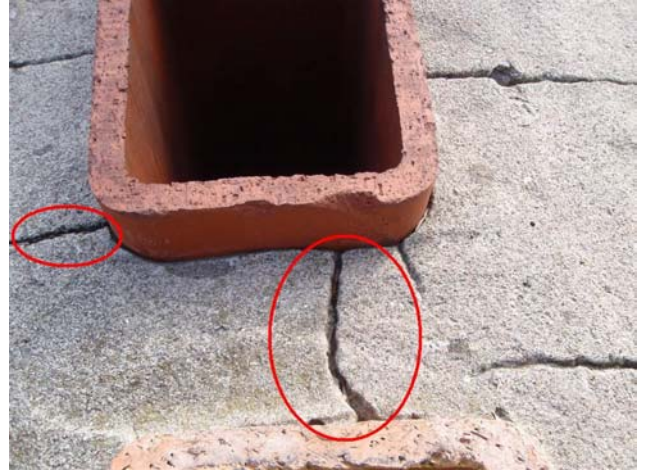
- **Repair:** The cap of the masonry chimney is cracked. These cracks should be sealed or caulked to prevent damage from freezing water.
- **Repair:** The metal chimney requires a cap to avoid damage.
