**Star
Home
Inspection Services**

Home Inspection Report

4942 Wells Dr Roeland Park, KS 66205

Inspection Date: 10/12/2009

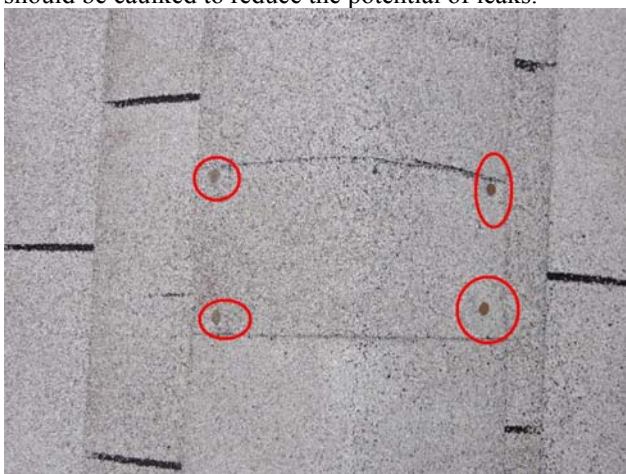
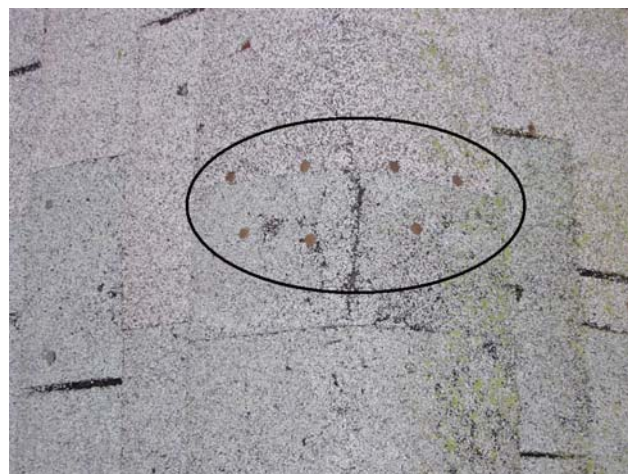
- **Recommend:** Exposed nail heads were observed in the roofing shingles and/or ridge caps. All exposed nail heads should be caulked to reduce the potential of leaks.

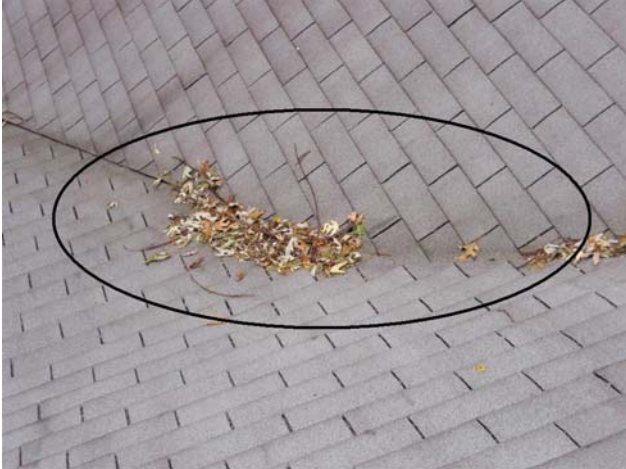
- **Improve:** Debris should be removed from the roofing to reduce risk of leaks and early roof wear.

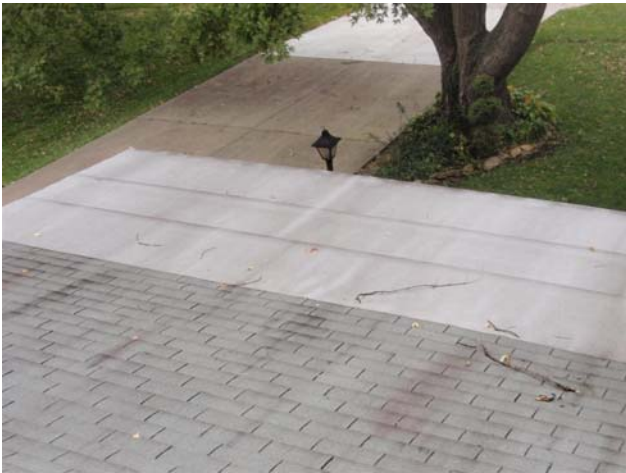
- **Note:** Rolled roofing over the front porch is prone to leaking and requires close monitoring and higher than normal maintenance.

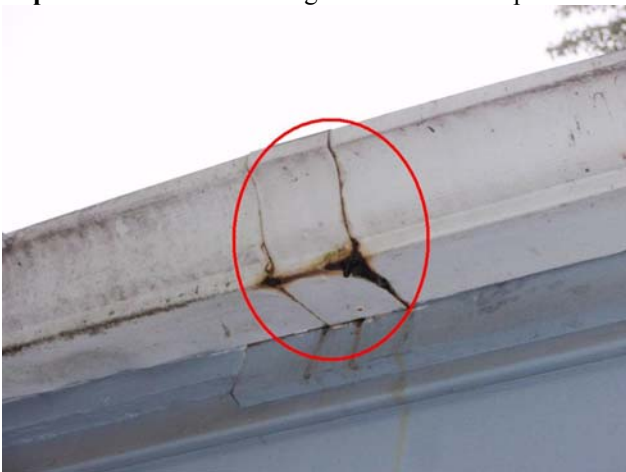
- **Repair:** The gutters require cleaning to avoid spilling roof runoff around the building – a potential source of water entry or water damage.
- **Repair:** Minor leaks in the gutters should be repaired.

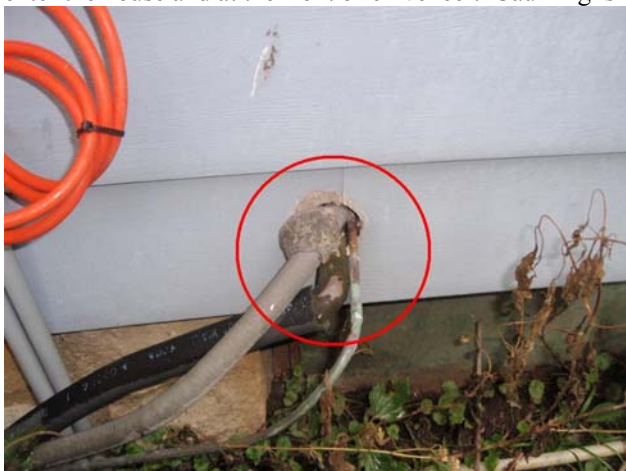
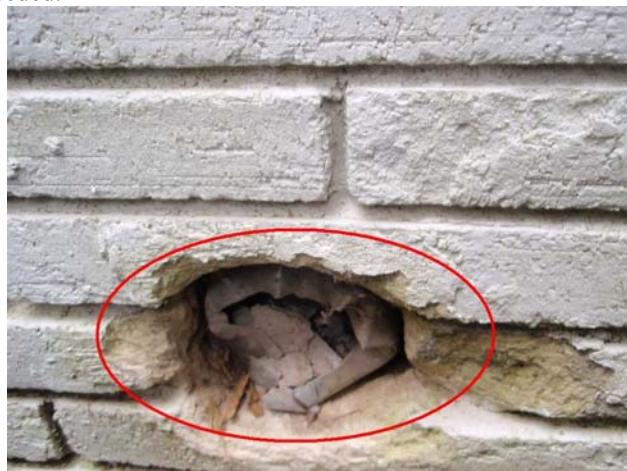
- **Repair:** Any openings in the exterior siding should be sealed. An example is where the air conditioner refrigerant lines enter the house and at the front brick veneer. Caulking is needed.

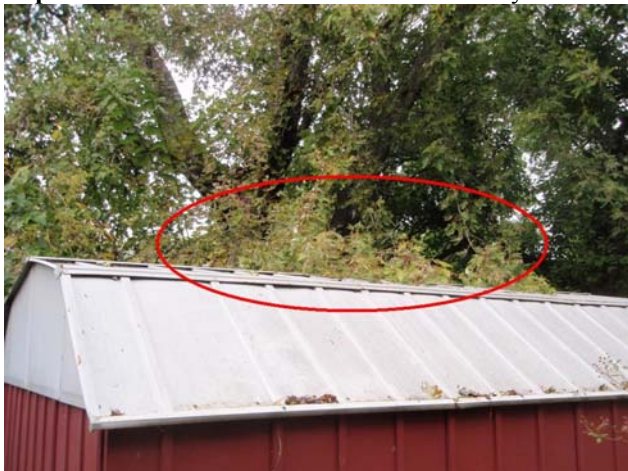
- **Repair:** Tree branches should be trimmed away from the storage shed to avoid damage to the building.

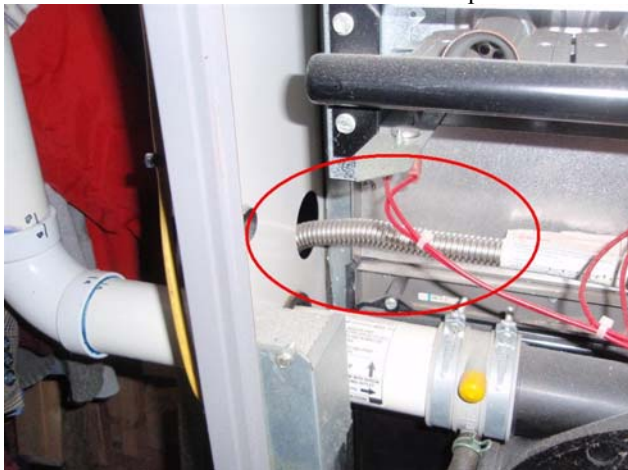
- **Monitor, Repair:** Galvanized steel pipe is no longer suitable for gas piping by most gas utility companies. This should be confirmed or verified with the local gas company and if confirmed it's recommended any galvanized pipe be replaced with one of suitable material.
- **Repair:** Flexible gas appliance connections should not pass through walls, floors or the appliance housing as is the case of the furnace. This connector should be replaced with one of suitable solid gas piping.

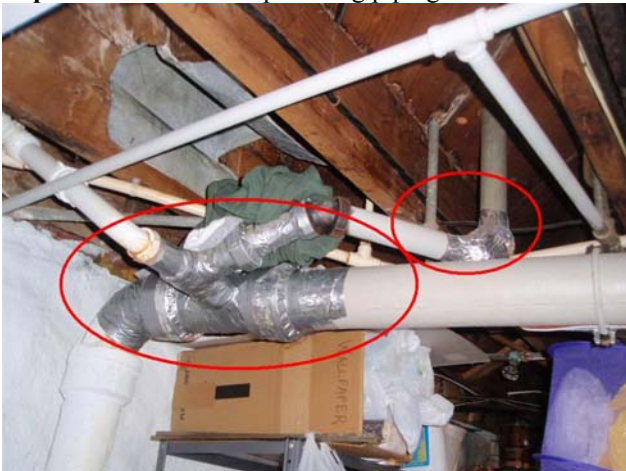
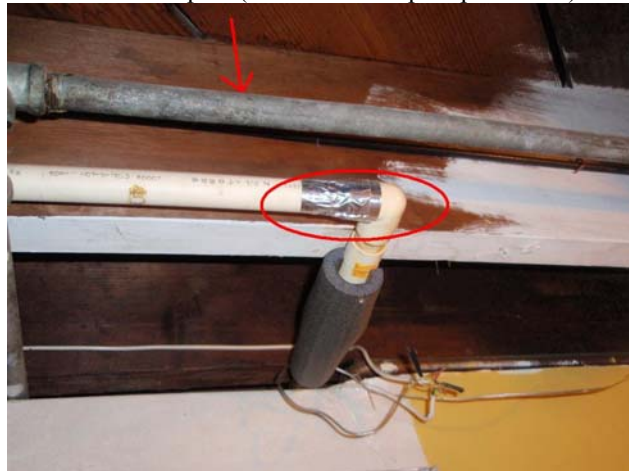
- **Repair:** The drain pipe below the kitchen sink is leaking.
- **Repair:** The master bath sink drain pipe is disconnected and the basement laundry sink faucets are not connected.
- **Repair:** The waste and plumbing piping connections in the basement are suspect (foil and duct tape repair noted).
