**Star
Home
Inspection Services**

Home Inspection Report

500 Mill Ct Belton, MO 64012

Report Number: 09222011-2L

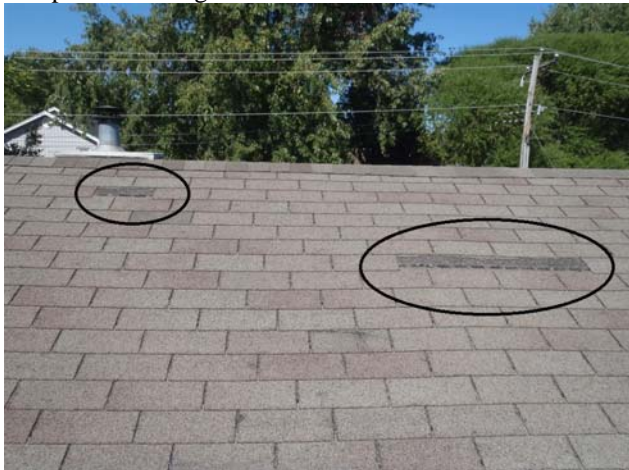
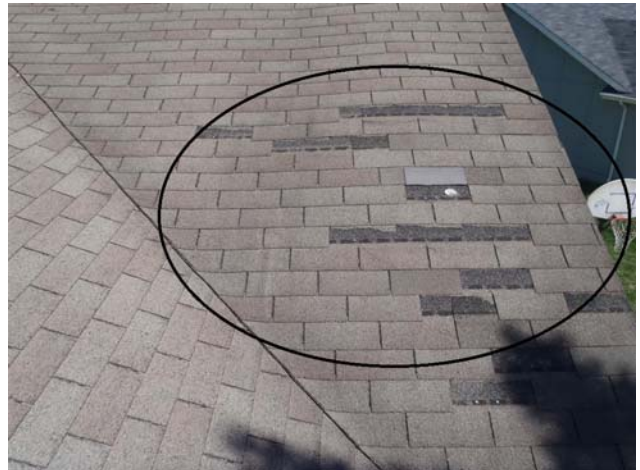
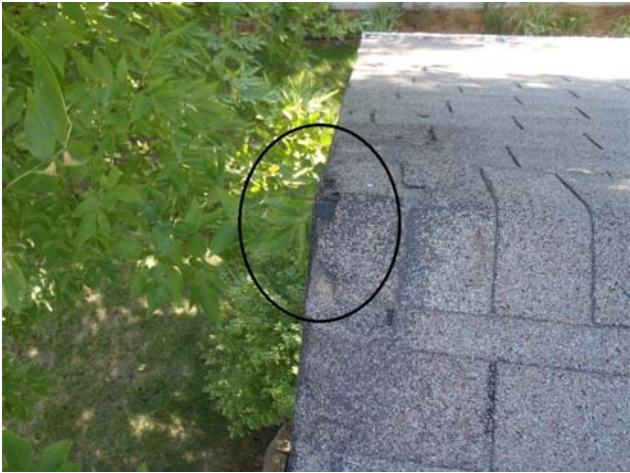
- **Repair:** The back half of the roof was replaced when the fire damage was repaired. Missing tabs on the front half of the roof were observed and some minor damage from the tree was also visible on the front ridge cap. Repairs are needed to prevent leakage.

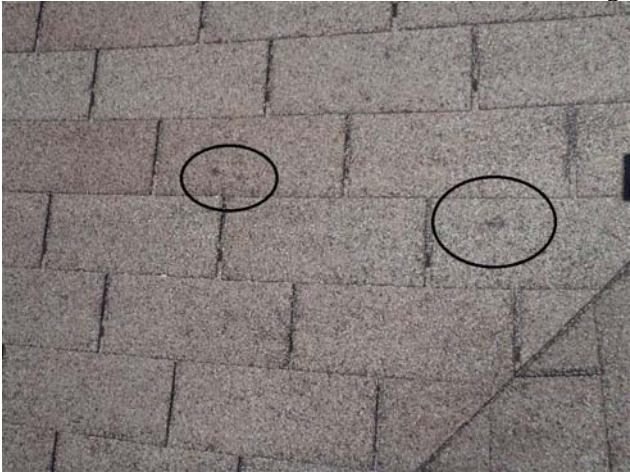
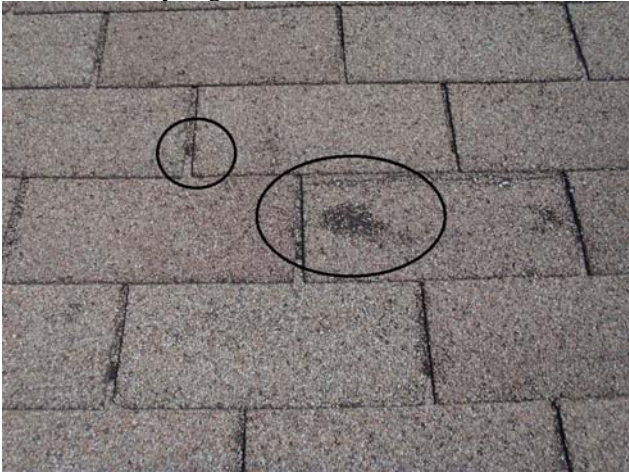
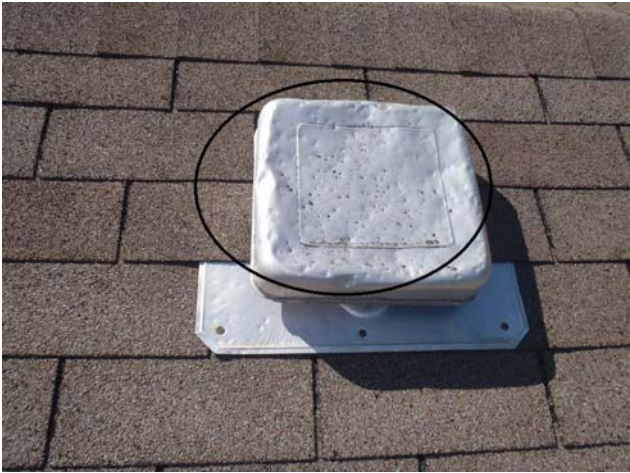
- **Monitor, Repair:** What appears to be hail damage was observed on the front and east roof and roof vents. Hail damage can shorten the life of a roof. This should be investigated further and may eligible for an insurance claim.

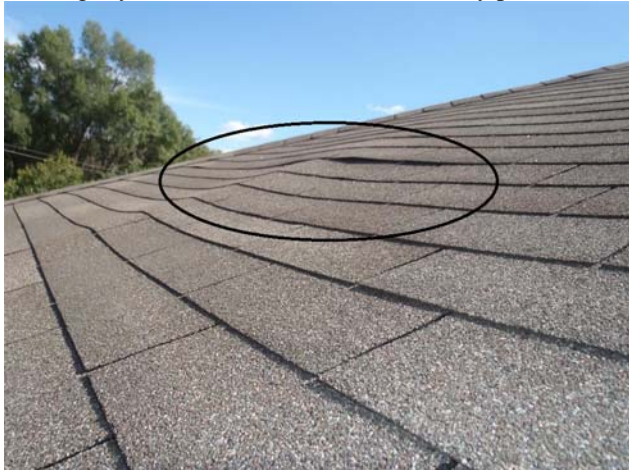
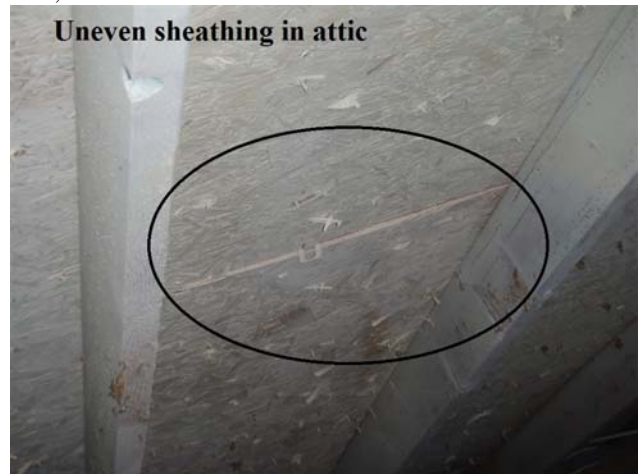
- **Monitor:** A high spot on the rear roof was observed. Further investigation in the attic revealed that the sheathing was slightly uneven and should not cause any problems. However, this area should be monitored.

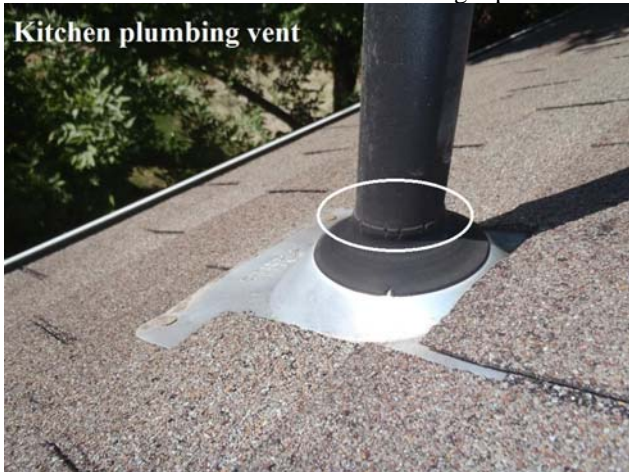
- **Monitor, Repair:** The kitchen plumbing vent flashing boot is split making it vulnerable to leaks. It's recommended that the boot be caulked or the flashing replaced.

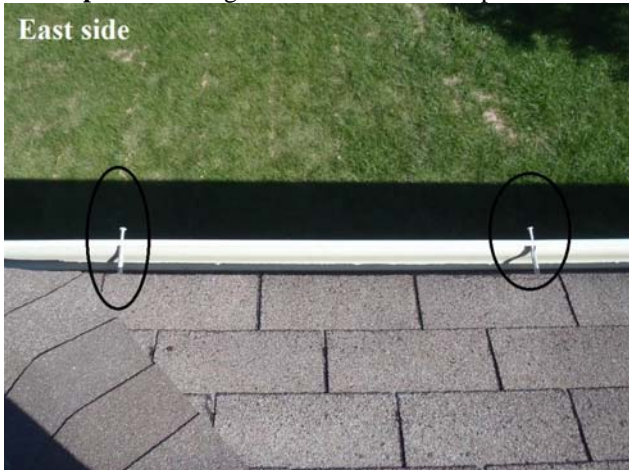
- **Repair:** Loose gutter nails should be repaired.

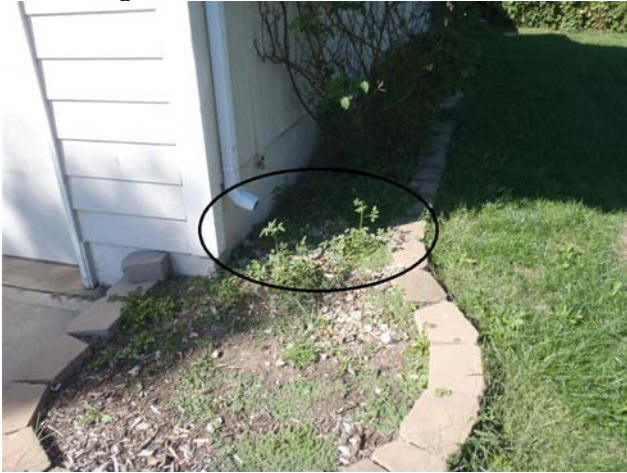
- **Repair:** The downspout(s) should discharge water at least five (5) feet from the house. Storm water should be encouraged to flow away from the building at the point of discharge. Some splash pans and/or downspout extensions are missing.

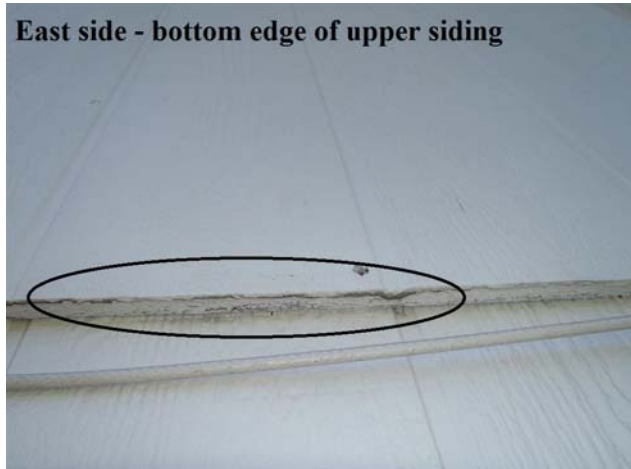
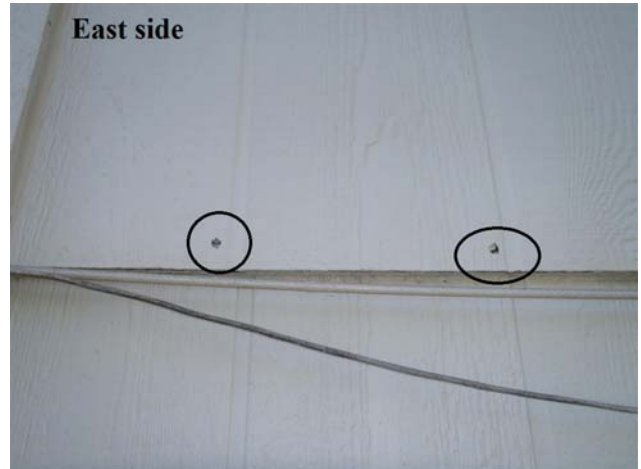
- **Repair:** Siding of this type requires considerable monitoring and maintenance. It has a tendency to pop out past nail heads creating a space where two panels join together. Re-securing and caulking the seams and nail holes is standard maintenance for this type of siding. The installed bat boards over the seams is an excellent way to prevent the seams from opening. During the inspection some nails driven deep into the siding and the lack of paint on the bottom edge of the siding was observed. The nails holes should be caulked and the bottom edge painted to prevent water damage and rot.

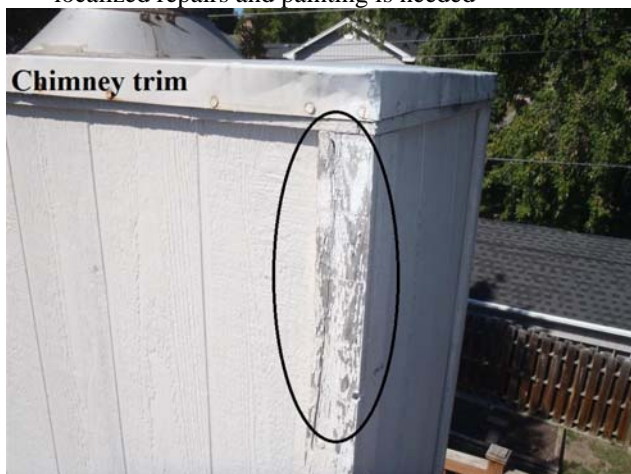
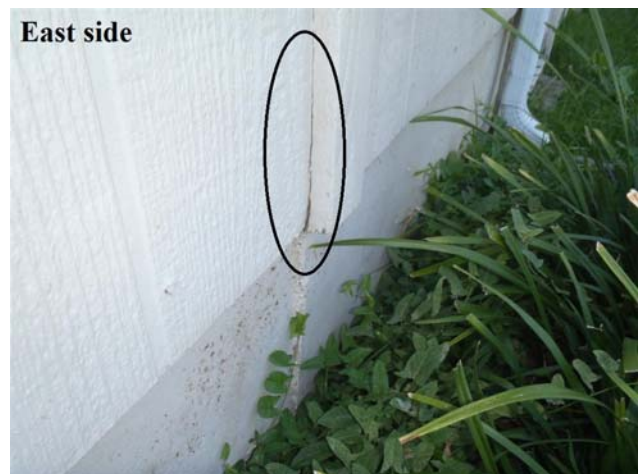
- **Repair:** The paint on the trim around the siding is peeling in localized areas and some bat boards need caulking. Minor localized repairs and painting is needed

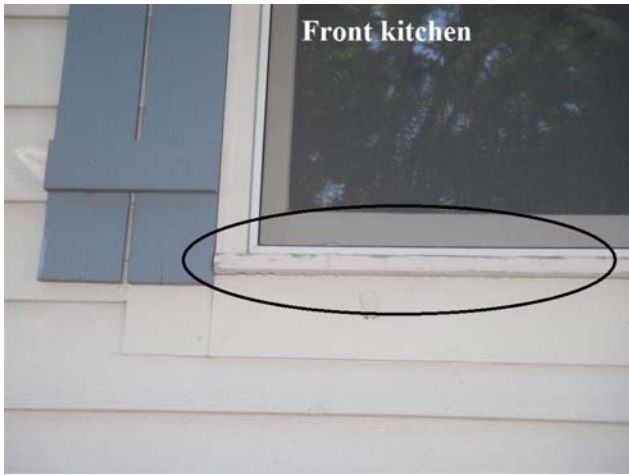
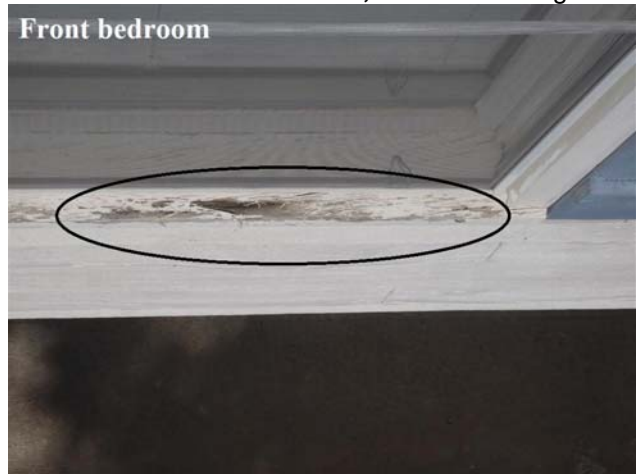
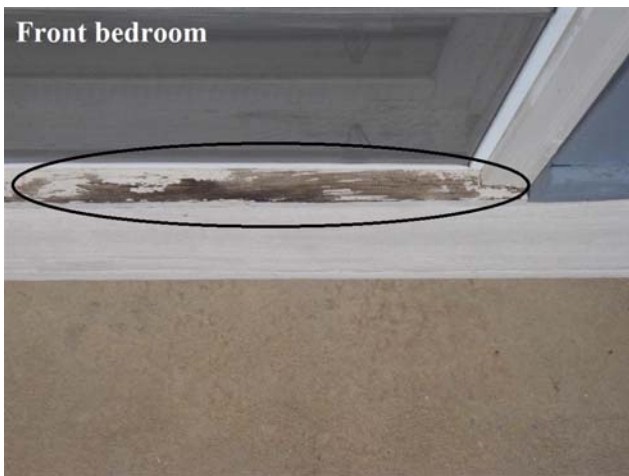
- **Repair:** The window frames require painting and caulking.

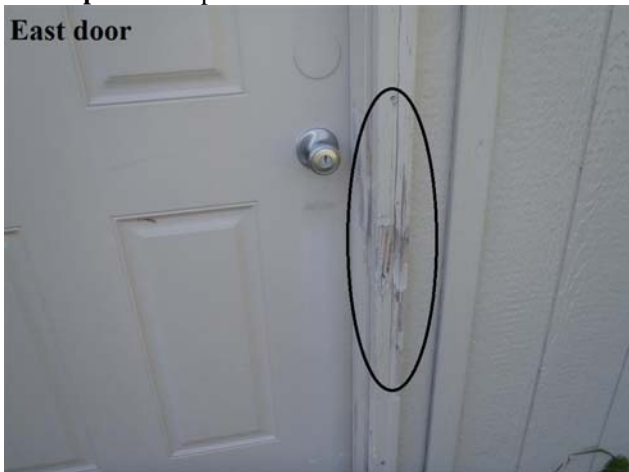
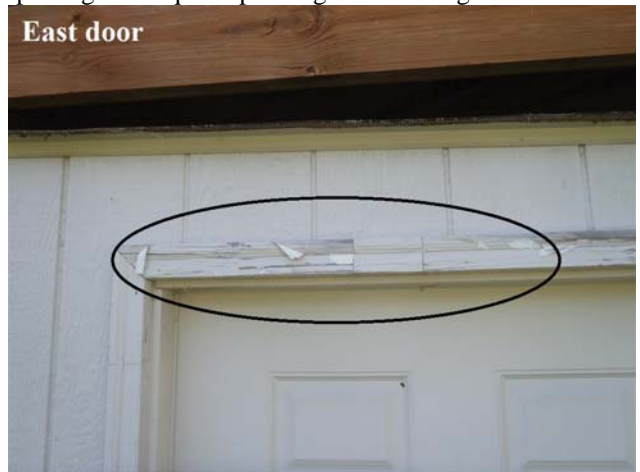
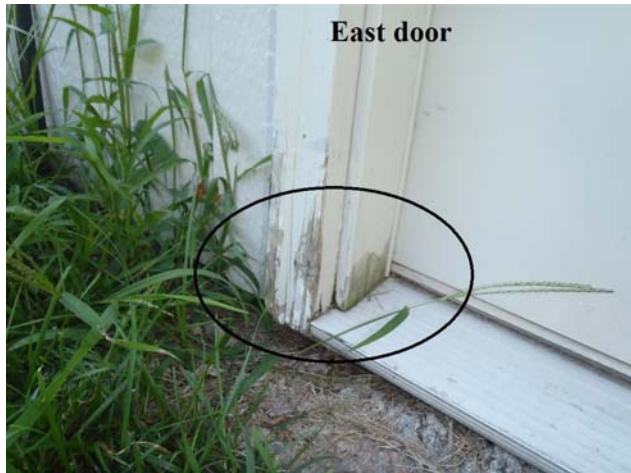
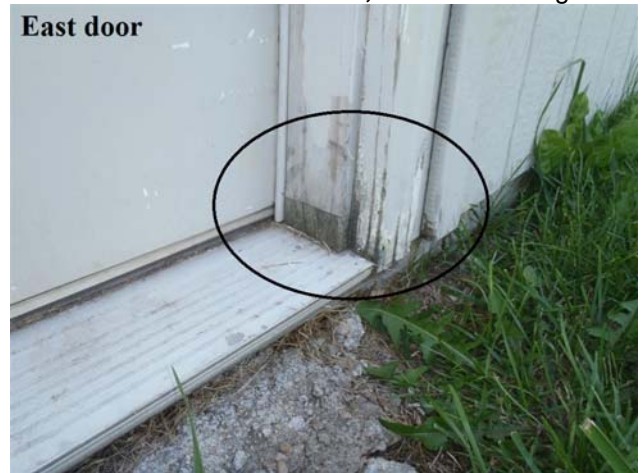
- **Repair:** The paint on the east exterior door frame/ trim is peeling and requires painting and caulking.

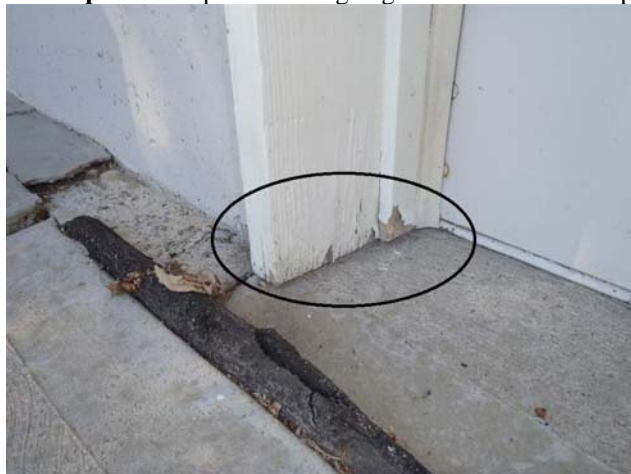
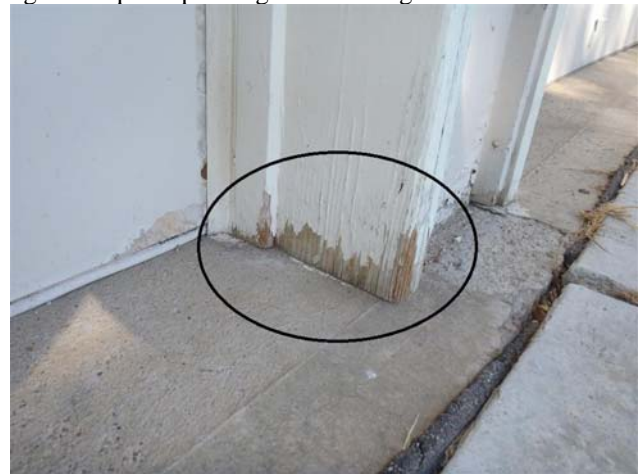
- **Repair:** The paint on the garage door frame/ trim is peeling and requires painting and caulking.

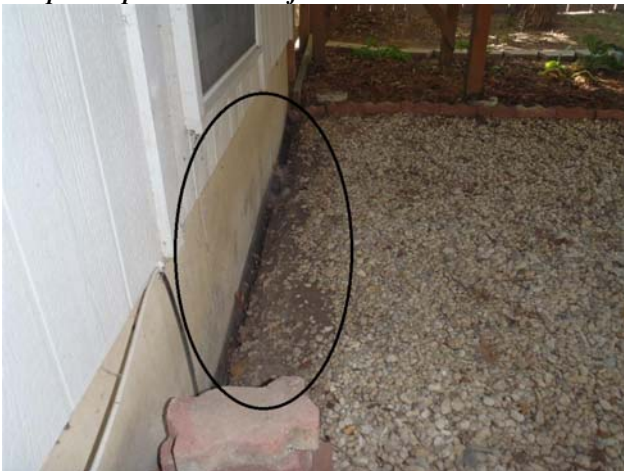
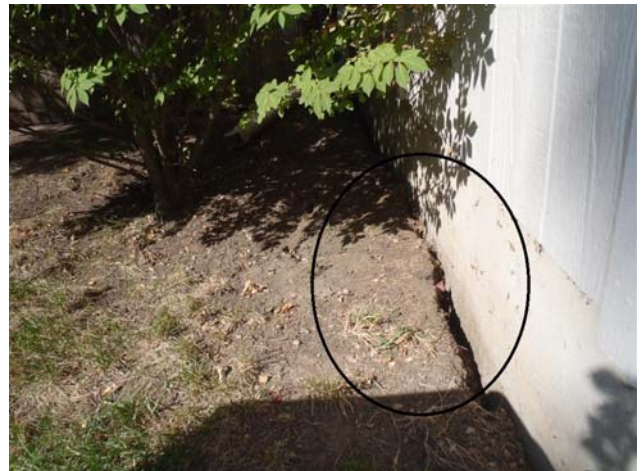
- **Recommend:** The grading should be improved to promote the flow of storm water away from the house. This can often be accomplished by the addition of top soil. The ground should slope away from the house at a rate of one inch per foot for at least the first five feet. At least eight (8) inches of clearance should be maintained between soil level and the bottom of exterior wall siding. *It should be understood that it is impossible to predict whether moisture penetration will pose a problem in the future.*

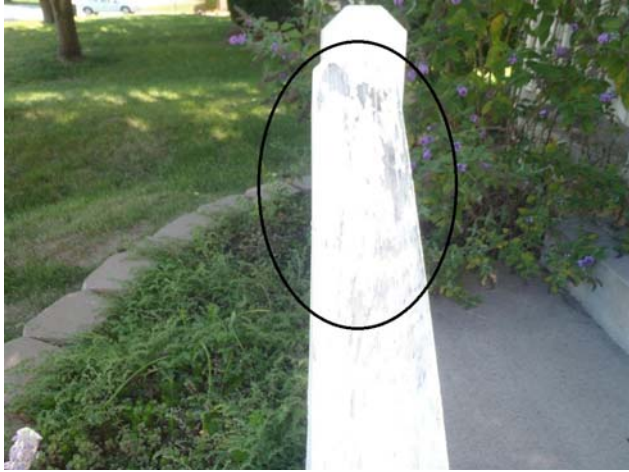
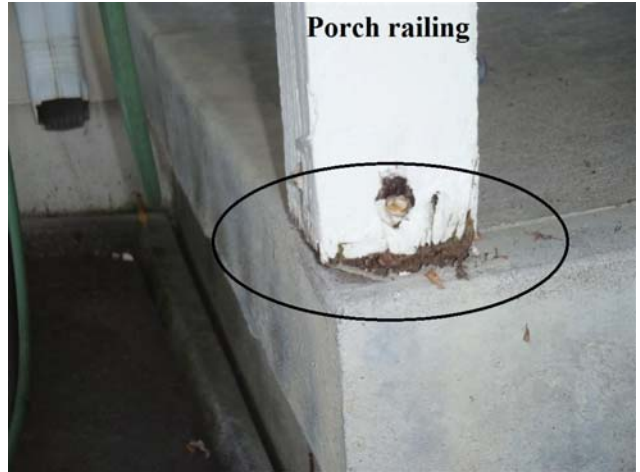
- **Repair:** The porch railing paint is peeling and there is evidence of rot. It is recommended that this be repaired. Further deterioration could compromise safety.

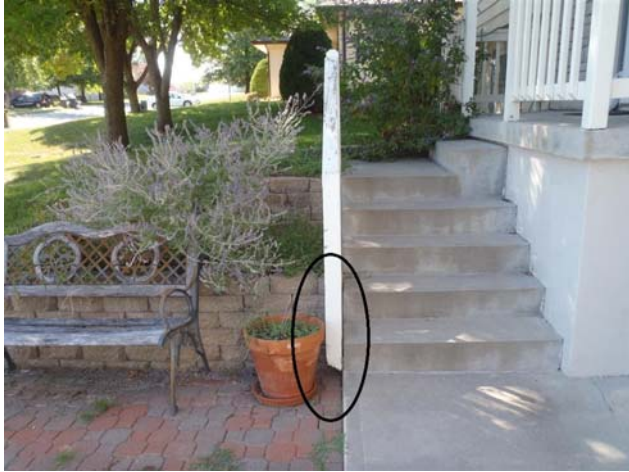
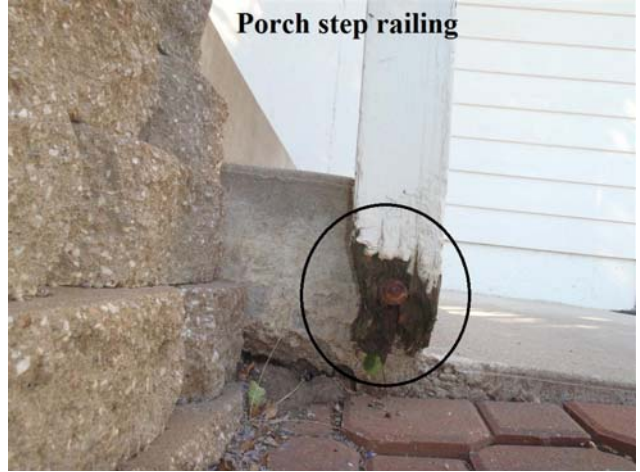
- **Repair, Safety Issue:** The porch step railing is rotted and loose. It is recommended that this be repaired for improved safety.

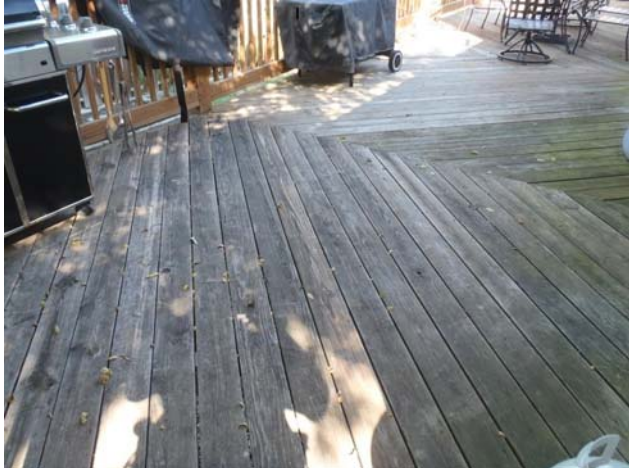
- **Recommend:** The deck should be painted or stained to improve durability.

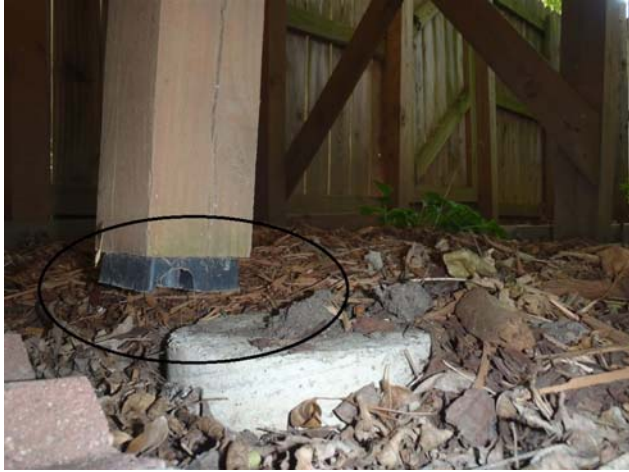
- **Monitor:** The deck steps have settled and some support posts for the deck steps are not well supported. This should be repaired to prevent further movement.

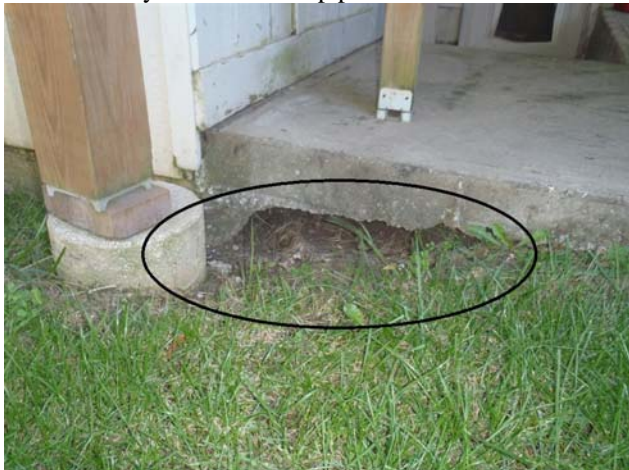
- **Monitor, Repair:** There is an absence of soil underneath the patio due to settlement and/or erosion. It's recommended the cavity be filled to help prevent further settlement.

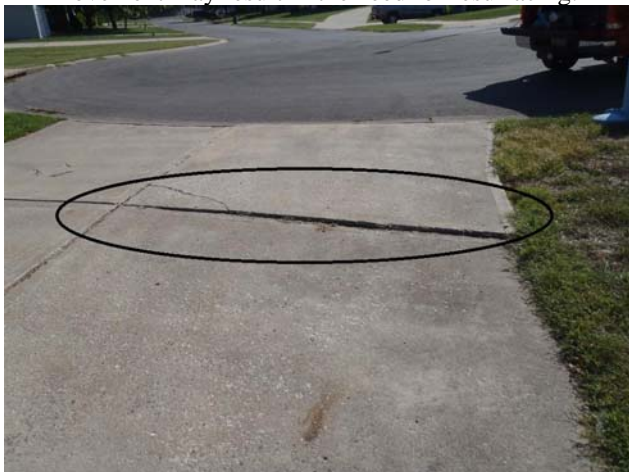
- **Monitor:** The soil below the driveway has settled and/or heaved resulting in cracks and an uneven surface. Persisting movement may result in the need for resurfacing.

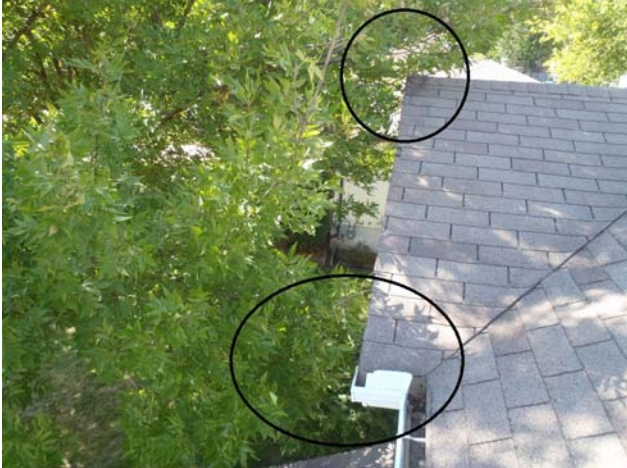
- **Repair:** Tree branches should be trimmed away from the house to avoid damage to the building.

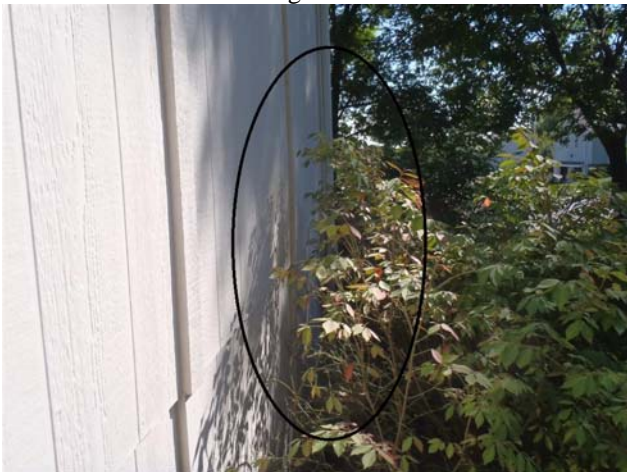
- **Repair:** Shrubs, bushes and/or vines growing on exterior walls need to be trimmed away from the structure to reduce the risk of water damage and insect infestation.

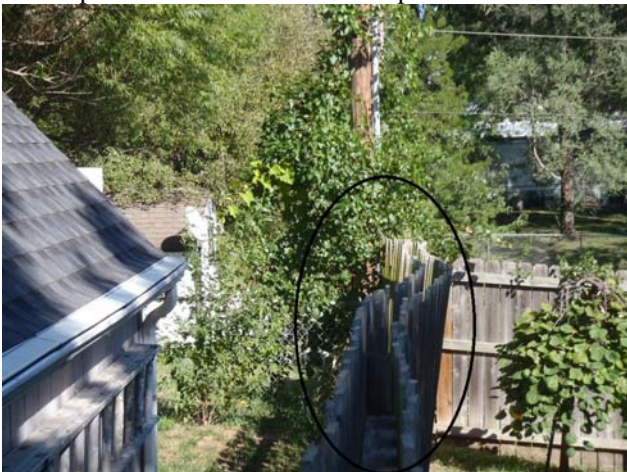
- **Repair:** While the fencing sections are in reasonably good condition, some support posts are in poor condition. Replacement of the deteriorated posts is recommended.

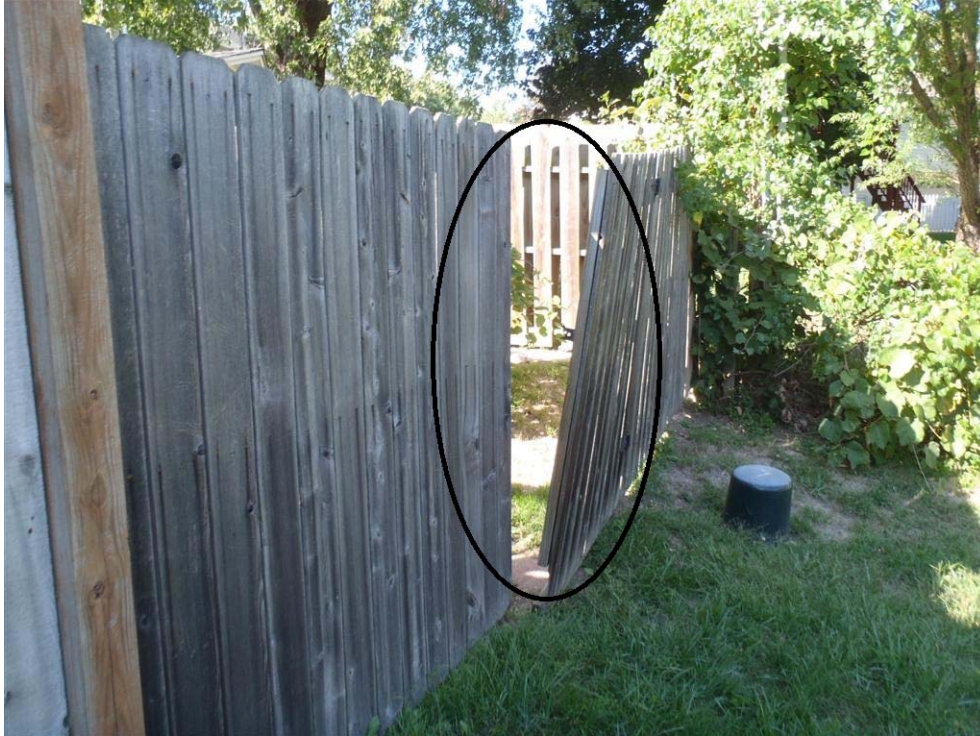
- **Repair:** The gate and/or latch mechanisms on both gates need adjustment to function properly.

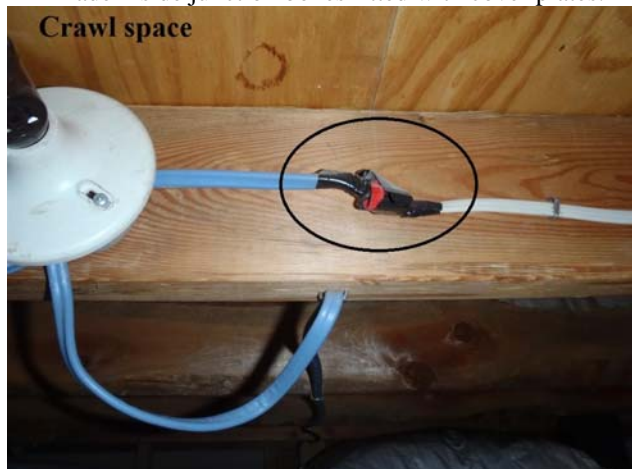
- **Repair:** Improper electrical connections in the crawl space should be repaired. All electrical connections should be made inside junction boxes fitted with cover plates.

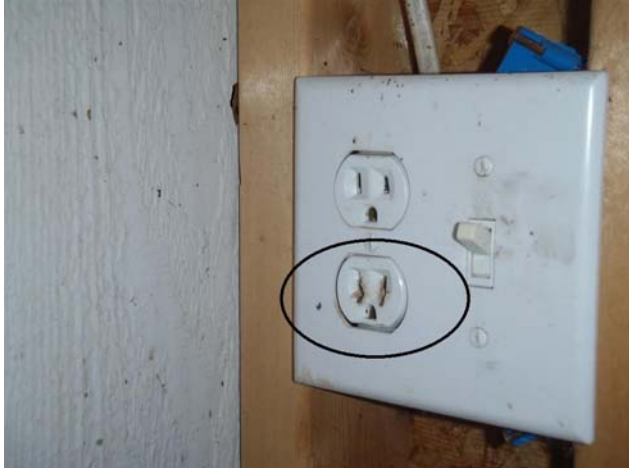
- **Repair:** An outlet in the storage room under the deck is damaged. It should be replaced.

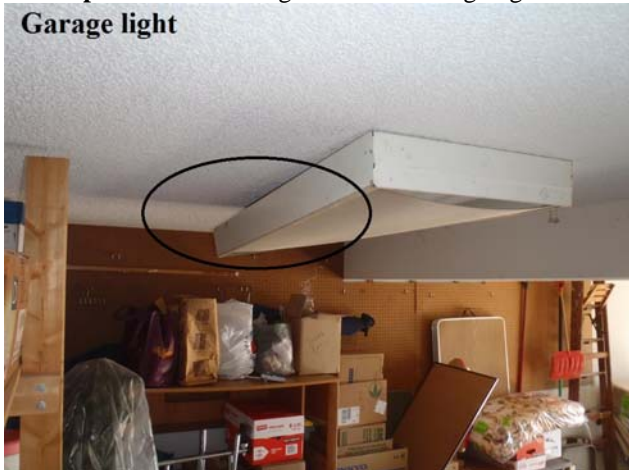
Garage light

- **Repair:** The loose light fixture in the garage should be repaired or replaced.

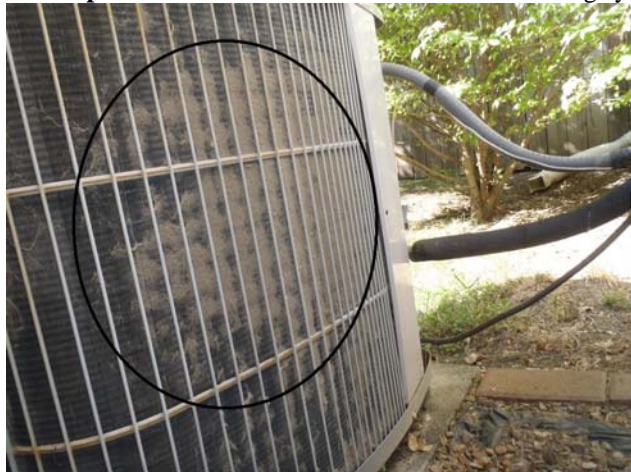
- **Improve:** The outdoor unit of the air conditioning system requires cleaning.

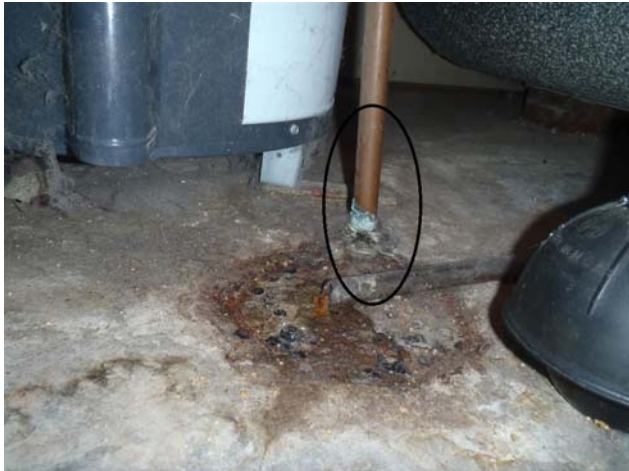
- **Monitor:** Water heaters have a typical life expectancy of 7 to 12 years. The existing unit is approaching or has exceeded this age range. One cannot predict with certainty when replacement will become necessary.
- **Repair:** The discharge piping serving the Temperature and Pressure Relief (TPR) Valve for the water heater should terminate not less than 6 inches or more than 24 inches above the floor.

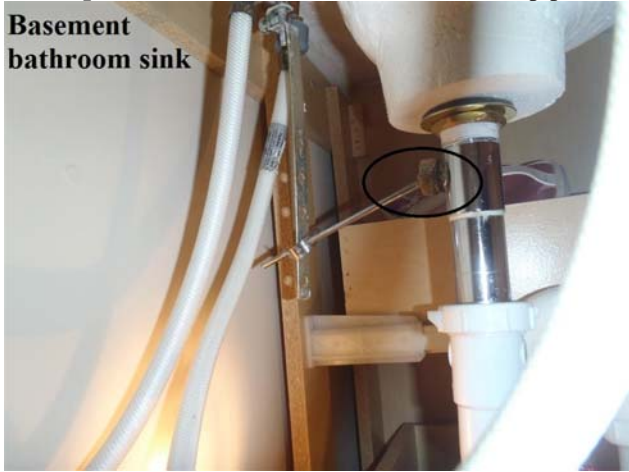
**Basement
bathroom sink**

- **Repair:** The basement bathroom sink drain pipe is leaking.

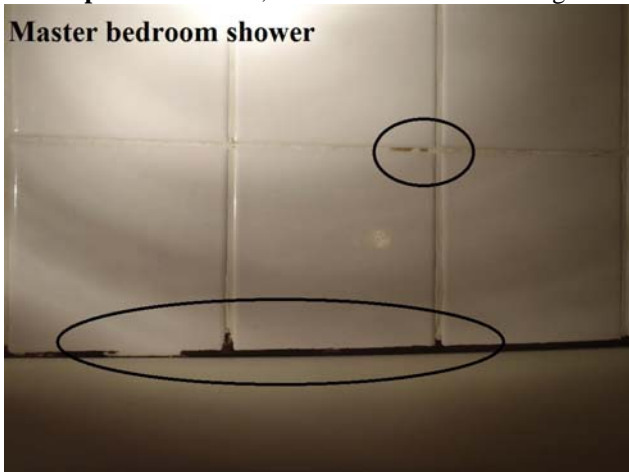
Master bedroom shower

- **Repair:** The sink drain plug is missing and needs repair in the hallway and master bedroom bathrooms.
- **Improve:** Cracked, deteriorated and/or missing shower stall grout and caulk should be improved.(very minor)

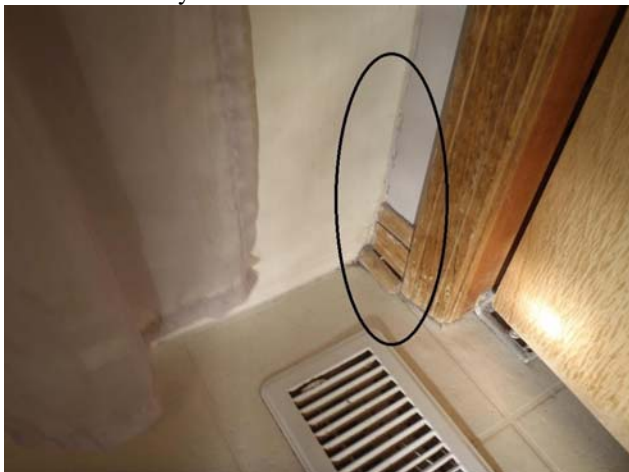
- **Monitor, Repair:** Typical evidence of minor water damage to the trim adjacent to the bathtub was observed. Repair is discretionary.

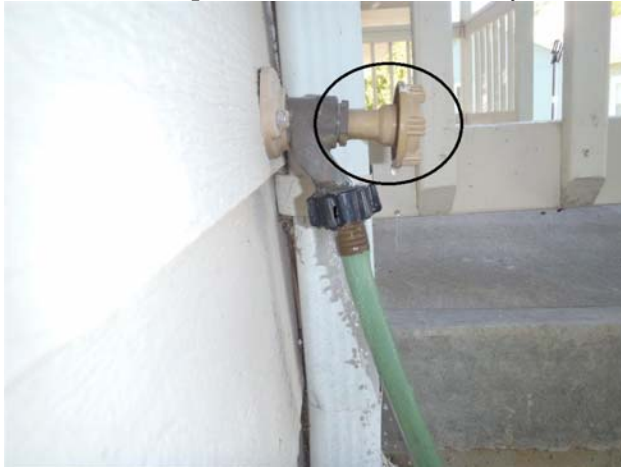
- **Monitor, Repair:** Both hose bibs are leaky when the water is running. Repair is discretionary.

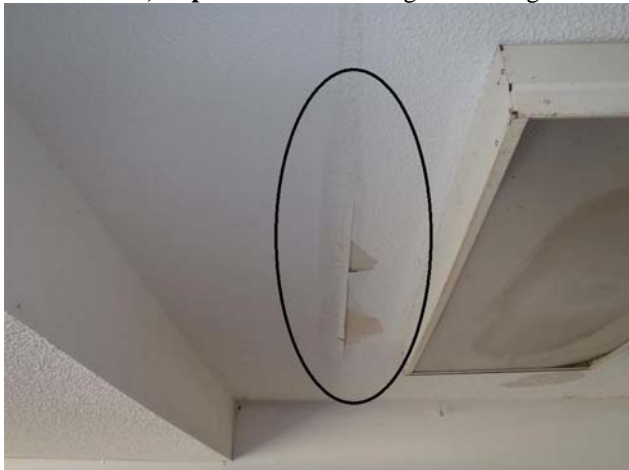
- **Monitor, Repair:** Water staining and damage was noted on the garage ceiling.

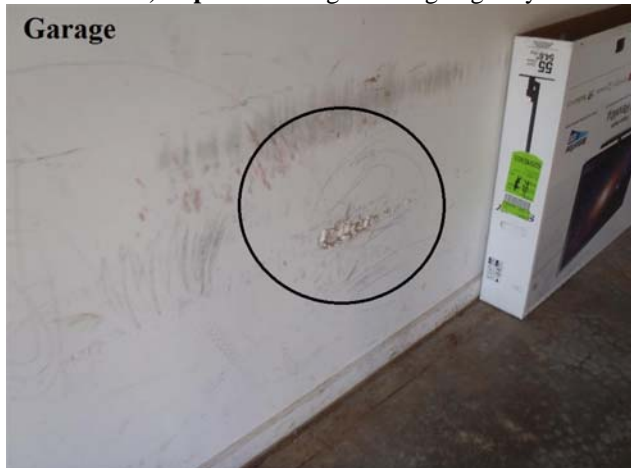
- **Monitor, Repair:** Damage to the garage drywall was observed.

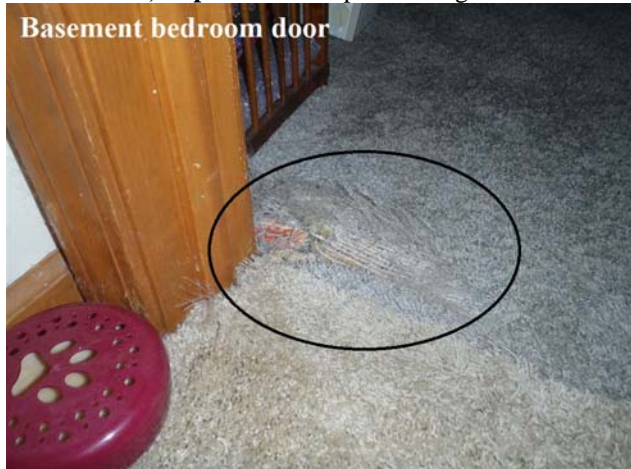
- **Monitor, Repair:** The carpet flooring in the basement bedroom doorway has minor damage

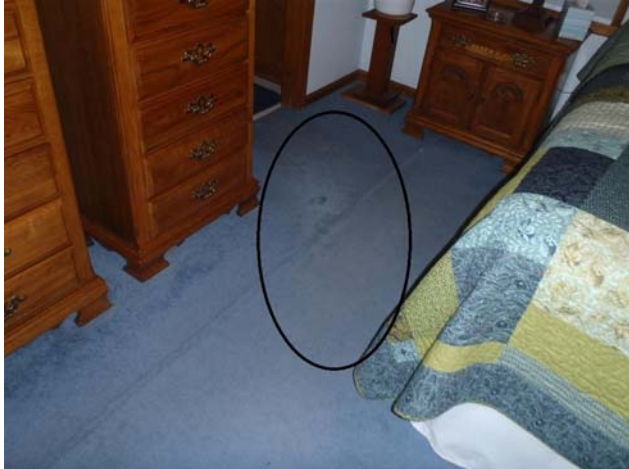
- **Monitor, Repair:** The carpet shows typical wear and/or soiled spots and stains needs stretching in some areas.

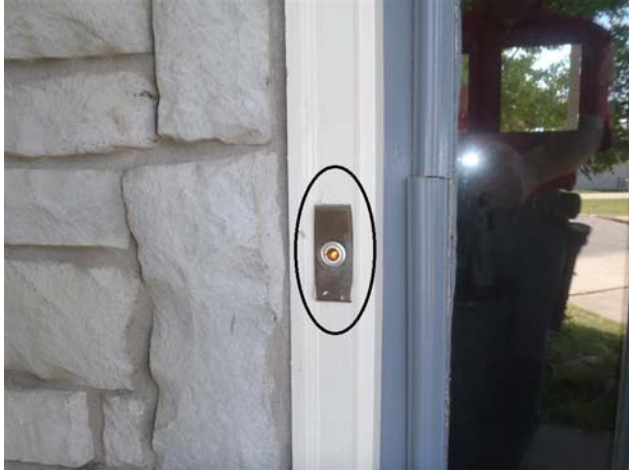
- **Monitor, Repair:** The door bell button is damaged but functional.
