Star Home Inspection Services

Home Inspection Report

501 N Evergreen St, Gardner, KS 66030

Inspection Date: 4/7/2008

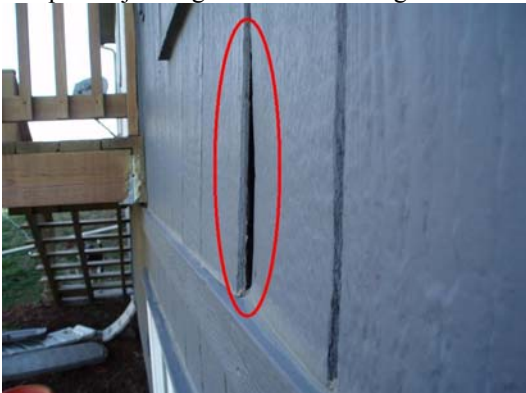
- **Repair:** The loose siding should be re-secured (example near back deck) to avoid water damage. Siding of this type requires considerable monitoring and maintenance. It has a tendency to pop out past nail heads creating a space where two panels join together. Re-securing and caulking these areas is standard maintenance for this type of siding.

- **Repair:** The paint on the trim around the garage door and back deck door is peeling. These areas should be painted to prevent water damage and rot.
- **Monitor. Repair:** Localized minor damage of the siding was observed (back area where pet chewed small area at bottom edge of siding). This area should be repaired/painted.
