**Star  
Home  
Inspection Services**

*Home Inspection Report*

**5042 Canterbury St, Roeland Park, KS 66205**

**Report Number:** 11142008-1A

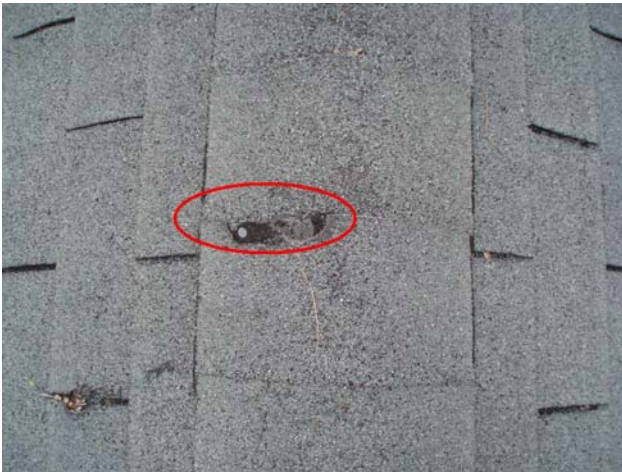
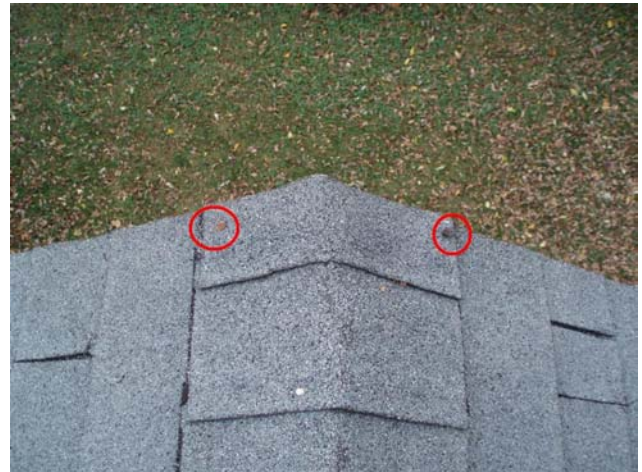
- **Repair:** Minor repairs to the roofing are needed. Damaged or missing roofing material should be repaired. All roof penetrations should be examined and sealed as necessary. Nail heads are exposed at the flashing and ridge cap. They should be sealed to reduce risk of leaks.

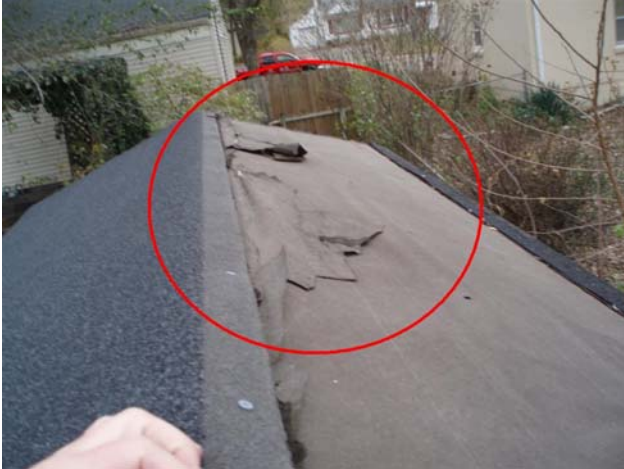
- **Repair:** The roofing for the back shed is missing roof shingle covering and should be repaired/replaced.

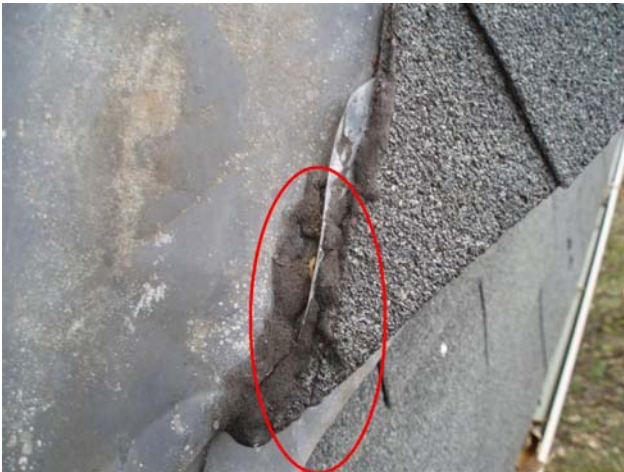
- **Monitor:** The flashing is vulnerable (example near the bottom edge of front garage valley) and should be carefully monitored for leaks.

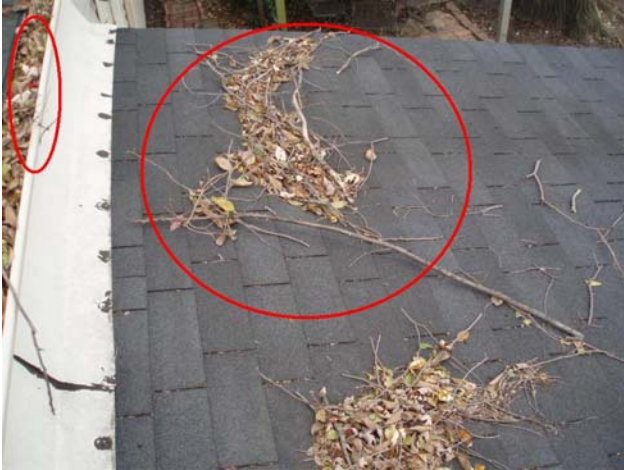
- **Repair:** The gutters require cleaning to avoid spilling roof runoff around the building – a potential source of water entry or water damage. Leaves and debris should be removed from sunroom roof.

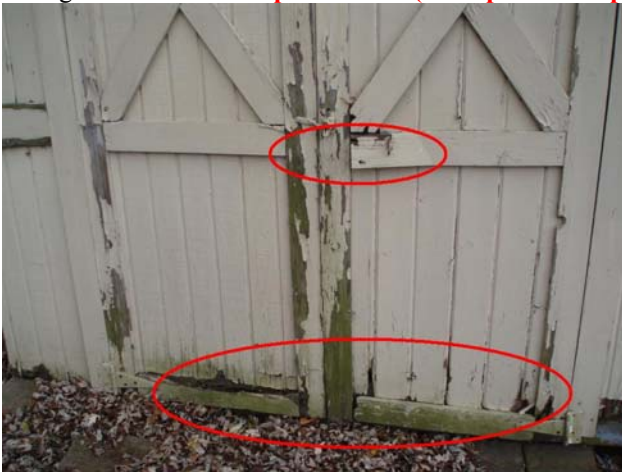
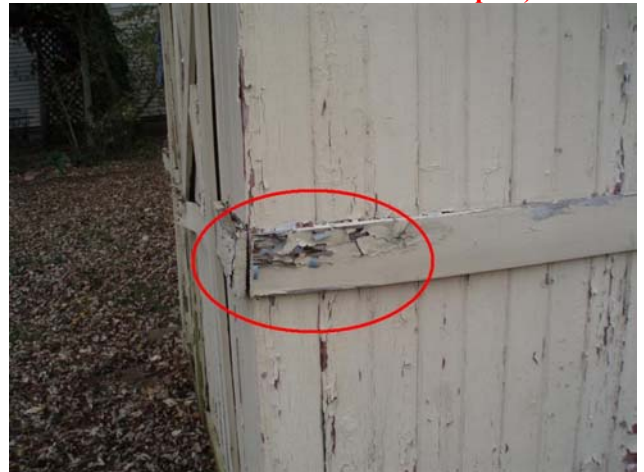
- **Repair:** The paint on the trim around the windows and door frames is peeling. These areas should be painted to prevent water damage and rot. **Repaired (scrapped and painted windows and painted back door)**
- **Repair:** Localized damage of the siding and of exterior walls at shed should be repaired. There is extra risk of hidden damage in such areas. **Replaced shed (see replacement picture at the bottom of this section of the report)**

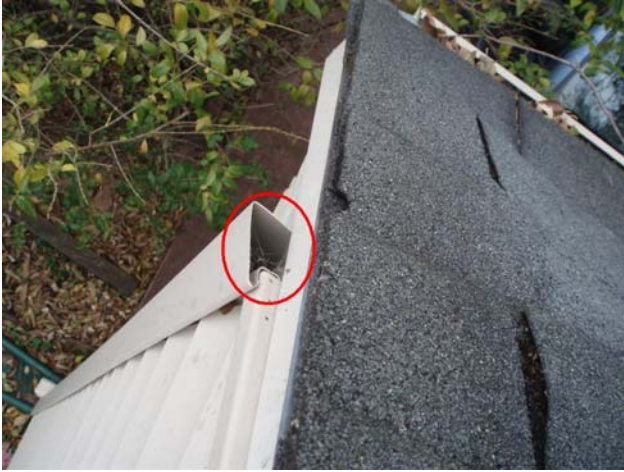
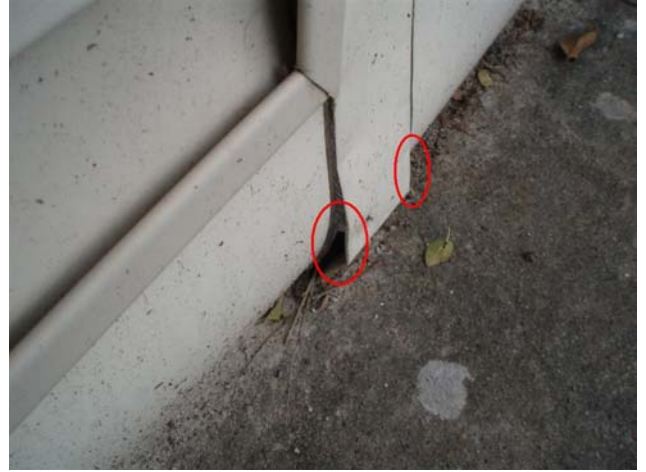
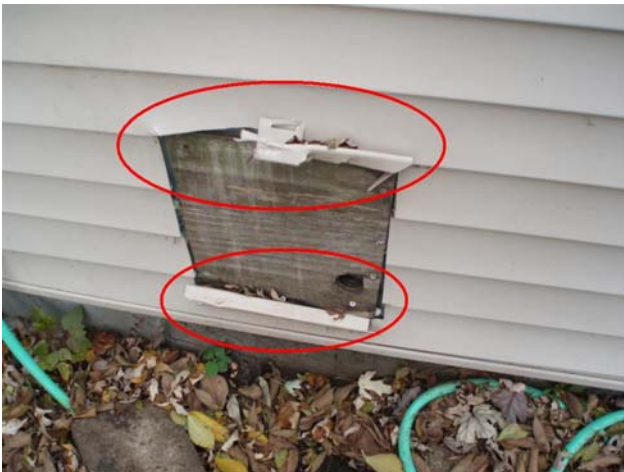
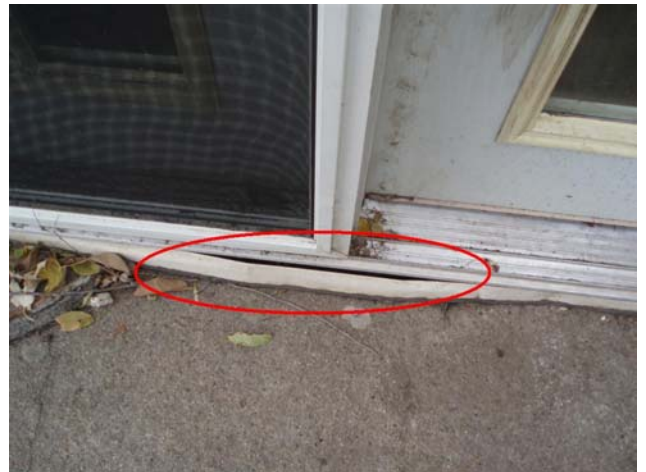
- **Monitor, Repair:** Localized damage of the vinyl exterior should be repaired and all openings (examples at top corners of siding and near sunroom) should be sealed. There is extra risk of hidden damage in such areas. **Repaired (fixed siding on patio door, repaired and painted brick mold on patio door, covered dog door)**

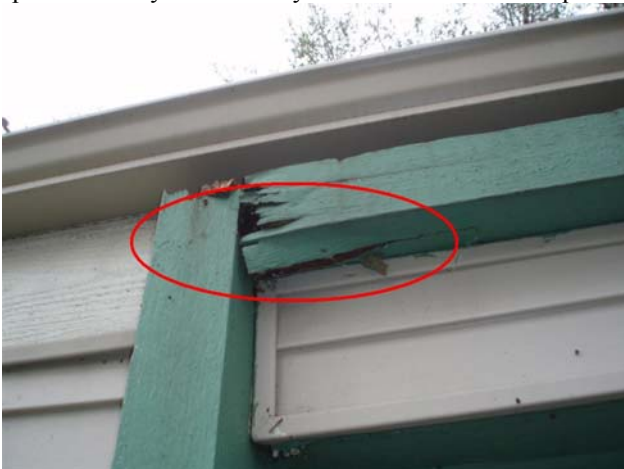
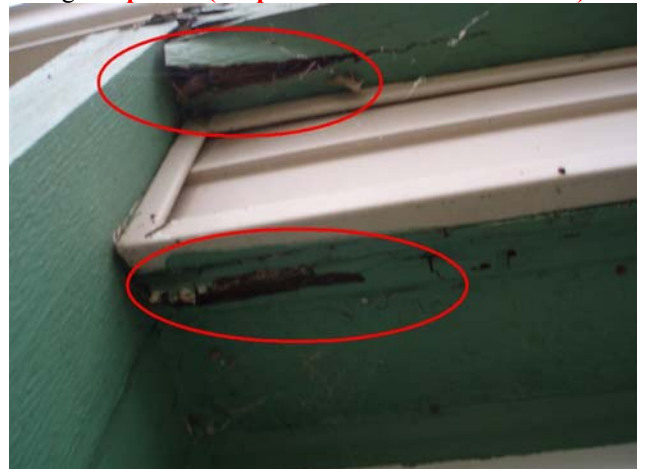
- **Repair:** The front windows are in need of glazing (putty) improvements.
- **Repair:** Localized evidence of rot was visible on window trim/frame. Repair to the window frame can usually be accomplished by a skilled carpenter. It's recommended that a thorough "inventory" be taken by a competent window repair technician to ascertain exactly how many areas will need to be repaired or replaced. Further evaluation by a specialist may well identify additional areas that require servicing. **Repaired (see picture at end of this section)**

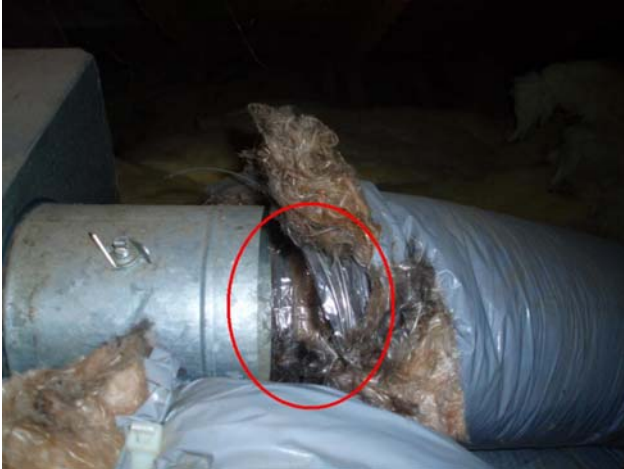
- **Repair:** Loose fitting joints and/or openings in the ductwork should be improved.
