**Star
Home
Inspection Services**

Home Inspection Report

5100 W 158th St Overland Park, KS 66224

Report Number: 04152010-1A

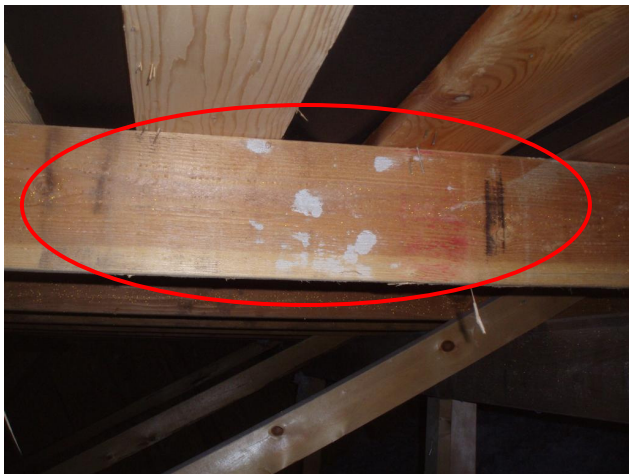
- **Monitor:** Construction mold was visible on some roof rafters. This is mold that grows on the lumber while lying in the weather during construction as evidenced by the strap marks. Most homes have some level of this mold and it goes dormant once removed from the elements and normally does not present any problems.

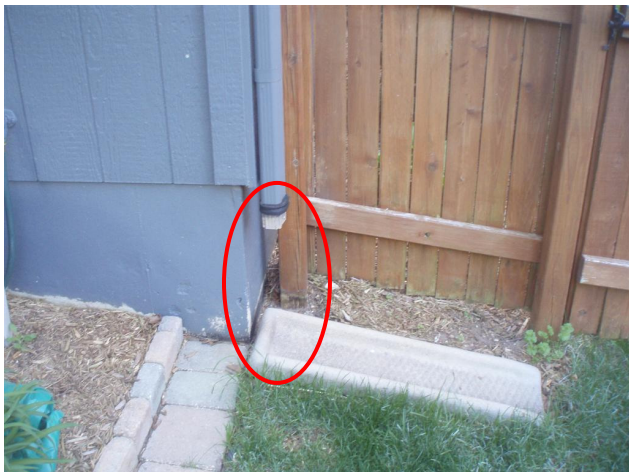
- **Repair:** The downspout should be extended on the northwest corner of the house and should discharge water at least five (5) feet from the house. Storm water should be encouraged to flow away from the building at the point of discharge.

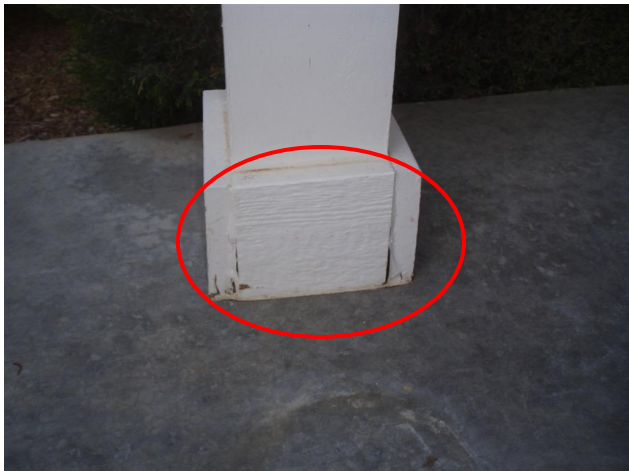
- **Repair:** The trim on the front porch columns needs caulking improvements in localized areas to prevent water damage and rot.

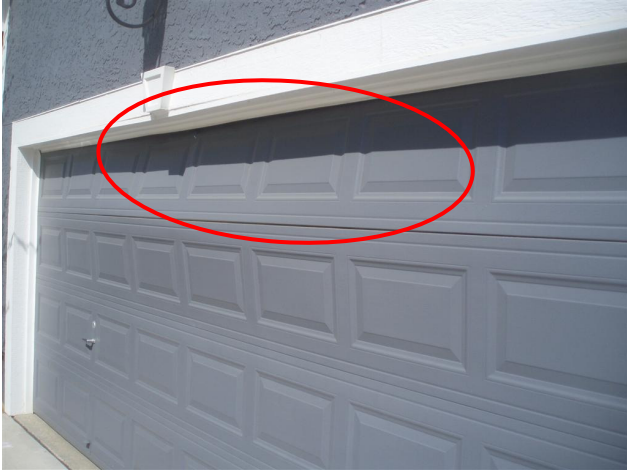
- **Monitor, Repair:** The overhead garage door is damaged and needs repair.

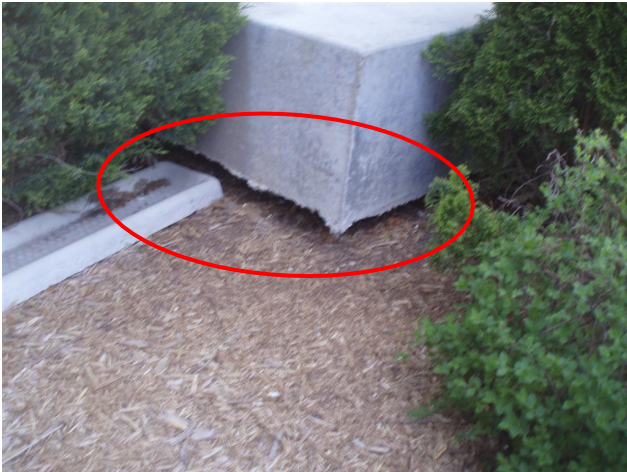
- **Monitor, Repair:** The steps serving the porch have settled and there is an absence of soil underneath due to settlement and/or erosion. It's recommended the cavity be filled to help prevent further settlement.

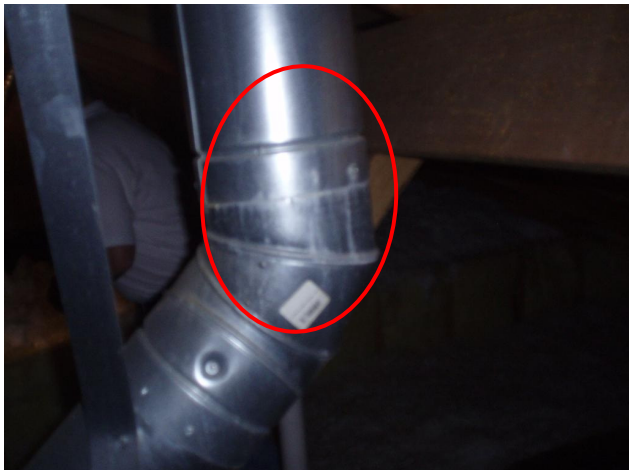
- **Monitor:** While in the attic water stains were observed on the lower sections of the furnace flue. The insulation below the elbow also showed signs of past moisture. It appears that rain blew in under the rain cap and came down the interior of the flue until it got to the first joint where it then transferred to the outside surface and dripped off the elbow. This is a common condition in 80% of homes but very seldom is enough to penetrate completely through the insulation to the drywall below. Monitor for any additional wetness after rains.
