**Star  
Home  
Inspection Services**

*Home Inspection Report*

**5104 W 131st St, Leawood, KS 66209**

**Inspection Date: 06/22/2009**

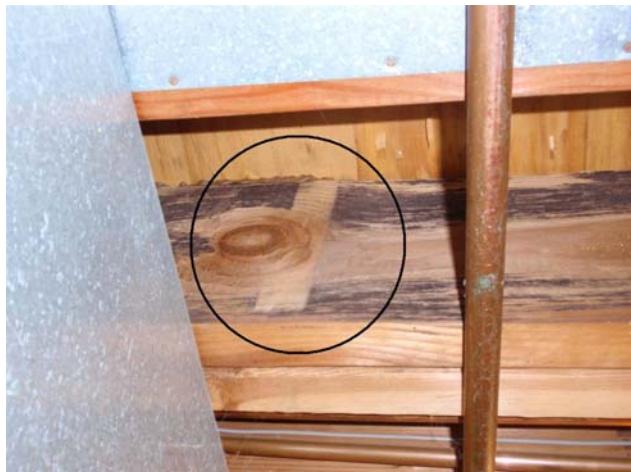
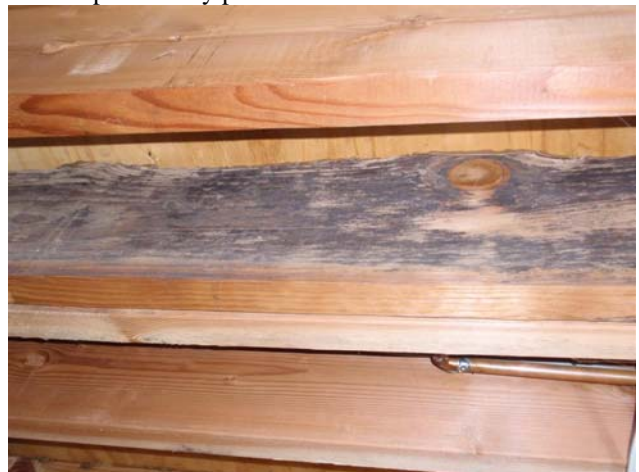
### Floors

- **Monitor:** Construction mold was visible on some floor joists. This is mold that grows on the lumber while lying in the weather during construction as evidenced by the strap marks. Most homes have some level of this mold and it goes dormant once removed from the elements and normally does not present any problems.

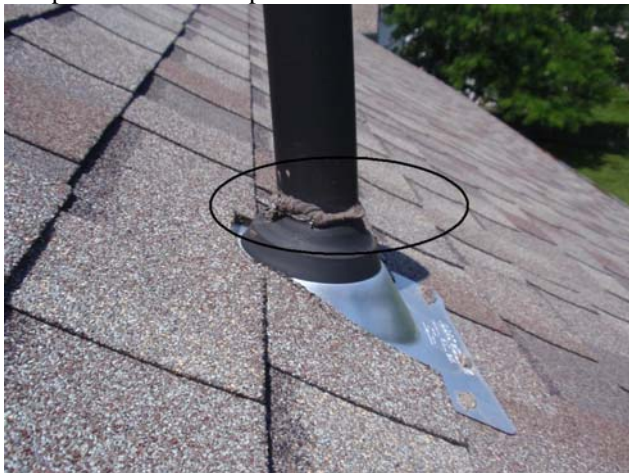
### Flashings

- **Monitor:** The plumbing vent flashing boot(s) have been heavily caulked, leaked in the past and may be vulnerable to leaks. These flashings should be monitored closely. They appear to be in good shape at this time and may have leaked prior to the roof replacement.

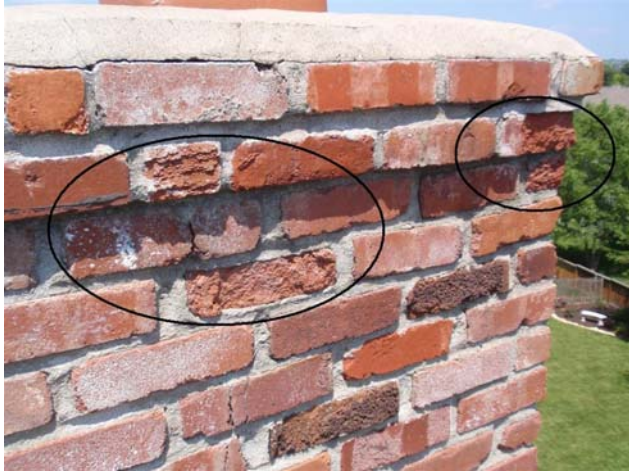
### Chimneys

- **Monitor, Repair:** The masonry chimney shows evidence of spalling (surface deterioration of the masonry). Repair is not critical at this time but this condition should be monitored.

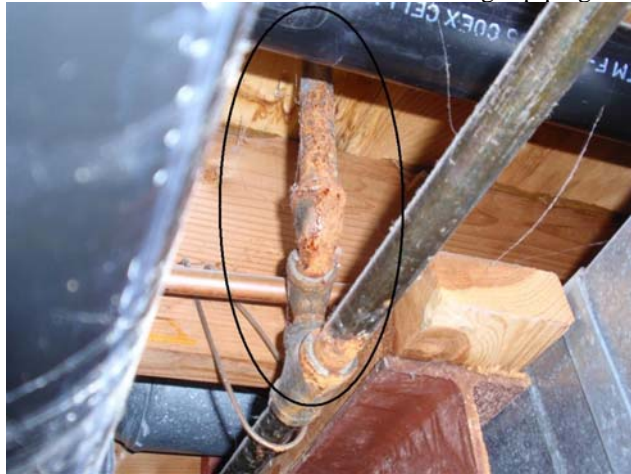
#### Gas Piping

- **Monitor:** Evidence of corrosion of the gas piping was observed on the pipe for the clothes dryer.

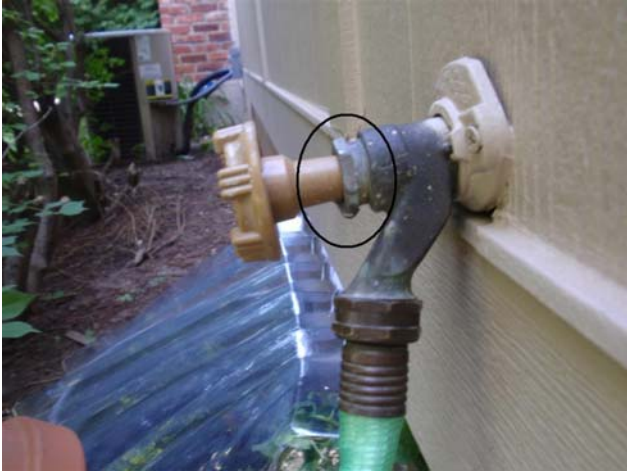
### Plumbing Fixtures

- **Repair:** The half bath toilet is inoperative. Repairs are needed to the handle and chain. **Repaired**
- **Repair:** The west hose bib is leaky. **Repaired**

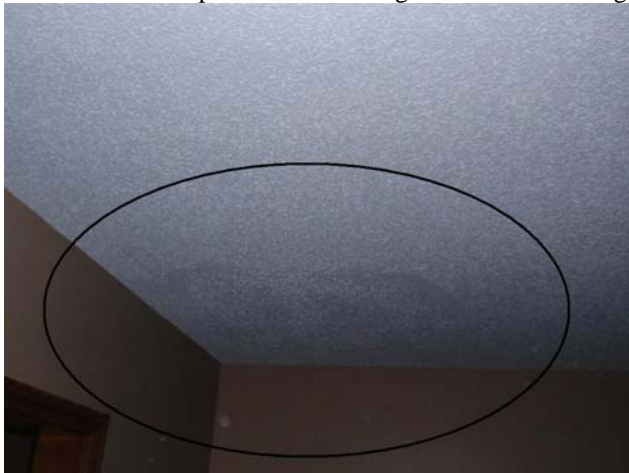
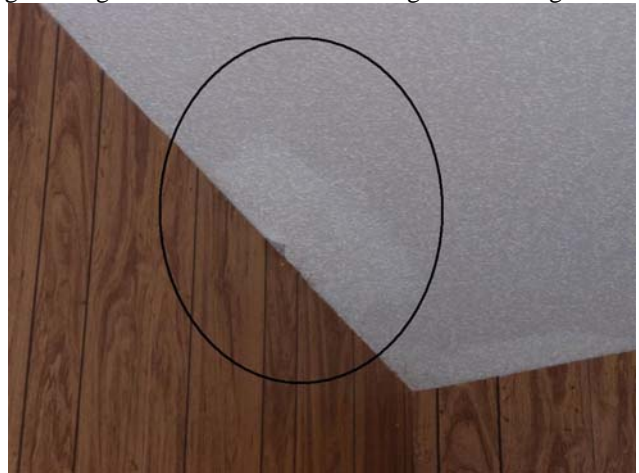
### Wall / Ceiling Finishes

- **Monitor:** Repaired water damage was noted on the garage ceiling and master bedroom reading room ceiling.
