**Star
Home
Inspection Services**

Home Inspection Report

512 NW Ambersham Dr Lees Summit, MO 64081

Inspection Date: 10/22/2009

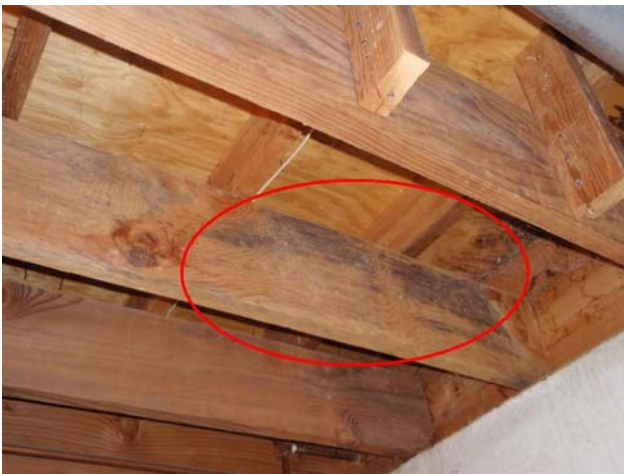
- **Monitor:** Construction mold was visible on some floor joists (i.e. southeast corner of basement). This is mold that grows on the lumber while lying in the weather during construction. Most homes have some level of this mold and it goes dormant once removed from the elements and normally does not present any problems. It can be easily mitigated if desired.

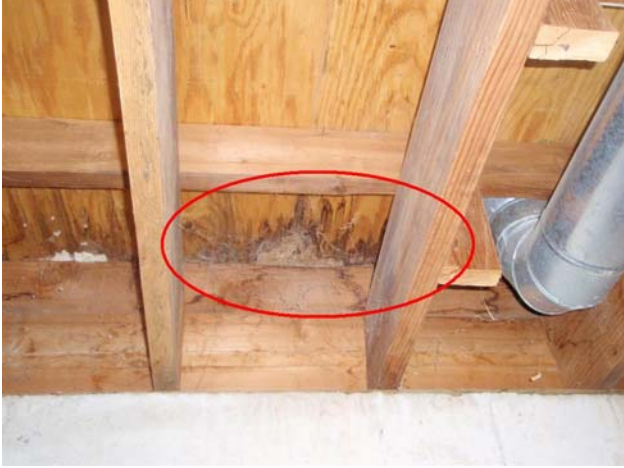
- **Monitor, Repair:** Subflooring at southeast corner of unfinished basement below kitchen east windows shows evidence of minor rot (supporting layer of flooring atop floor joists and below finish flooring or carpeting). Where only limited areas of damage exist this repair can be deferred until combined with other carpentry work at the property.

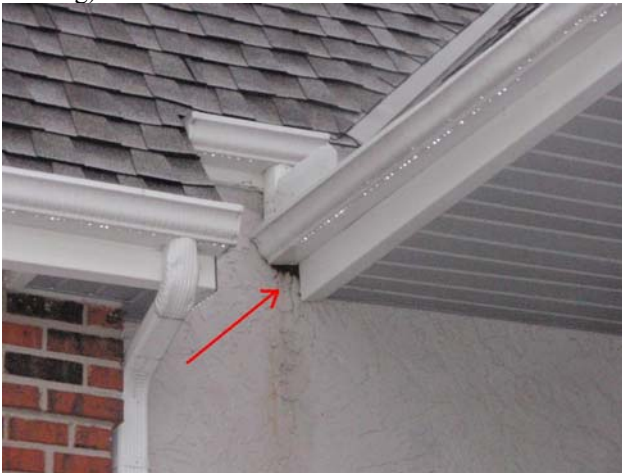
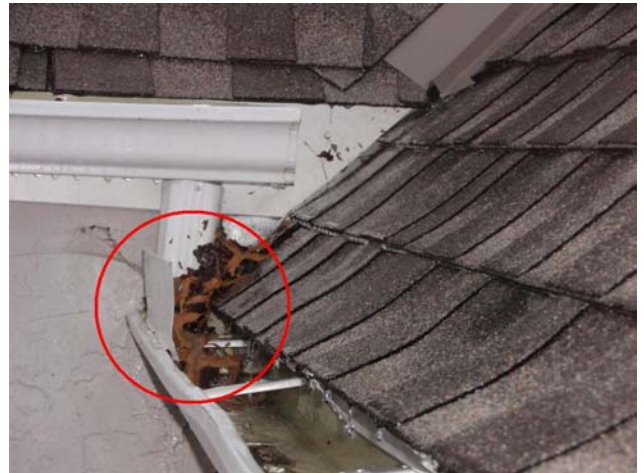
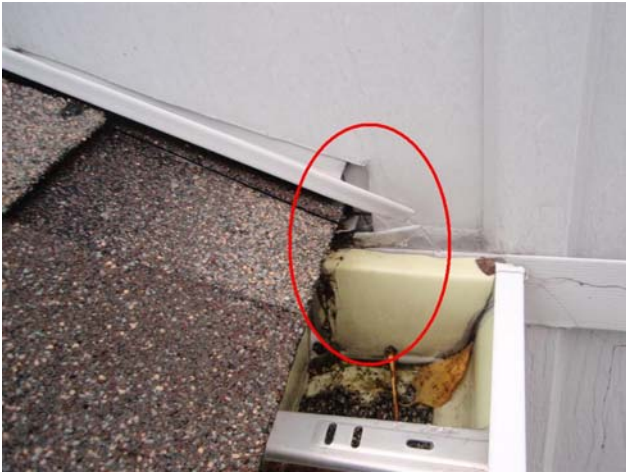
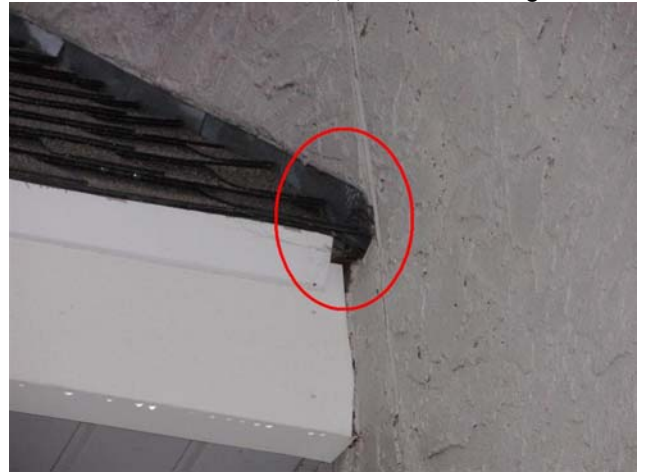
- **Repair:** The installation of the flashing is incomplete (kick-out /diverter flashings are needed) at several locations and should be repaired to avoid leaks (i.e. front area south gutter near porch, corner over garage and at chimney siding flashing).

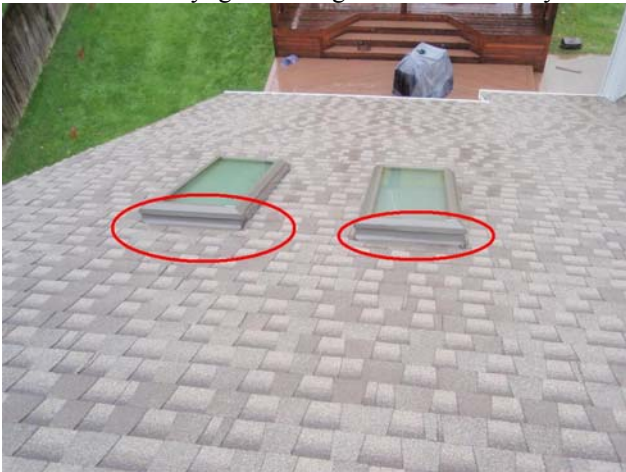
- **Monitor:** The skylight flashing should be carefully monitored. Skylight flashings are extremely vulnerable to leakage.

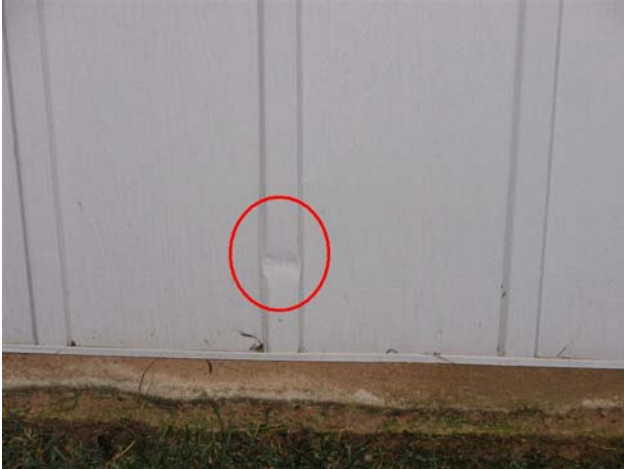
- **Monitor:** Localized minor cosmetic damage of the metal siding was observed.

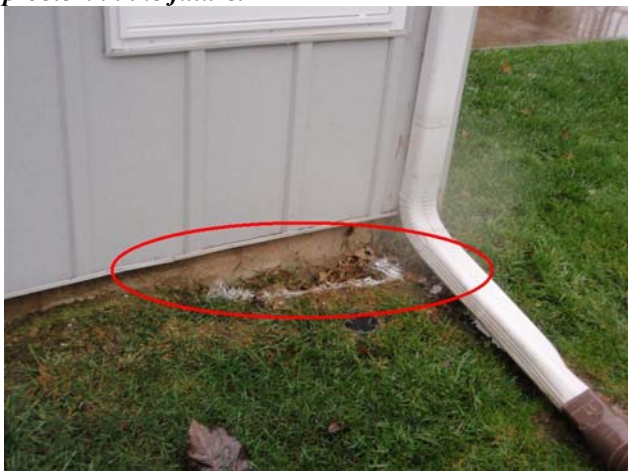
- **Repair:** The grading should be improved to promote the flow of storm water away from the house. This can often be accomplished by the addition of top soil. The ground should slope away from the house at a rate of one inch per foot for at least the first five feet. At least eight (8) inches of clearance should be maintained between soil level and the bottom of exterior wall siding. *It should be understood that it is impossible to predict whether moisture penetration will pose a problem in the future.*
