**Star
Home
Inspection Services**

Home Inspection Report

512 SE Sherri Ln, Blue Springs, MO 64014

Inspection Date: 1/10/2008

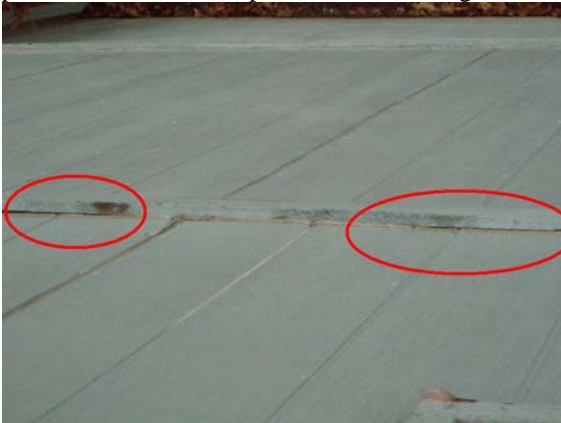
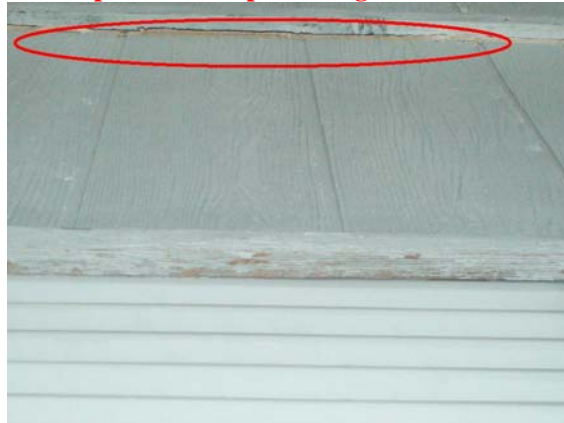
- **Repair:** The paint on the trim around the siding and at north south gable vents trim is peeling. These areas should be painted and caulked to prevent water damage and rot. **Will repair weather permitting**
