**Star
Home
Inspection Services**

Home Inspection Report

5121 Stanton Dr, Kansas City, MO 64133

Inspection Date: 08/13/2009

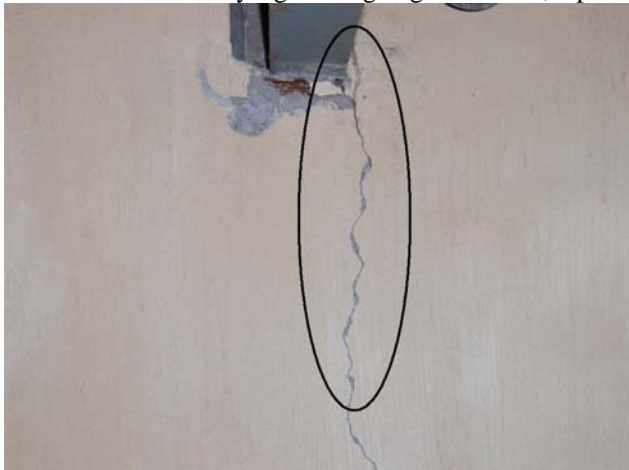
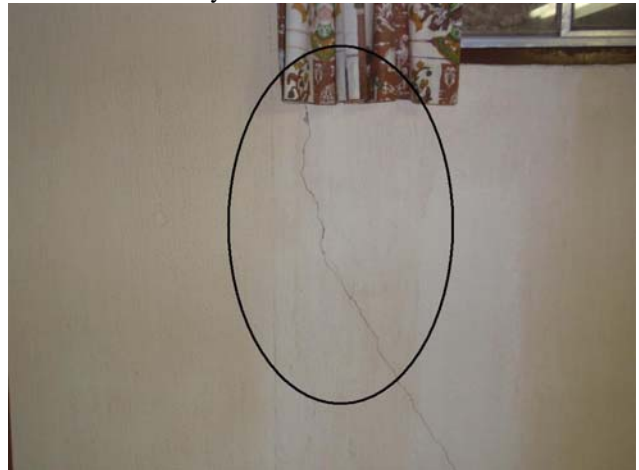
- **Monitor:** Common minor settlement cracks were observed in the foundation walls. This implies that some structural movement of the building has occurred. Cracks of this type should be watched for any sign of additional movement. In the absence of any sign of ongoing movement, repair should not be necessary.

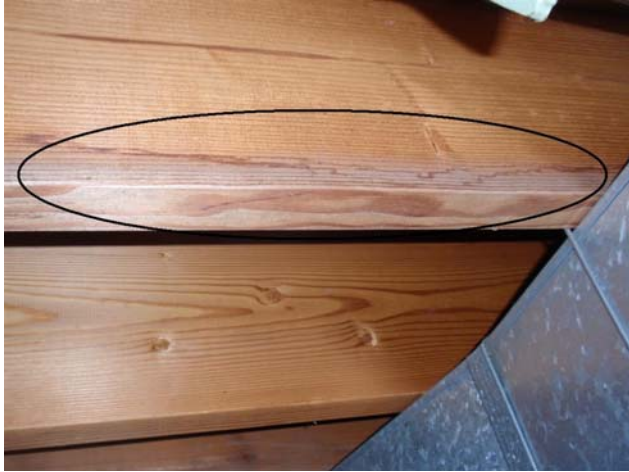
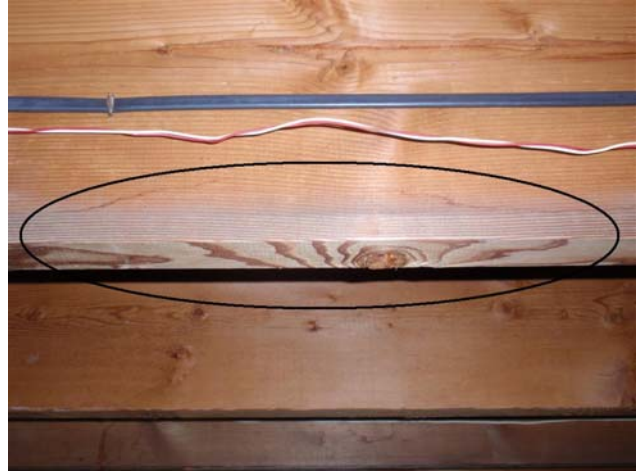
- **Monitor:** Minor amount of construction mold was visible on some floor joists. This is mold that grows on the lumber while lying in the weather during construction. Most homes have some level of this mold and it goes dormant once removed from the elements and normally does not present any problems.

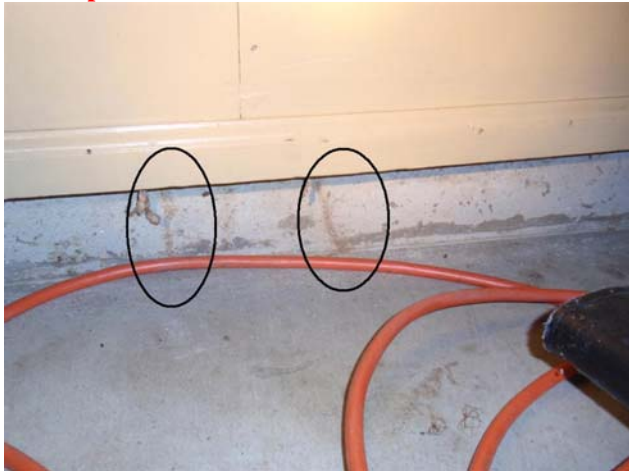
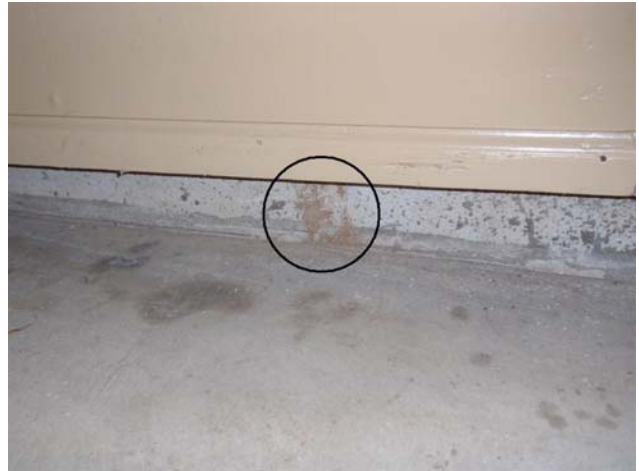
- **Monitor, Repair:** Evidence of termite activity was observed in the garage and there is risk of additional hidden damage. If the property has not already been treated, a licensed pest control specialist should be engaged. Termites can do a substantial amount of damage to the wood structural components of a home. See termite report by third party for additional information and recommendations if any. Seller indicates it is scheduled to be treated in the near future.

Inspected and hole hose treated

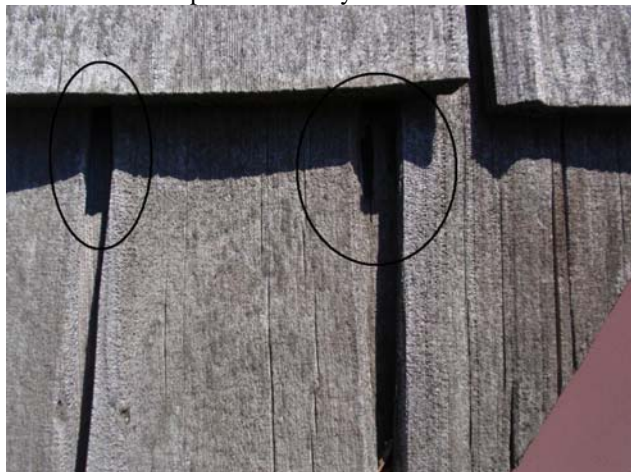
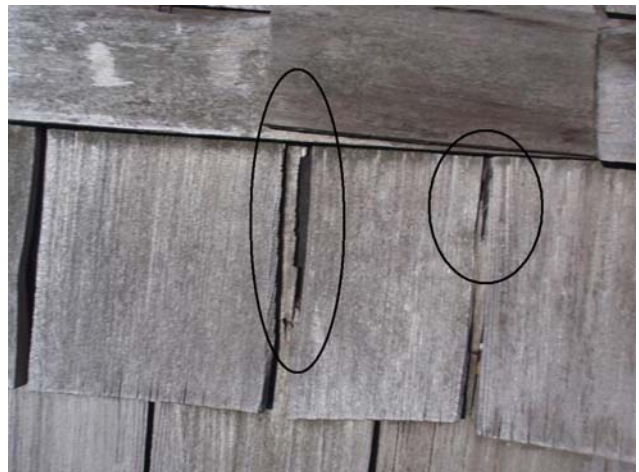
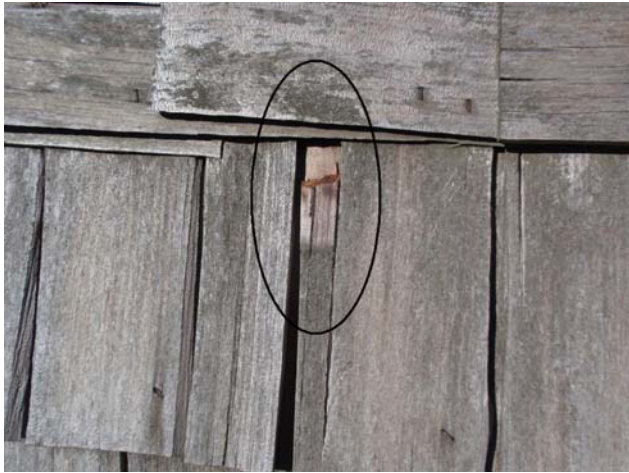
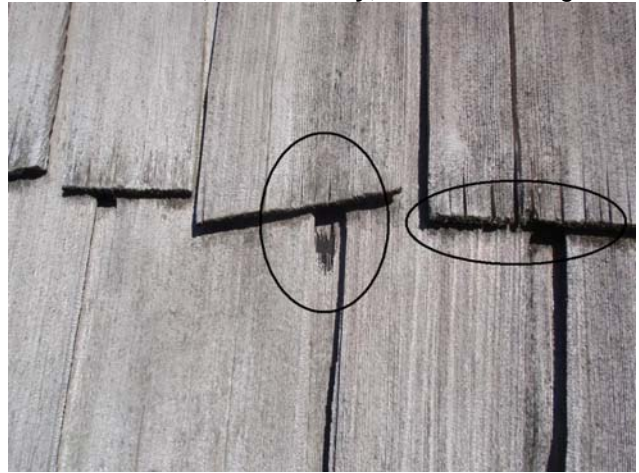
- **Repair:** The life expectancy of wood roofs is generally 15 to 20 years with some spot repairs or tune ups needed around the 10th year. This will depend on several factors such as the quality of shingle or shake, the slope of the roof (steeper is better), the amount of exposed shingle, and the amount of sun or shade. As with all roofs, annual maintenance is needed. Cracked, curled, or displaced shingles or shakes should be repaired. As a rule of thumb, replacement of the entire roof covering may be logical if more than ten percent of the wood roof requires repair. Some minor curling, a few places of exposed black felt sheathing, loose shingles and minor deterioration of the shingle ends was observed. It's recommended that a roofing contractor be consulted for a second opinion and to get an estimate of any repairs needed. A minor tune up is most likely needed.

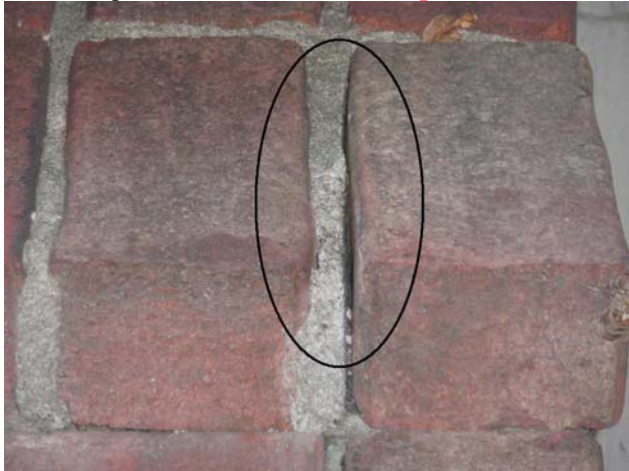
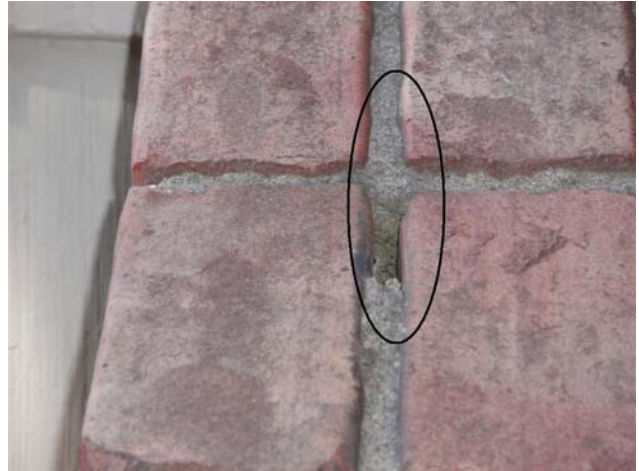
- **Repair:** The masonry chimney needs re-pointing (replacing the mortar between the bricks) to avoid water damage on the top of the smoke chamber. **Repaired**

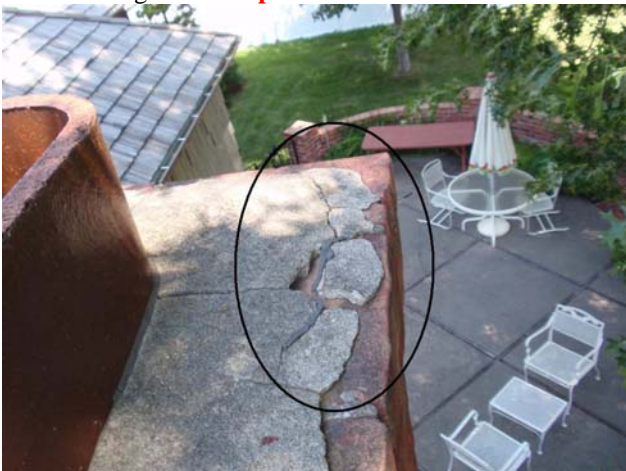
- **Repair:** The cap of the masonry chimney is cracked and deteriorating. This should be repaired to prevent further damage from freezing water. **Repaired**

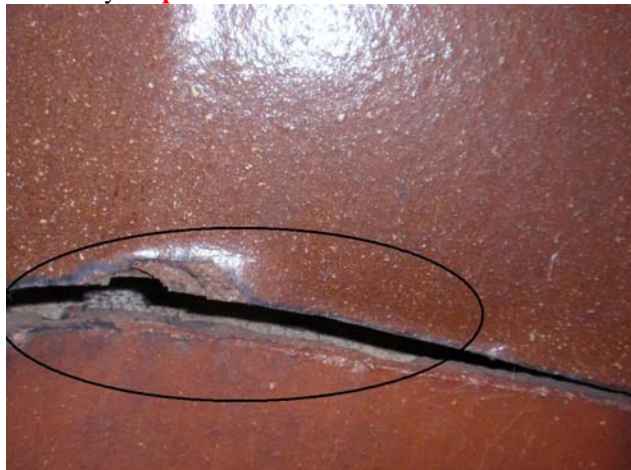
- **Repair, Safety Issue:** There are gaps in the flue liner. The flue needs to be repaired and the entire flue inspected for safety. **Repaired**

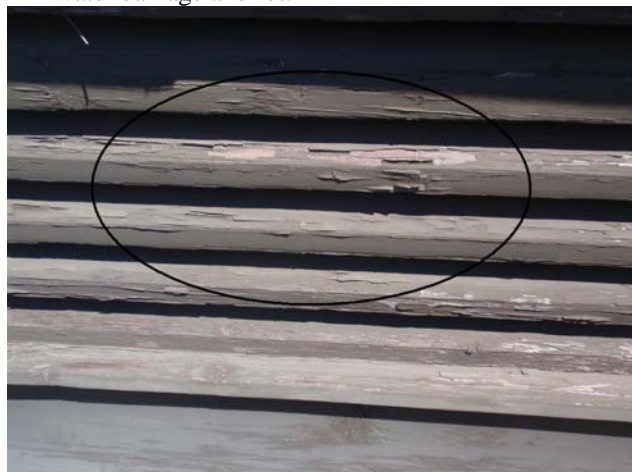
- **Repair:** The paint on the trim of the large roof vent over the garage is peeling. These areas should be painted to prevent water damage and rot.

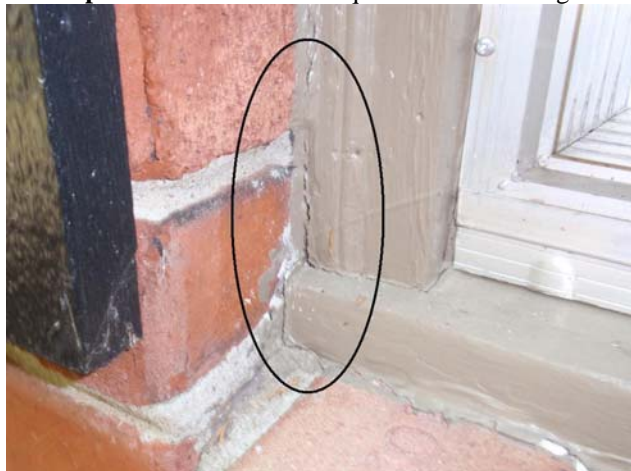
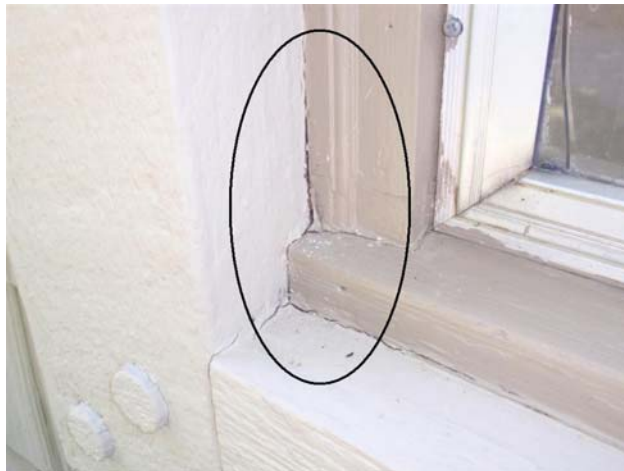
- **Repair:** Some windows require minor caulking.

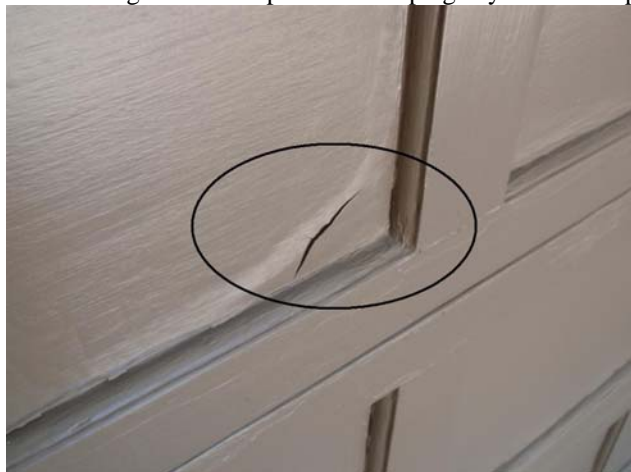
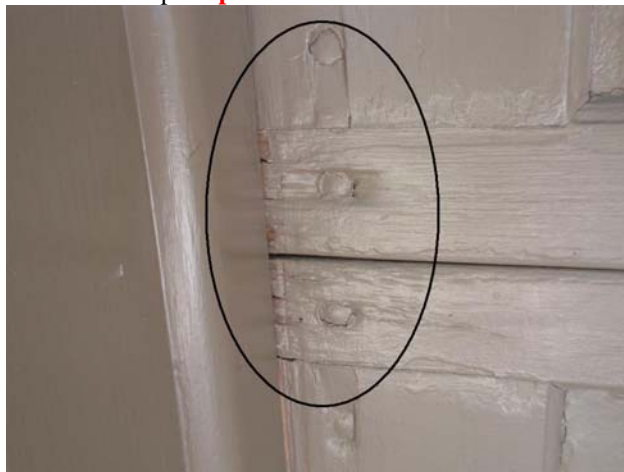
- **Monitor, Repair:** The overhead garage door shows evidence of repaired minor water damage and the hinge bolts are beginning to pull through the door panels and some paint is peeling. These areas should be monitored closely. Maintain with a good coat of paint and keeping any cracks or open areas closed up. **Repaired**

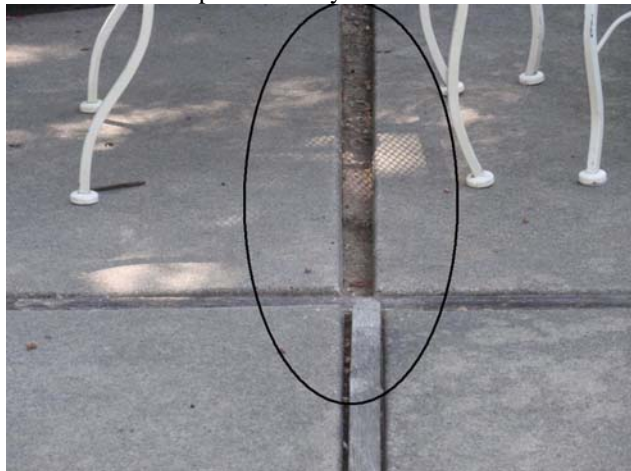
- **Repair, Safety Issue:** The patio has missing and loose spacer boards creating a trip hazard. This condition should be altered for improved safety.

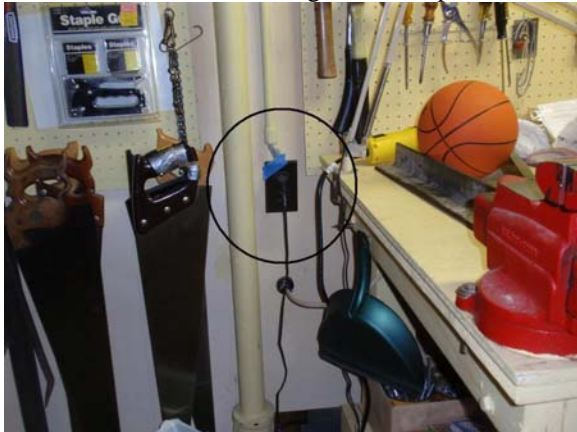
- **Repair:** An outlet by the basement workbench has reversed polarity (i.e. it is wired backwards). This outlet and the circuit should be investigated and repaired as necessary.

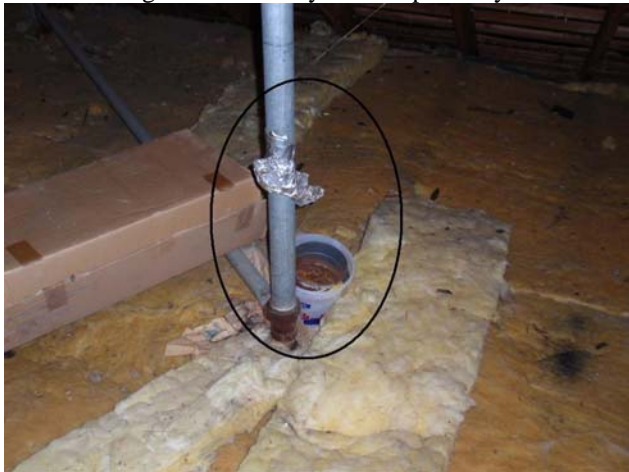
- **Monitor:** While in the attic a bucket was observed next to the kitchen plumbing vent pipe. It appears to have been there for a long time and is dry. It was probably never removed once the roof was replaced or the vent flashing repaired.

Left over from a leak years ago. Removed bucket

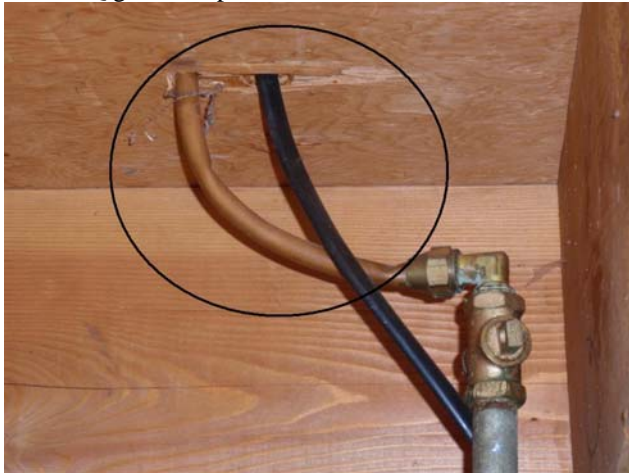
- **Monitor, Repair:** Copper tubing is no longer suitable for gas piping by most gas utility companies. This should be confirmed or verified with the local gas company and if confirmed it's recommended this pipe to the clothes dryer and BBQ grill be replaced with one of suitable material.

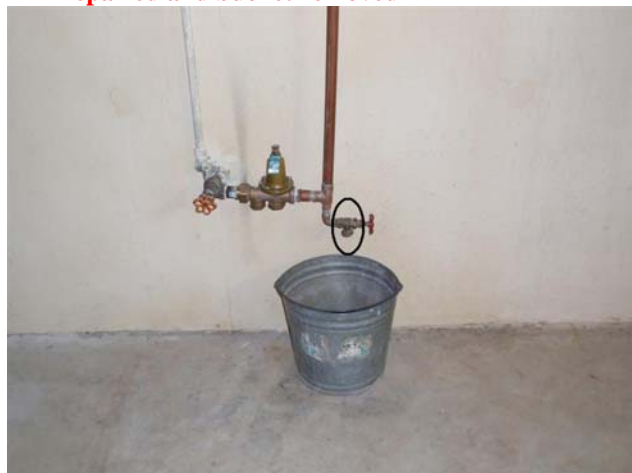
- **Monitor, Repair:** The master bedroom shower head needs improvement.
- **Repair:** The hose bib in the basement by the main water shut off continues to drip when turned off and needs repair.

Repaired and bucket removed

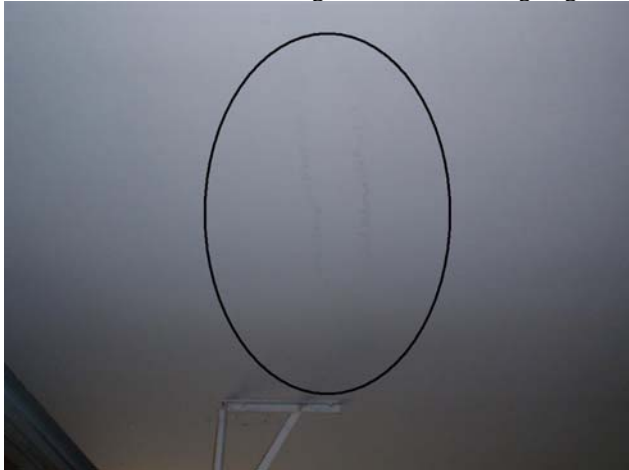
- **Monitor:** Water staining was noted on the garage ceiling and appears to be very old.

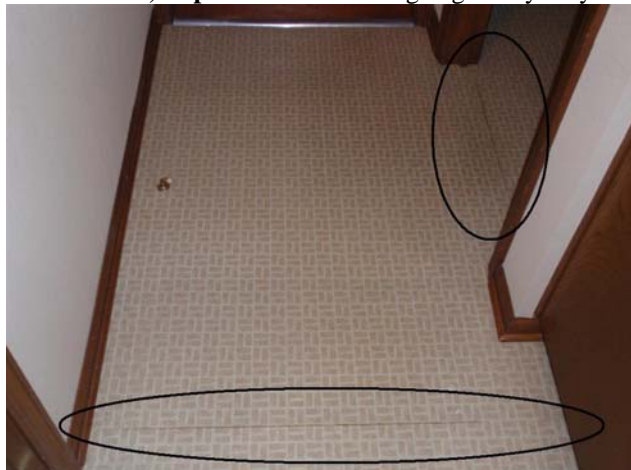
- **Monitor, Repair:** Seams in the garage entry vinyl flooring are curling. Improvement is discretionary.

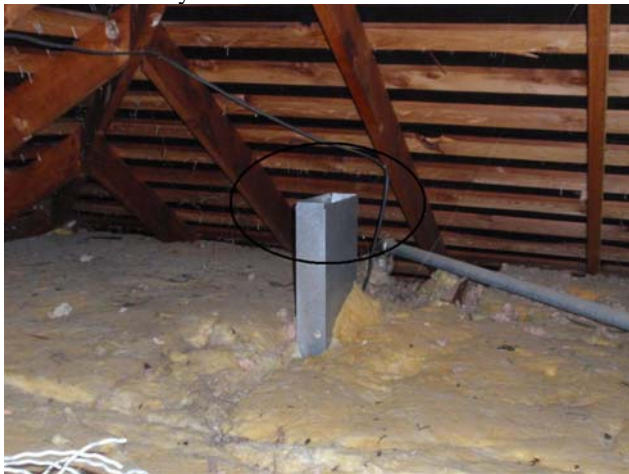
- **Monitor, Repair:** The hood exhaust fan should discharge to the building's exterior and not the attic. Repair is discretionary.

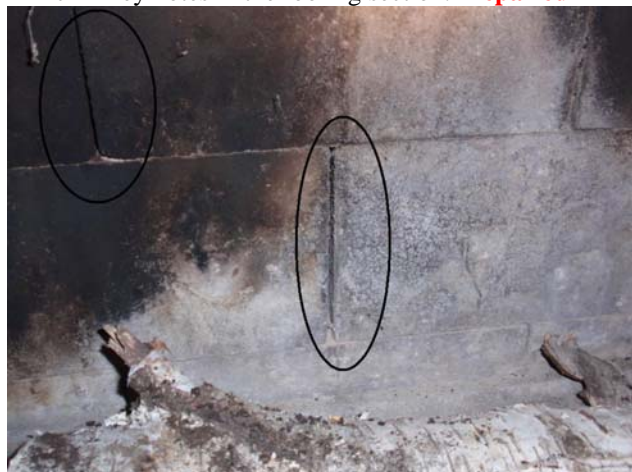
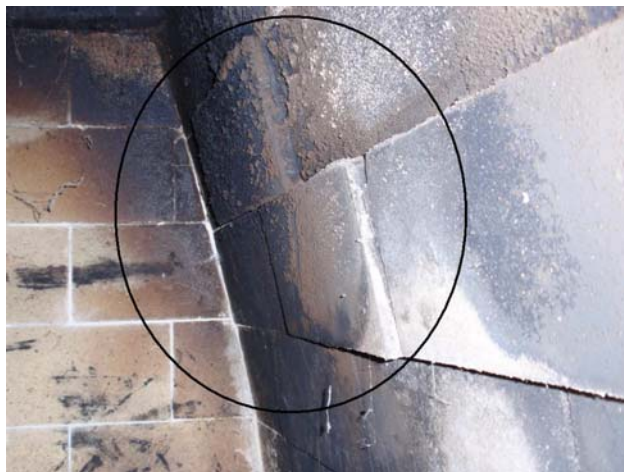
- **Repair, Safety Issue:** The rear wall of the fireplace firebox should be repaired for improved safety. See also the chimney notes in the roofing section. **Repaired**
