Star Home Inspection Services

Home Inspection Report

5411 W 77th St, Prairie Village, KS 66208

Report Number: 02032009-2A

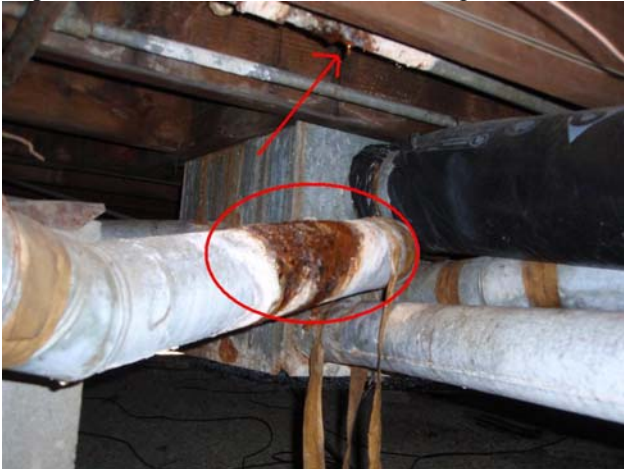
- **Repair:** Corroded ductwork in the crawl space should be repaired or replaced.

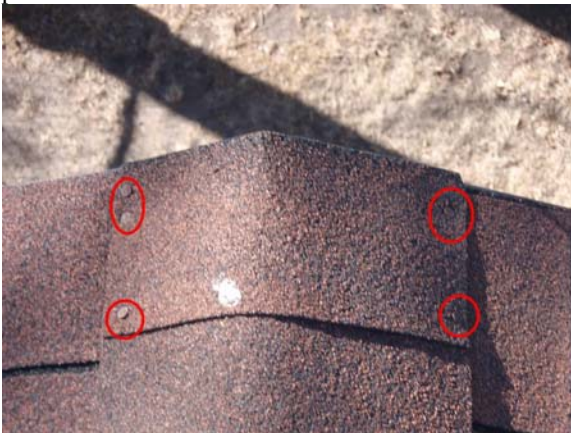
- **Repair:** Exposed nail heads were observed in the ridge caps. All exposed nail heads should be caulked to reduce the potential of leaks.

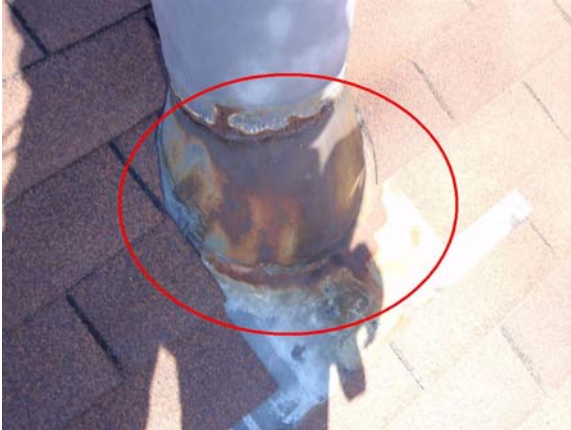
- **Repair:** The water heater vent flashing is rusting. It should be painted to extend its life.

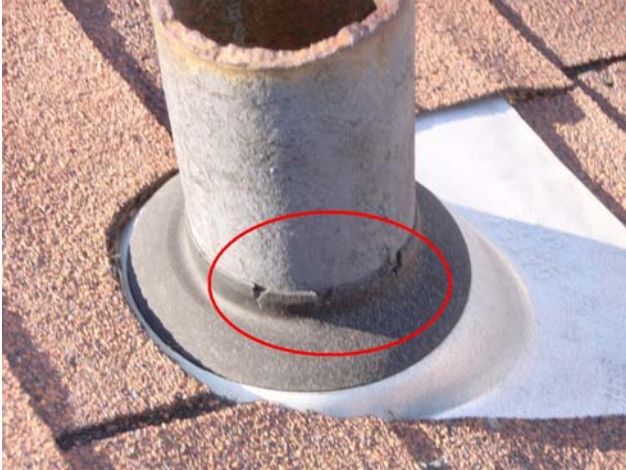
- **Monitor, Repair:** The plumbing vent flashing boot is split making it vulnerable to leaks. It's recommended that the boot be caulked or the flashing replaced.

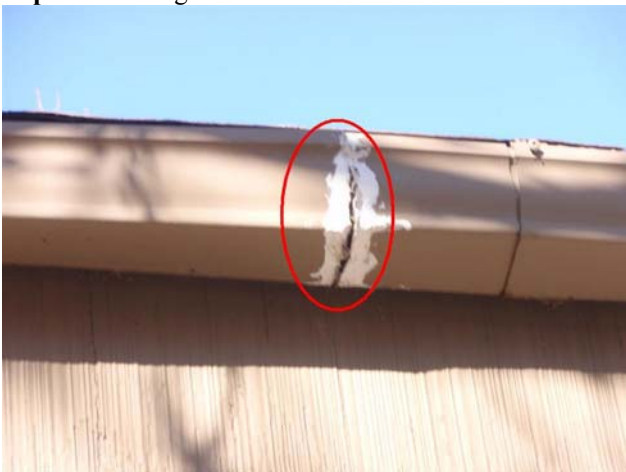
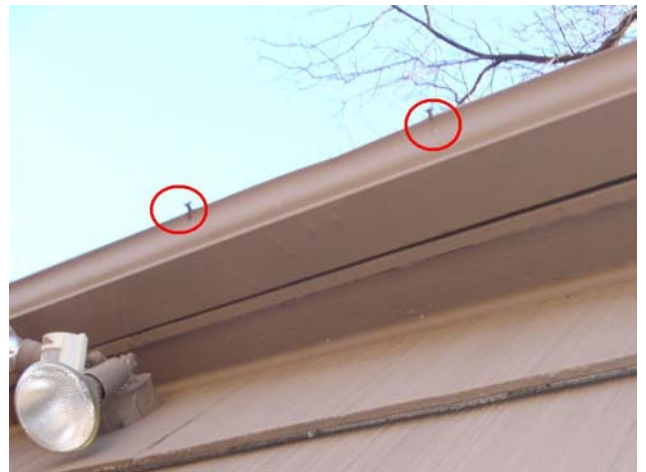
- **Repair:** Minor leaks in the gutters should be repaired.
- **Repair:** Loose gutter nails should be secured.

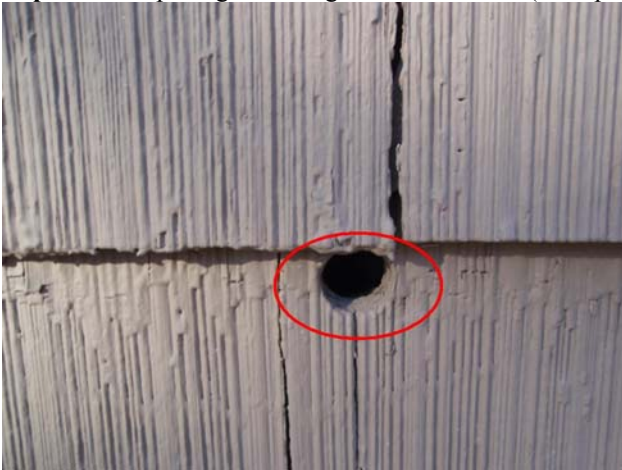
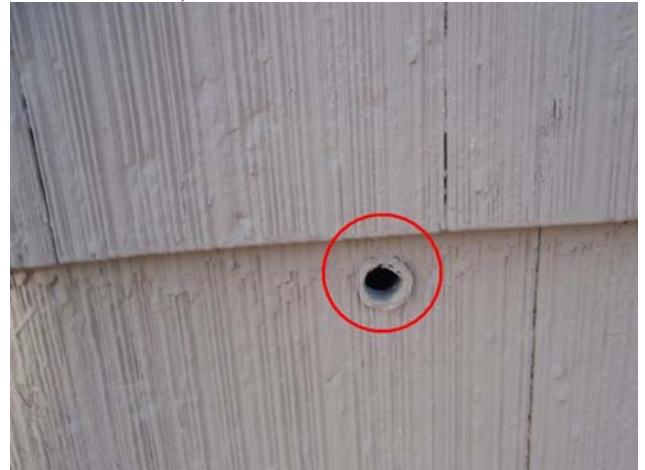
- **Repair:** All openings in siding should be sealed (examples at back of house).

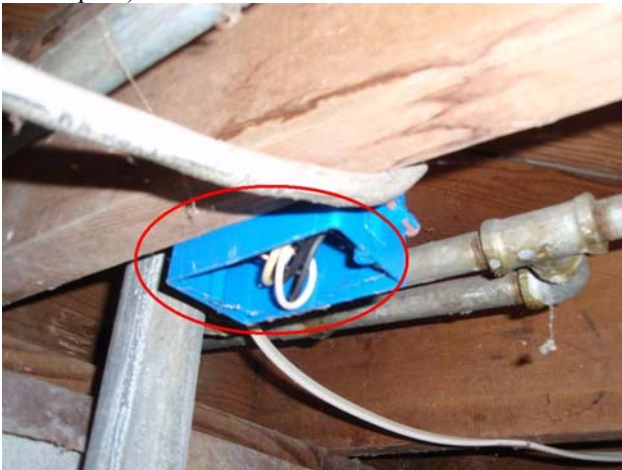
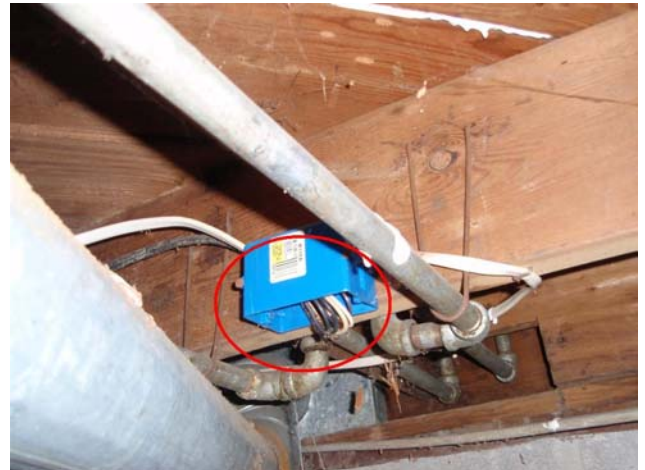
- **Repair:** All junction boxes should be fitted with cover plates, in order to protect the wire connections (examples in crawl space).

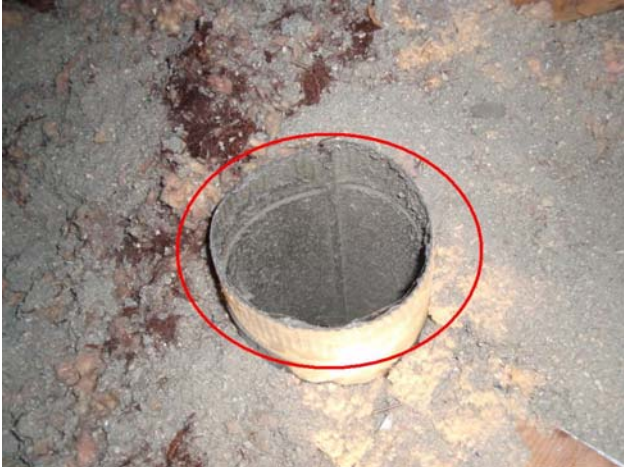
- **Improve:** The unused duct pipe in attic should be capped off.

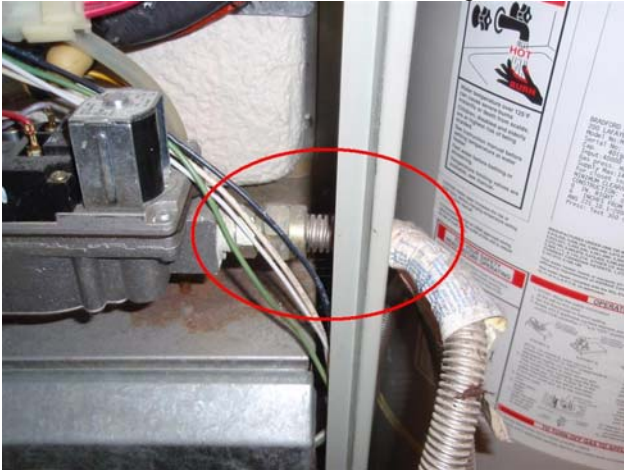
- **Repair:** Flexible gas appliance connections should not pass through walls, floors or the appliance housing as is the case of the furnace. This connector should be replaced with one of suitable solid gas piping.

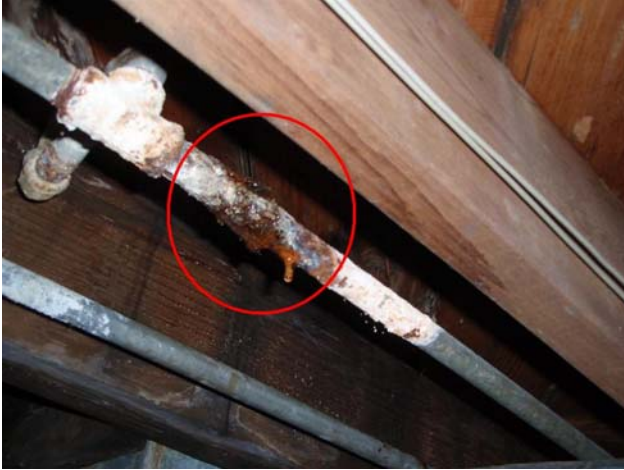
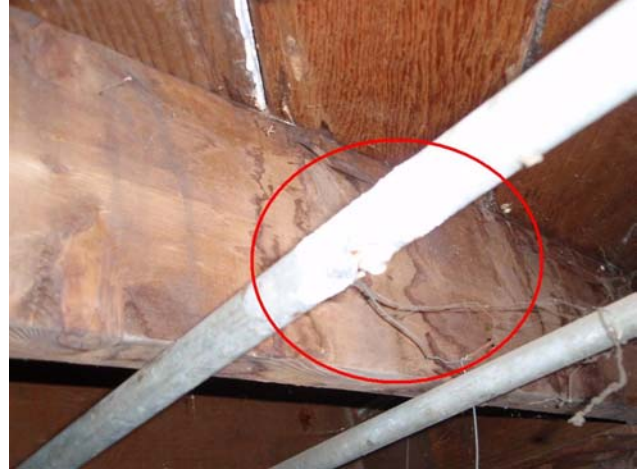
- **Repair:** The steel supply piping is leaking in the crawl space.

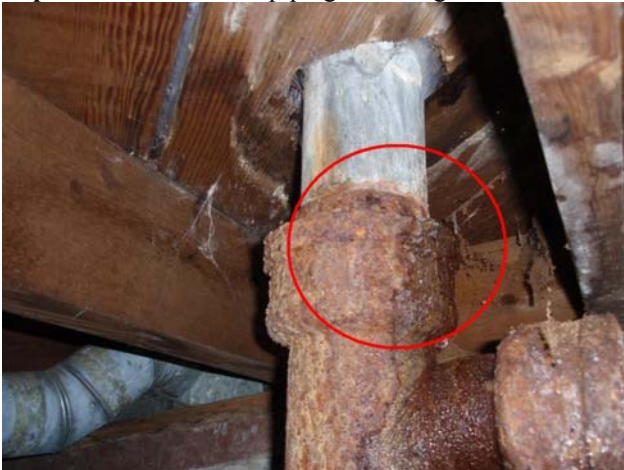
- **Repair:** The lead waste piping is leaking at connection to cast iron in crawl space.
