**Star  
Home  
Inspection Services**

*Home Inspection Report*

**5434 W 140th St, Overland Park, KS 66224**

**Report Number: 07222008-2L**

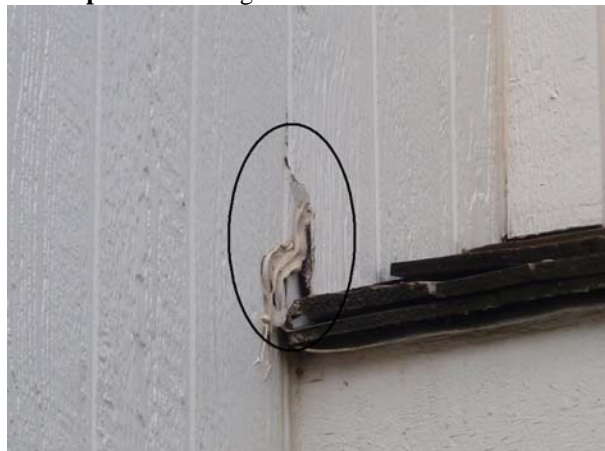
- **Repair:** Caulking is needed around the kick out flashing on the north side by the chimney. **Repaired**

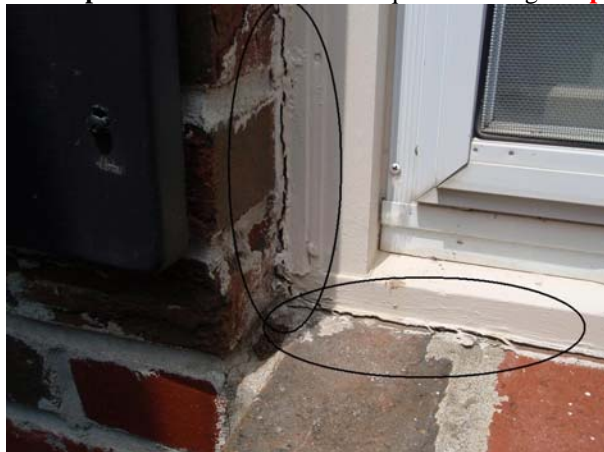
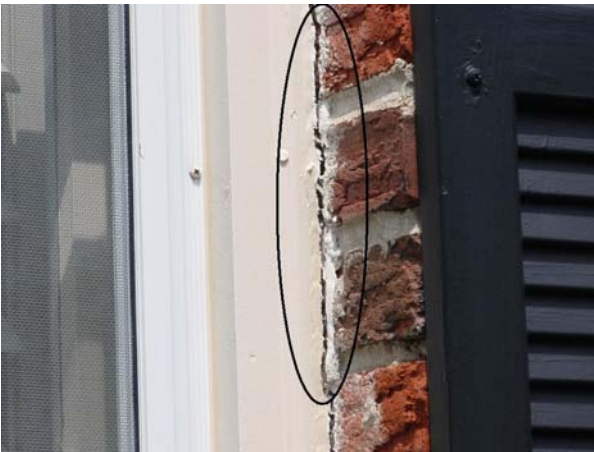
- **Repair:** The front windows require caulking. **Repaired**

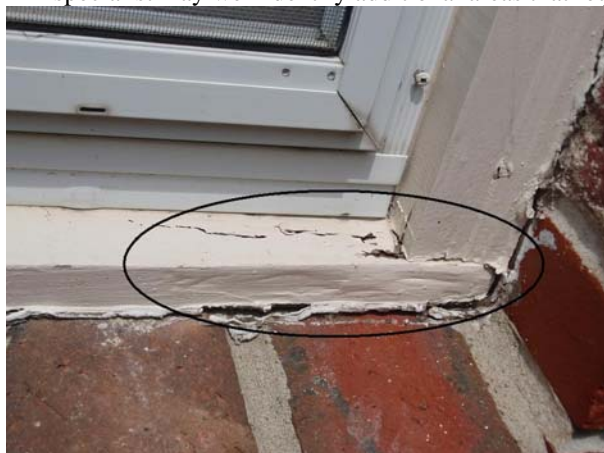
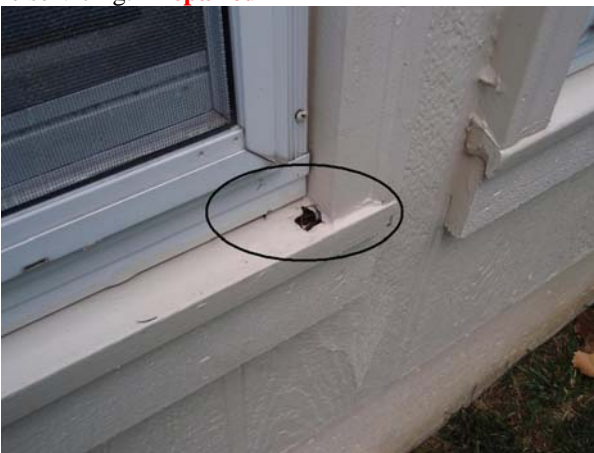
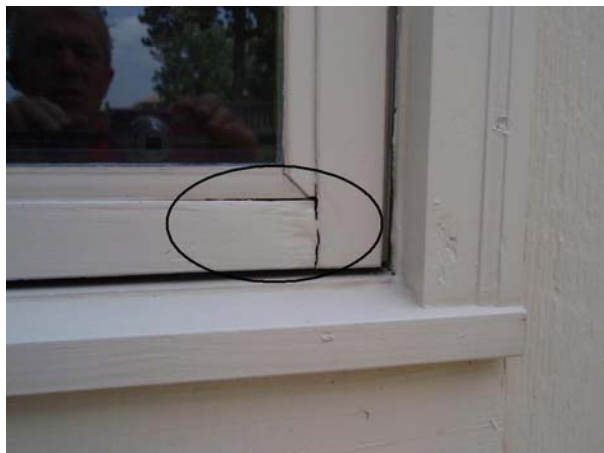
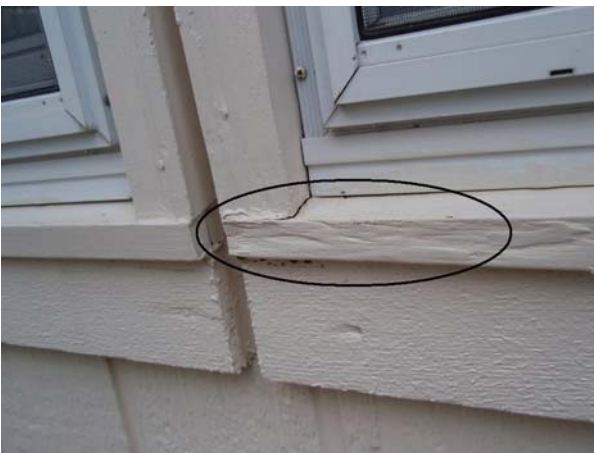
- **Repair:** Localized evidence of rot was visible on some window trim/frames. Repair to the window frame can usually be accomplished by a skilled carpenter. It's recommended that a thorough "inventory" be taken by a competent window repair technician to ascertain exactly how many areas will need to be repaired or replaced. Further evaluation by a specialist may well identify additional areas that require servicing. **Repaired**

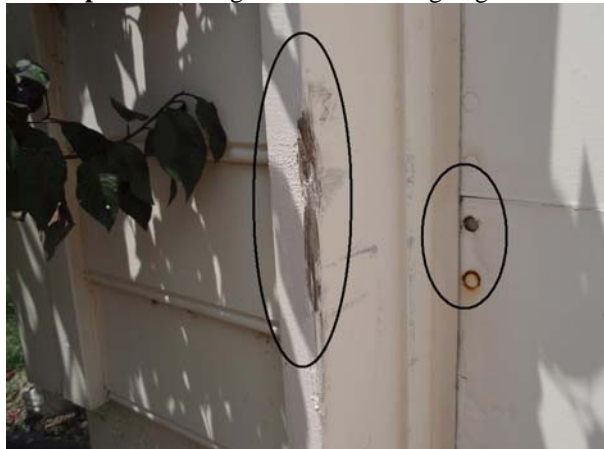
- **Repair, Safety Issue:** The garage door openers did not automatically reverse under resistance to closing. *There is a serious risk of injury, particularly to children, under this condition.* Adjustments are needed.
- **Monitor:** The garage floor slab has typical cracks usually the result of shrinkage and/or settling of the slab as it cures. Shrinkage cracks are very common and are not normally a concern.
- **Repair:** Painting is needed on the garage door frame and around the panel bolts.

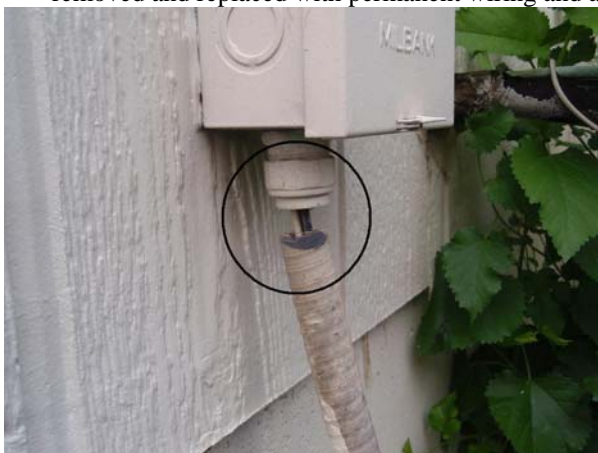
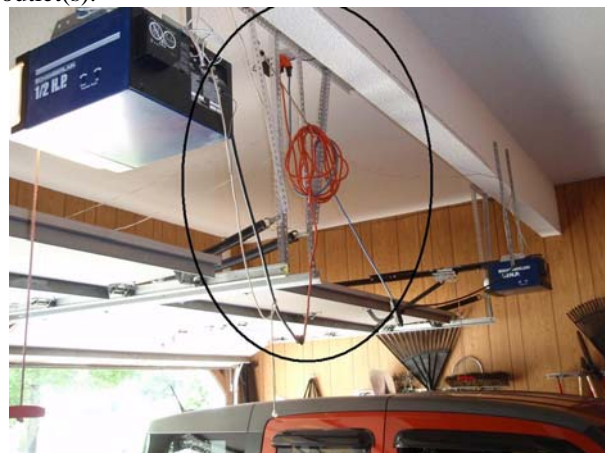
- **Repair:** The conduit has pulled loose from the air conditioner quick disconnect box and needs repair.
- **Repair:** Extension cords should not be used as permanent wiring as is the case in the garage. This wiring should be removed and replaced with permanent wiring and an outlet(s).

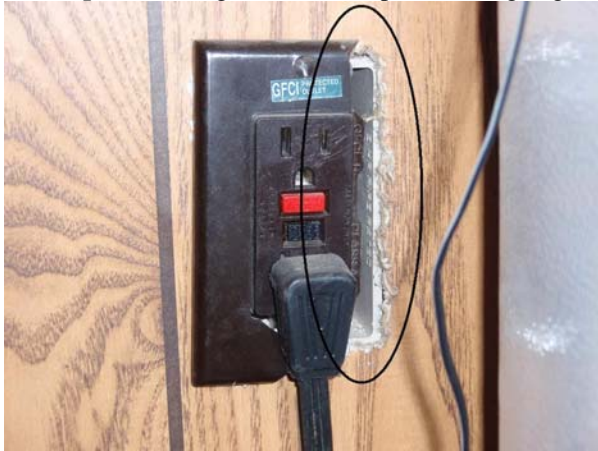
- **Repair:** Damage outlet cover plate in the garage should be replaced to avoid a shock hazard.

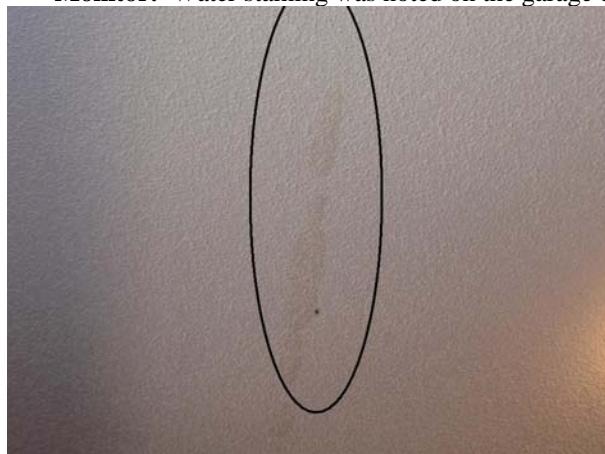
- **Monitor:** Water staining was noted on the garage ceiling.

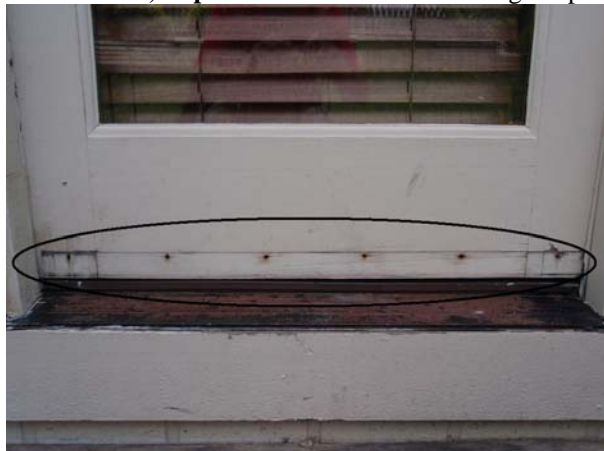
- **Repair:** The rear door should be trimmed or adjusted as necessary for the dead bolt to work freely.
- **Repair:** Doors to the master bedroom and basement closet should be adjusted as necessary to latch properly.
- **Monitor, Repair:** The rear door is missing the plate on the bottom edge.

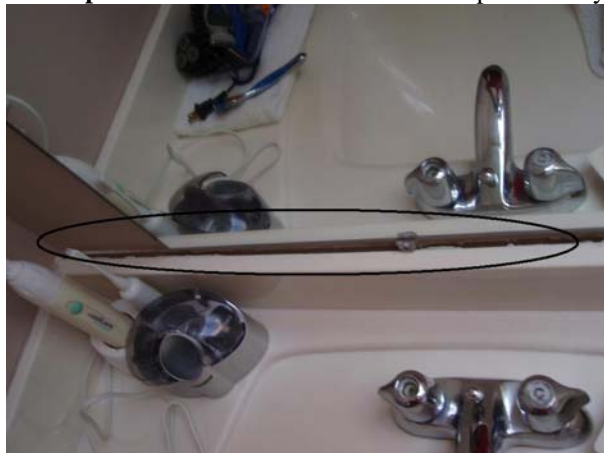
- **Repair:** The kitchen desk drawers need repair of put back on the track. **Repaired**
- **Repair:** Missing vanity handles in the master bedroom bath should be repaired. **Repaired**
- **Repair:** The master bedroom bath has pulled away from the wall and needs repair. **Repaired**
