**Star  
Home  
Inspection Services**

*Home Inspection Report*

**5507 W 147th Terr, Overland Park, KS 66223**

**Inspection Date: 2/18/2009**

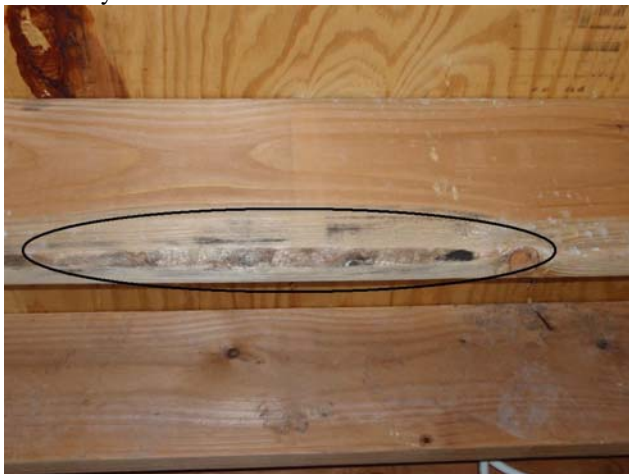
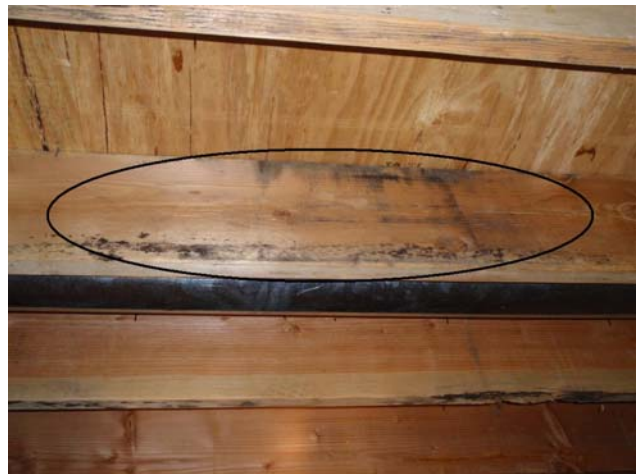
- **Monitor:** Common minor settlement cracks were observed in the foundation walls. This implies that some structural movement of the building has occurred. Cracks of this type should be watched for any sign of additional movement. In the absence of any sign of ongoing movement, repair should not be necessary.
- **Monitor:** The basement floor slab has typical cracks usually the result of shrinkage and/or settling of the slab as it cures. Shrinkage cracks are very common and are not normally a concern.

- **Monitor:** Construction mold was visible on some floor joists. This is mold that grows on the lumber while lying in the weather during construction as evidenced by the strap marks. Most homes have some level of this mold and it goes dormant once removed from the elements and normally does not present any problems. If desired it can be mitigated easily.

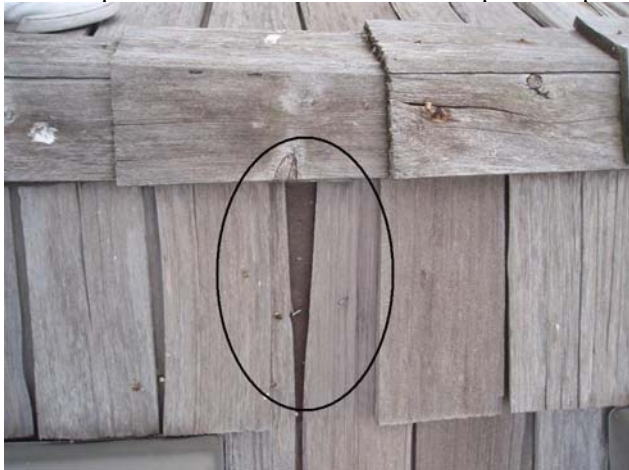
- **Monitor. Repair:** The life expectancy of wood roofs is generally 15 to 20 years. This will depend on several factors such as the quality of shingle or shake, the slope of the roof (steeper is better), the amount of exposed shingle, and the amount of sun or shade. As with all roofs, annual maintenance is needed. Cracked, curled, or displaced shingles or shakes should be repaired. As a rule of thumb, replacement of the entire roof covering may be logical if more than ten percent of the wood roof requires repair. One shingle at the top ridge appears to be missing and the black felt sheathing is exposed. It's recommended this be repaired to prevent leaking.

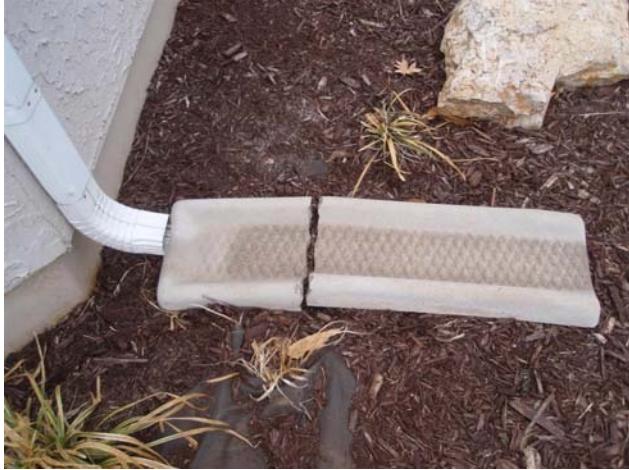
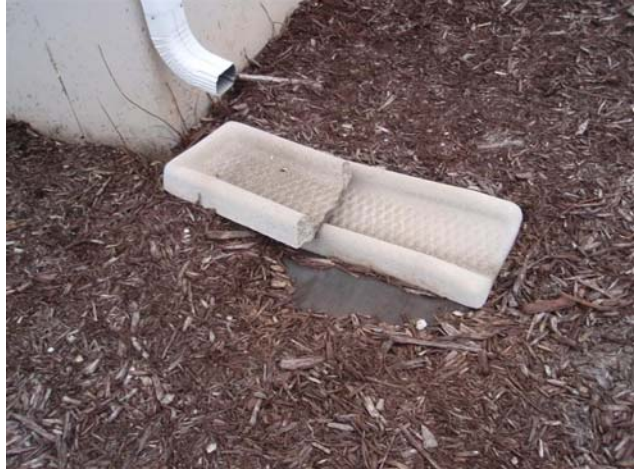
- **Monitor, Repair:** A couple of splash pans under the downspouts are broken. Repair is discretionary.

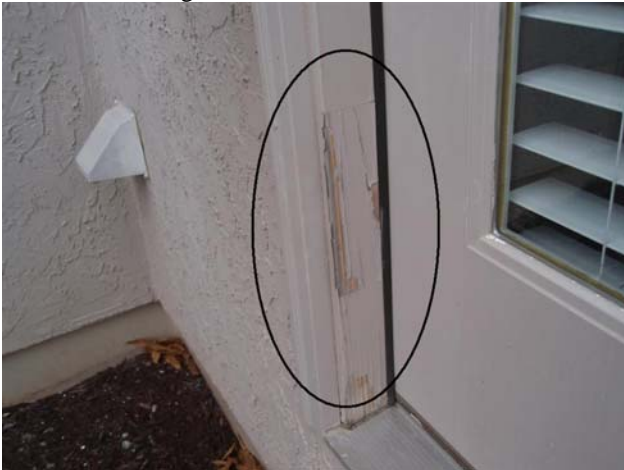
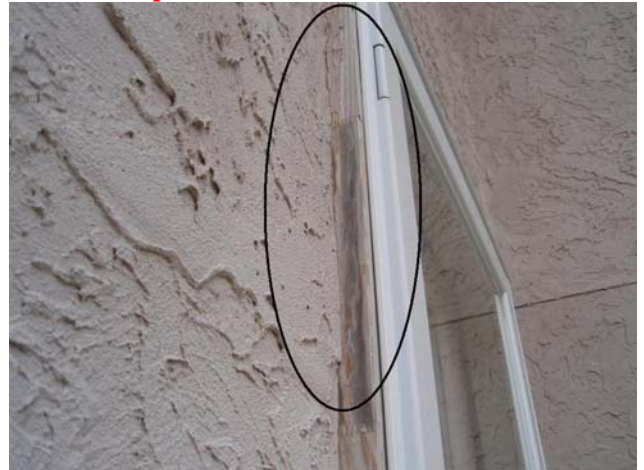
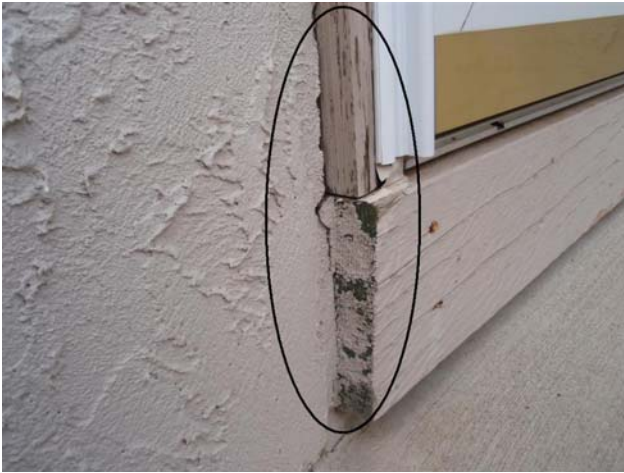
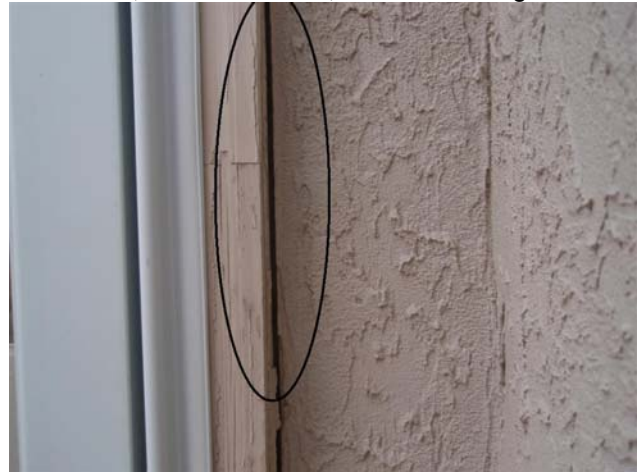
- **Repair:** The paint on the trim around the rear doors is peeling. These areas should be painted to prevent water damage and rot. Caulking is also needed around the rear door and stucco wall. **Repaired**

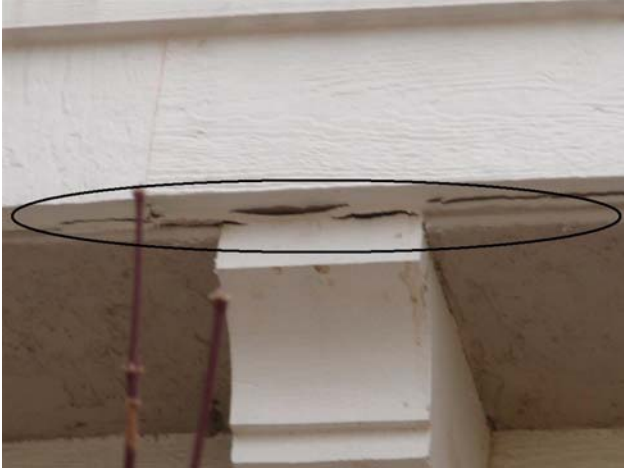
- **Repair:** Caulking is needed under the front bedroom window. **Repaired**

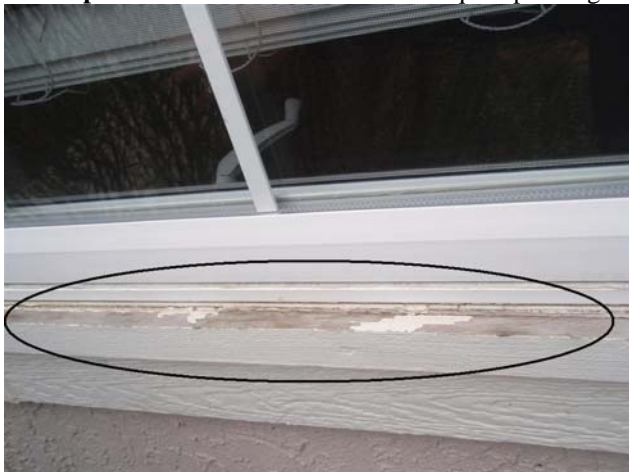
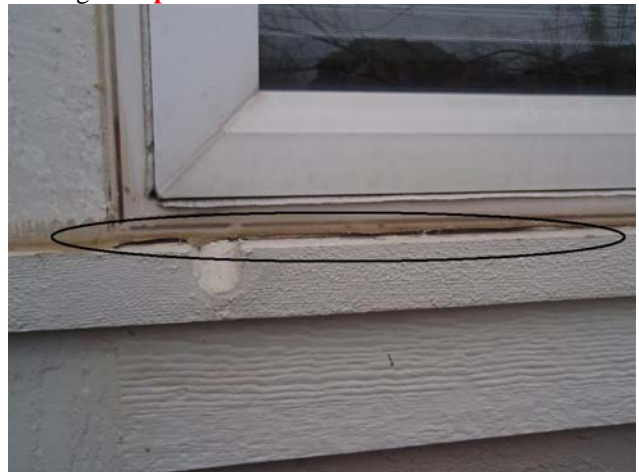
- **Repair:** The front window frames require painting and caulking. **Repaired**

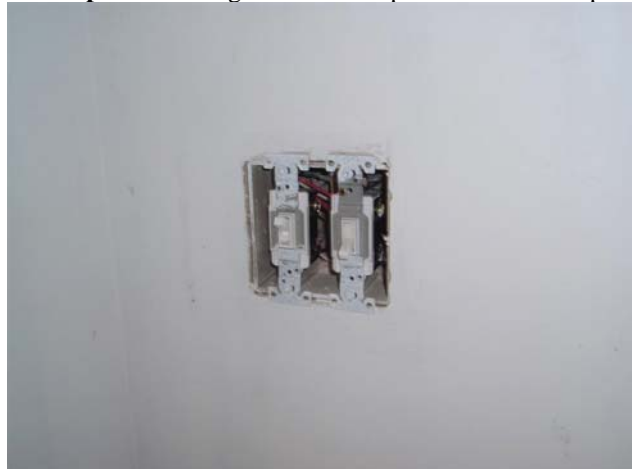
- **Repair:** Missing switch cover plates should be replaced to avoid a shock hazard. **Repaired**

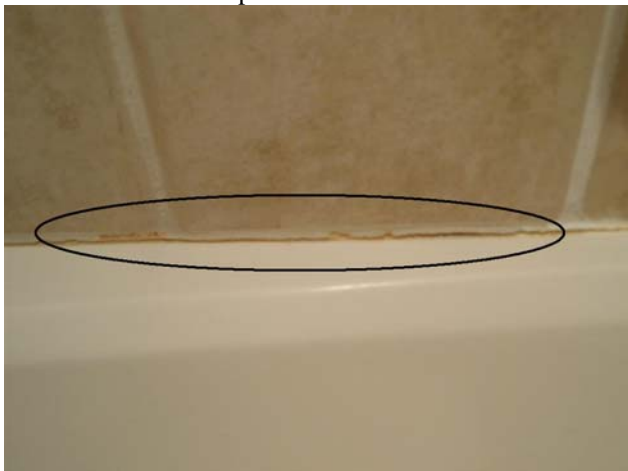
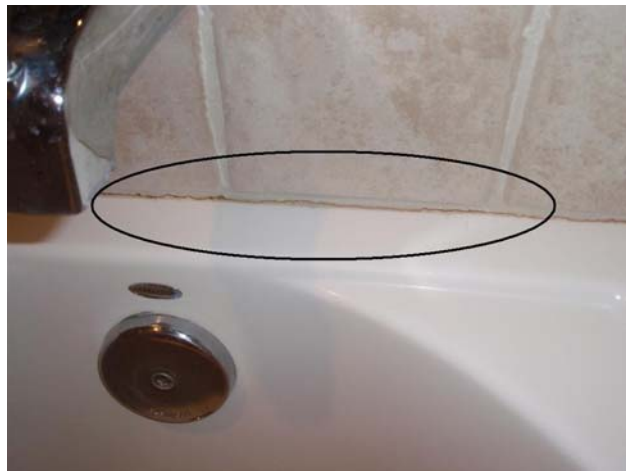
- **Repair:** The shower diverter knob in the north bathroom is inoperative and needs repair. **Repaired**
- **Monitor, Repair:** The southeast bedroom bath sink was observed to drain slowly, suggesting that an obstruction may exist.
- **Repair:** The toilet seats are loose in the southeast and north bathrooms. **Repaired**
- **Improve:** Cracked, deteriorated and/or missing bathtub enclosure grout around the top edge of the bathtub in the north bathroom could be improved.

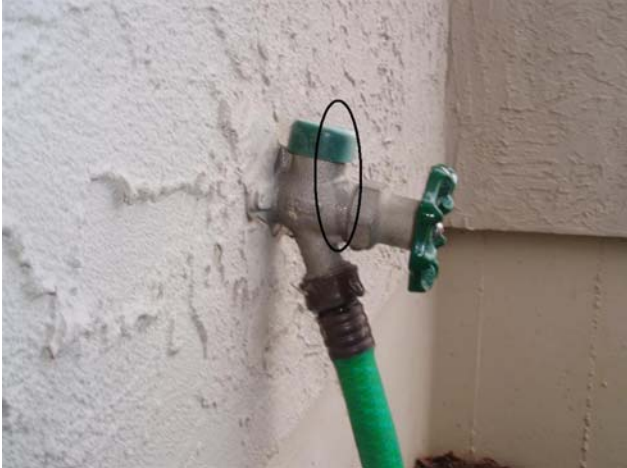
- **Repair:** The north hose bib is leaking from the anti-siphon cap. **Repaired**

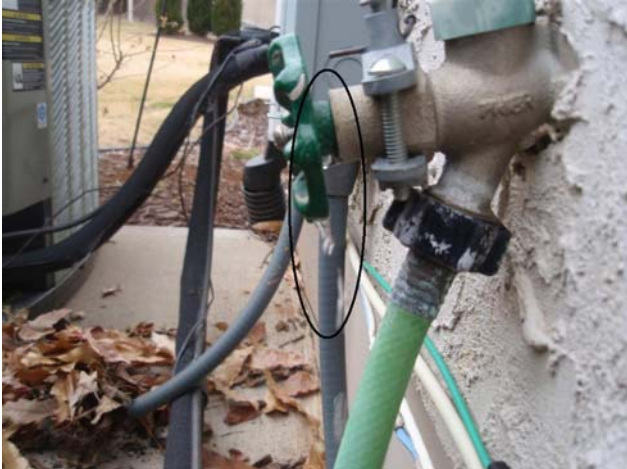
- **Repair:** The south hose bib is leaking from the stem behind the handle. **Repaired**

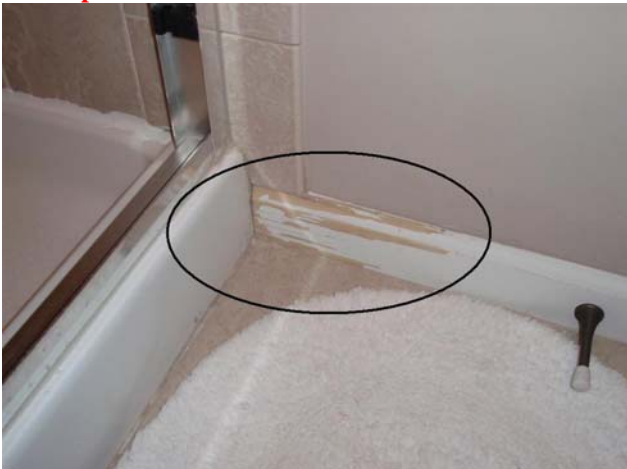
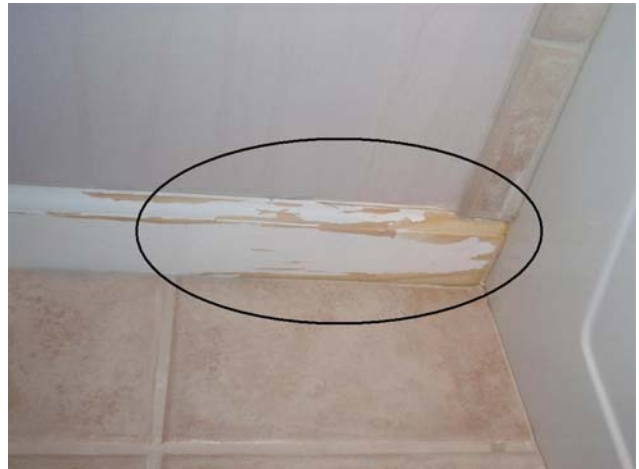
- **Repair:** The trim around the bathtub and shower in the southeast bedroom bath and north bath needs to be painted. **Repaired**

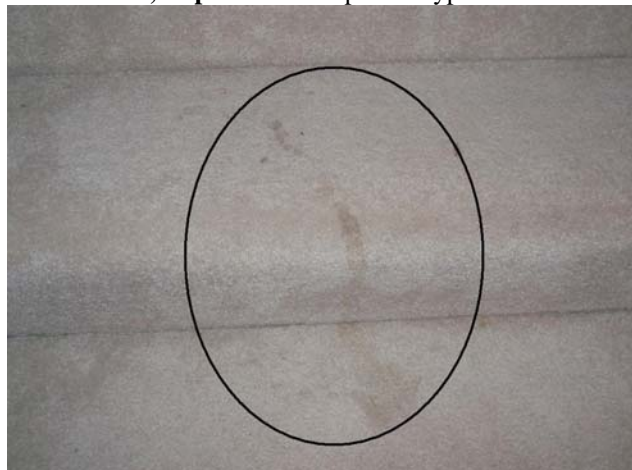
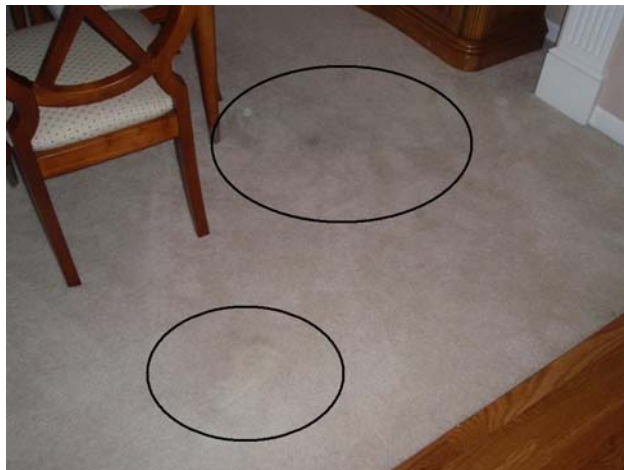
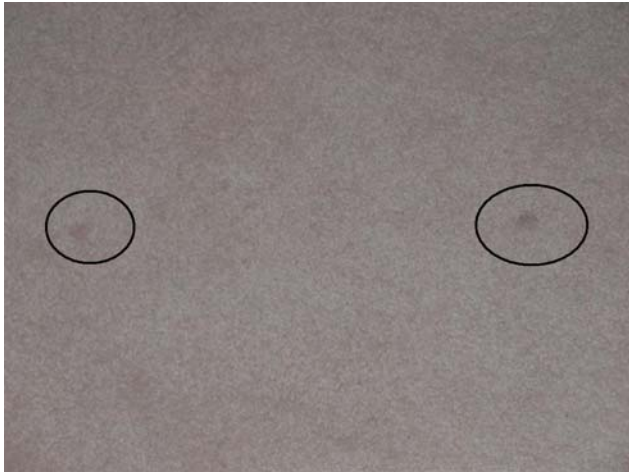
- **Monitor, Repair:** The carpet has typical minor stains.

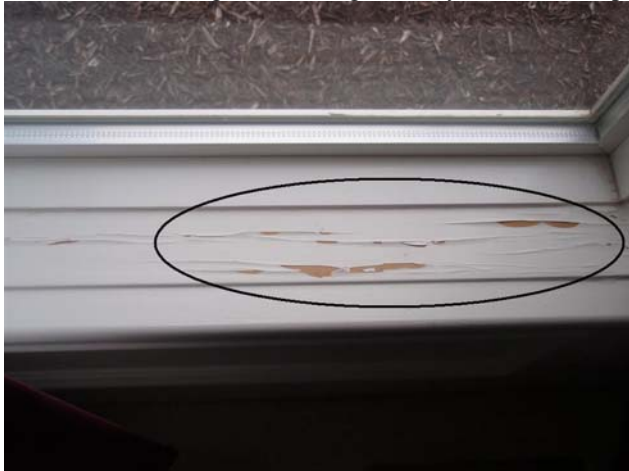
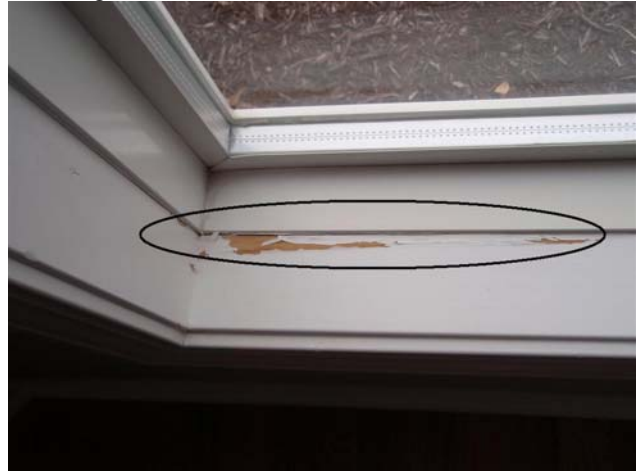
- **Monitor, Repair:** The paint is peeling on the interior window trim in the breakfast room, living room and dining room. There are no signs of leaking and may be a result of poor finishing.

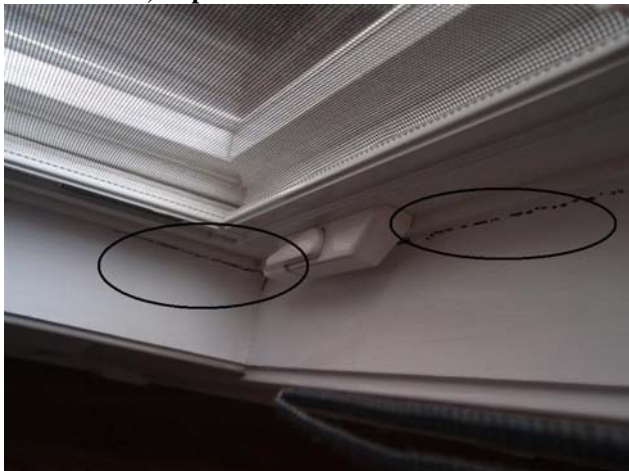
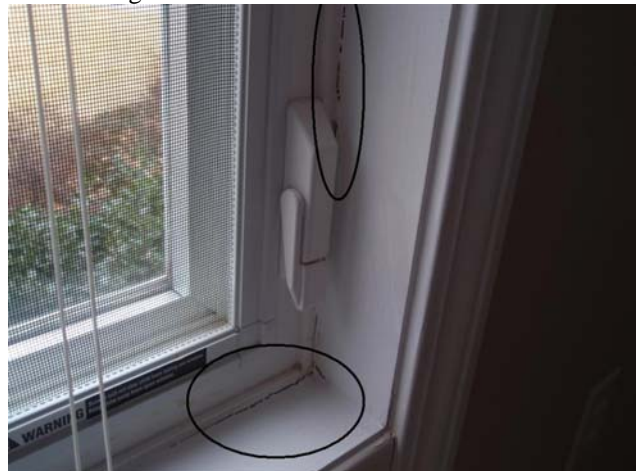
- **Monitor, Repair:** The left window in the front office needs caulking.
