# Star Home Inspection Services

## *Home Inspection Report*

**5601 Chadwick Rd Fairway, KS 66205**

**Inspection Date: 01/08/2010**

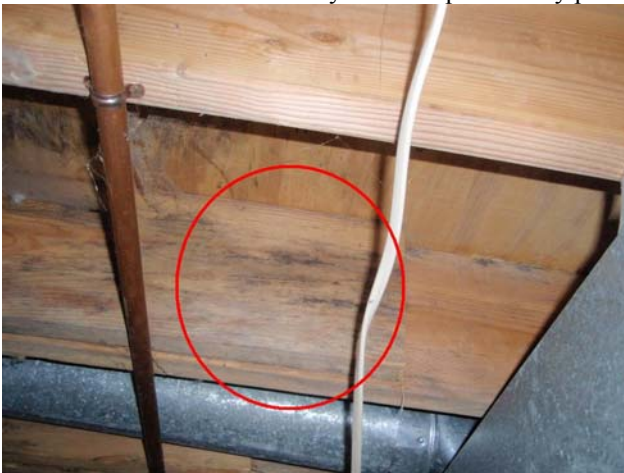
- **Monitor:** Construction mold was visible on some floor and ceiling joists. This is mold that grows on the lumber while lying in the weather during construction. Most homes have some level of this mold and it goes dormant once removed from the elements and normally does not present any problems.

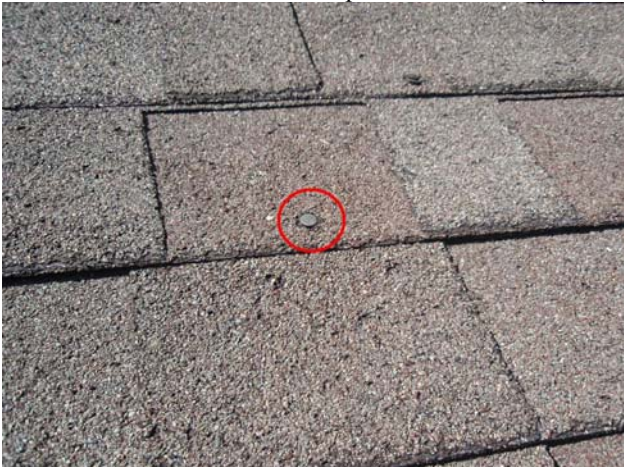
- **Recommend:** Exposed nail heads were observed in the roofing shingles and/or ridge caps. All exposed nail heads should be caulked to reduce the potential of leaks (i.e. at lower section of roof near deck area.)

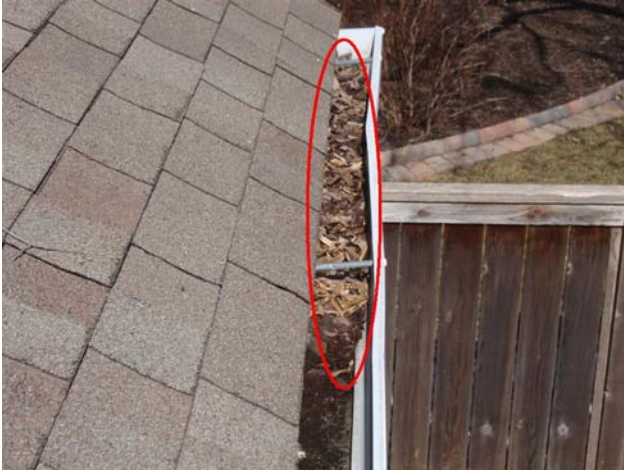
- **Repair:** The gutters require cleaning to avoid spilling roof runoff around the building – a potential source of water entry or water damage. **REPAIRED – Cleaned gutters**

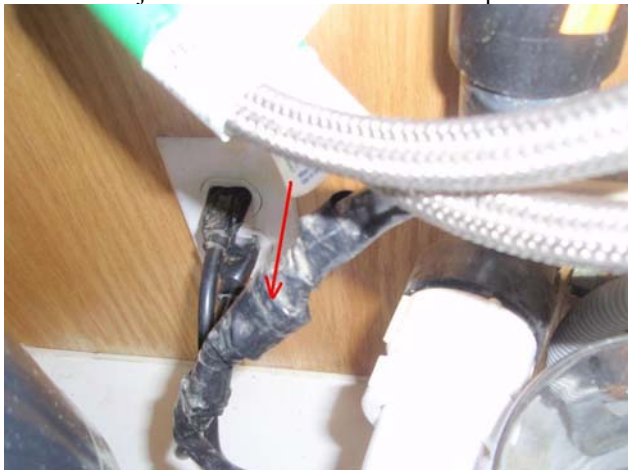
- **Repair:** Improper electrical connections under the kitchen sink should be repaired. All electrical connections should be made inside junction boxes fitted with cover plates. **REPAIRED – New dishwasher cord.**

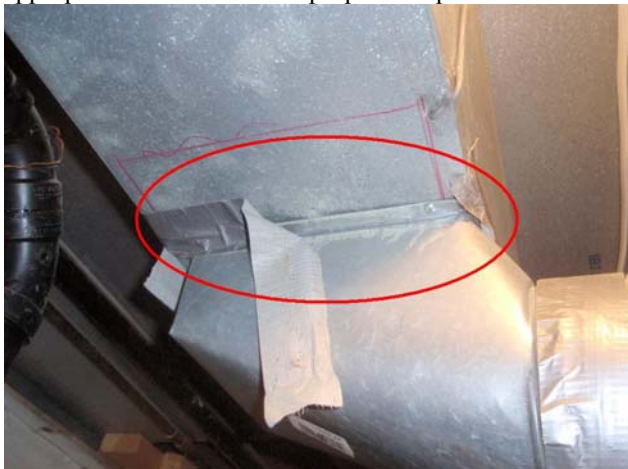
- **Repair:** Loose duct tape at duct connection openings in the ductwork should be improved. Duct tape is not the appropriate material for this purpose despite its name. **REPAIRED – Replaced with Foil Tape**

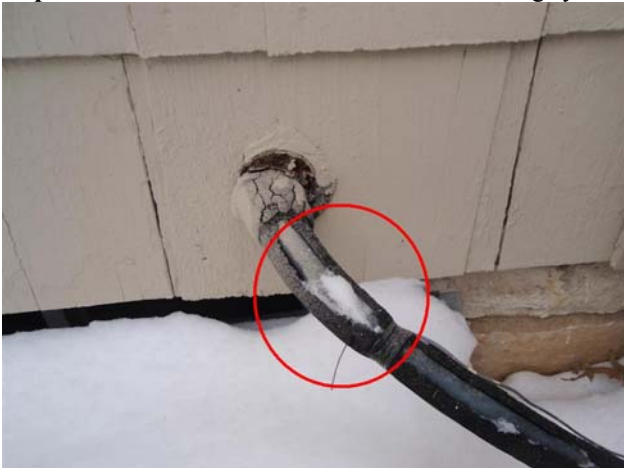
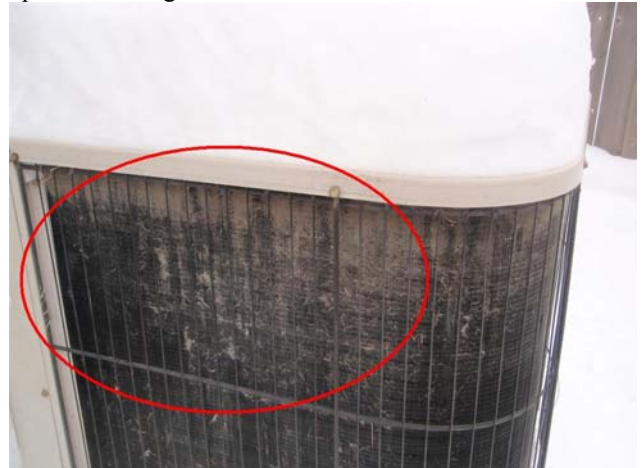
- **Repair:** Damaged insulation on refrigerant lines should be repaired. **REPAIRED – New Insulation**
- **Improve:** The outdoor unit of the air conditioning system requires cleaning.

- **Monitor:** The fins of the outdoor portion of the air conditioning system were observed to have minor damage. This condition can reduce the efficiency of the system.
