Star Home Inspection Services

Home Inspection Report

5605 Cherry St, Kansas City, MO 64110

Report Number: 12092008-1A

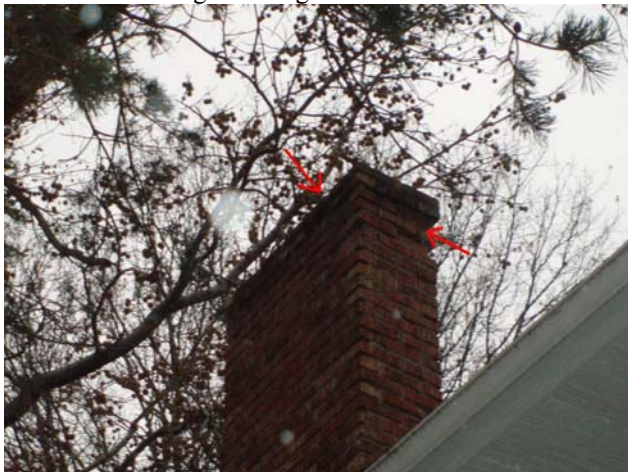
Chimneys

- **Repair:** The south masonry chimney shows evidence of substantial spalling (surface deterioration of the masonry). Rebuilding of this chimney brickwork is needed.
- **Repair:** A rain cap and vermin screen should be installed on the masonry chimneys and the chimney flue should be checked for damage. Damaged flues can be unsafe.

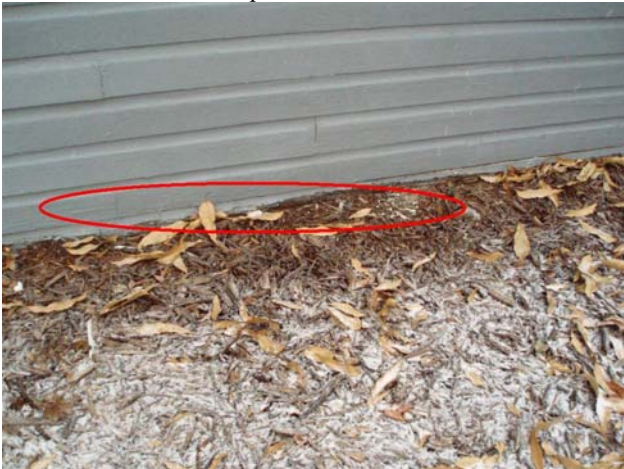
Exterior Walls

- **Repair:** Localized rot was observed in the siding of the garage (example on south side at wood soil contact). Following repair of the damaged areas (which should be combined with exterior painting/maintenance) proper maintenance of the siding and control of water from roof or surface runoff can avoid further damage.
- **Repair:** Wood/soil contact at the base of the siding for the shed should be eliminated. Rotted or damaged siding that is uncovered should be repaired. These areas are at risk of additional hidden damage.

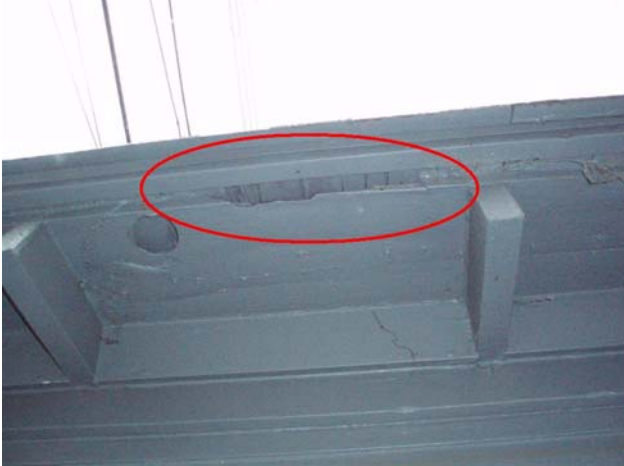
Exterior Eaves

- **Monitor, Repair:** Localized rot was observed in the garage soffit (example at north side). Improvement is not necessary at present, although this condition should be repaired when exterior painting or maintenance are planned.

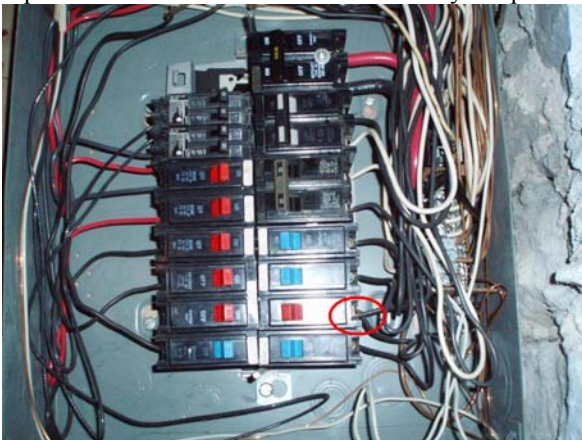
Main Panel

- **Repair:** Circuits within the main distribution panel that are doubled up (referred to as "double taps") should be separated. Each circuit should be served by a separate fuse or breaker. **Repaired**

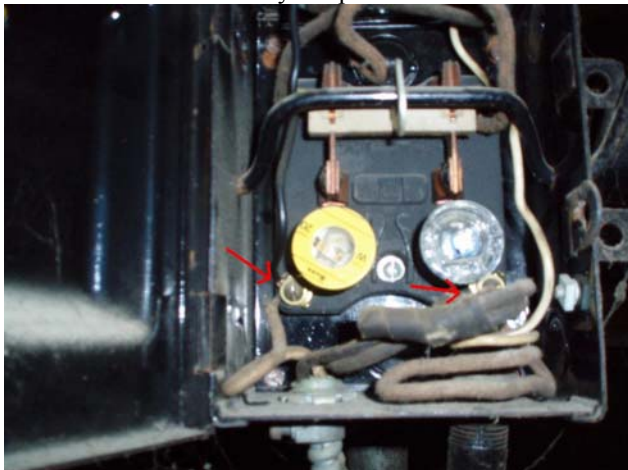
Auxiliary Panel(s)

- **Repair:** Circuits within the auxiliary panel that are doubled up (referred to as “double taps”) should be separated. Each circuit should be served by a separate fuse or breaker.

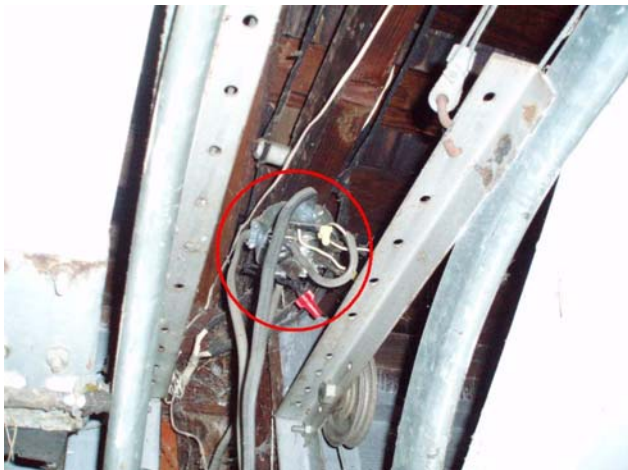
- **Repair:** All junction boxes should be fitted with cover plates (example in garage ceiling), in order to protect the wire connections.

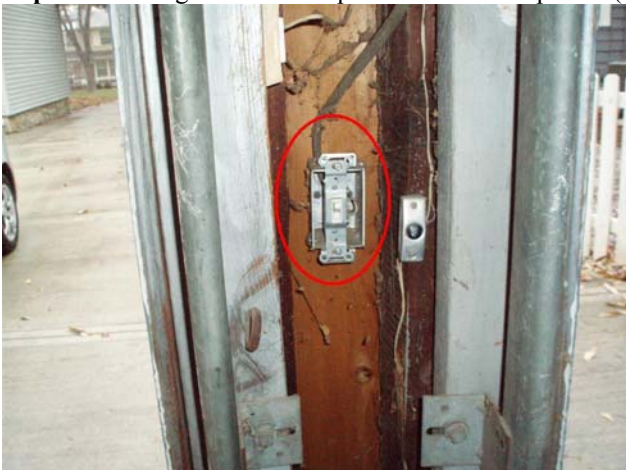
Switches

- **Repair:** The inoperative or inappropriately wired light switches at the top and bottom of main floor stairs should be repaired. The switch to the washer/dryer area light did not function properly. **Electrician stated the lower switch is a “runner” for the upstairs light**
- **Repair:** Missing switch cover plates should be replaced (example in garage) to avoid a shock hazard. **Repaired**

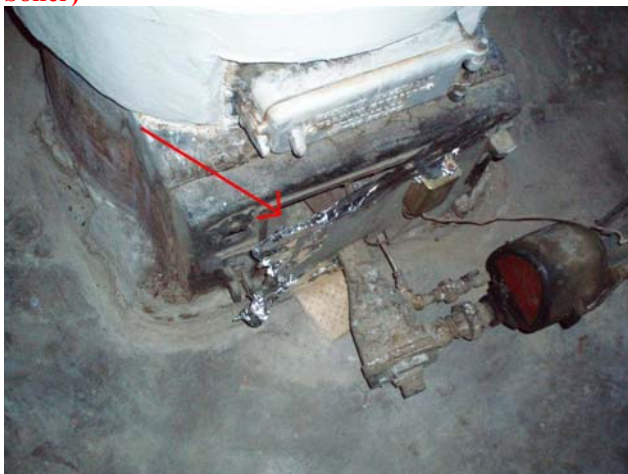
- Monitor:** The boiler for this unit appears to be in working condition and within its expected life span. Actual equipment life will vary depending on quality of equipment and quality/frequency of service. Old boilers tend to be less efficient than newer units. While replacement of the boiler would result in lower heating costs, replacement is often not cost justified if the present unit is reliable and if after cleaning and adjustment its efficiency is 74% or better. Insulation on the boiler and/or distribution piping may contain asbestos. *The Environmental Protection Agency (E.P.A.) reports that asbestos represents a health hazard if “friable” (damaged, crumbling, or in any state that allows the release of fibers).* If replacement of the boiler necessitates the removal of the asbestos containing insulation, an asbestos removal specialist should be engaged. If any sections of this insulation are indeed friable, or become friable over time, a specialist should also be engaged. Further guidance is available from the Environmental Protection Agency (E.P.A.). There may be other materials within the home that contain asbestos but are not identified by this inspection report. **Repaired (Replaced boiler with new high efficiency boiler)**

- Repair:** The bottom door to the boiler should be better secured. **Repaired (Replaced boiler with new high efficiency boiler)**

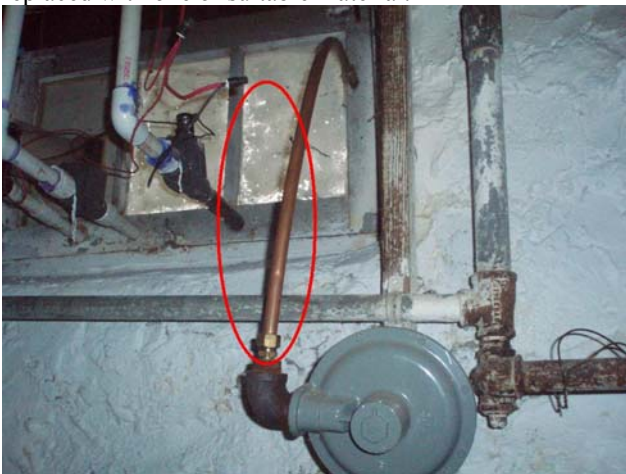
Gas Piping

- **Repair:** Copper tubing is no longer suitable for gas piping. It's recommended this pipe at the west side of basement be replaced with one of suitable material.
