Star Home Inspection Services

Home Inspection Report

5809 W 101st St Overland Park, KS 66207

Inspection Date: 05/06/2011

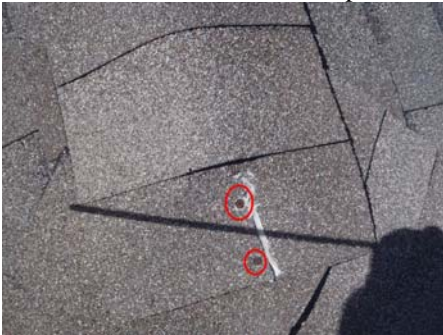
- **Recommend:** Exposed nail heads were observed in the roofing shingles and/or ridge caps. All exposed nail heads should be caulked to reduce the potential of leaks.

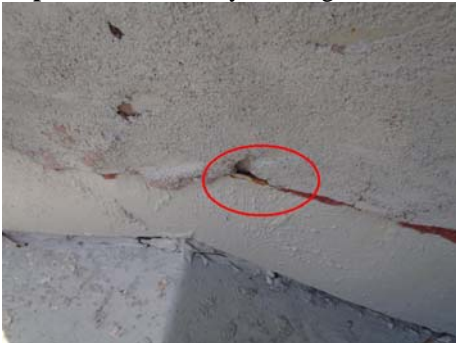
- **Repair:** The chimney flashing should be caulked to avoid leaks. **REPAIRED (Professionally repaired 6/1/2011)**

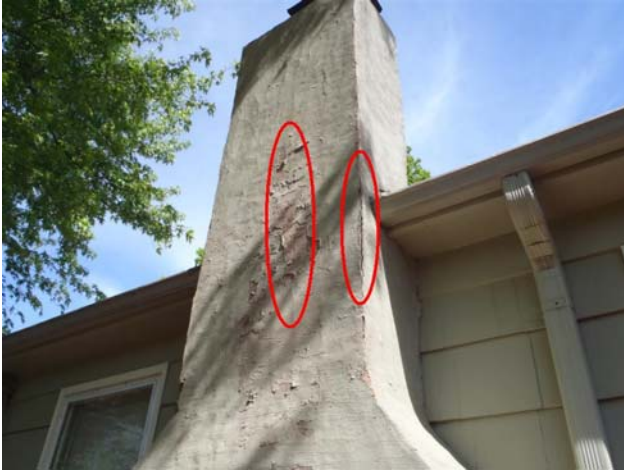
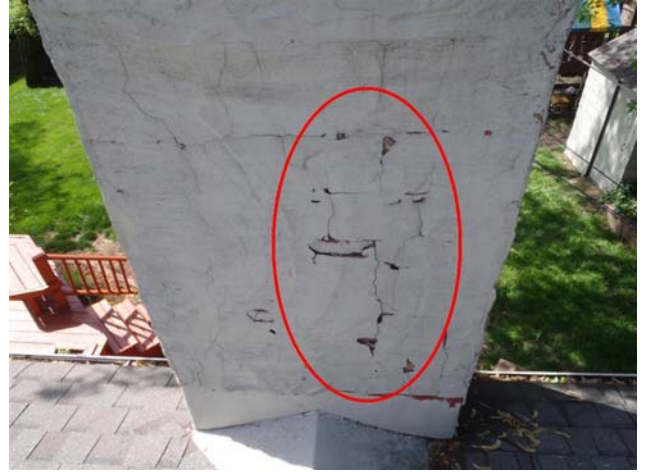
- **Repair:** The masonry chimney shows evidence of substantial spalling (surface deterioration of the parged masonry).
REPAIRED (Professionally repaired 6/1/2011)

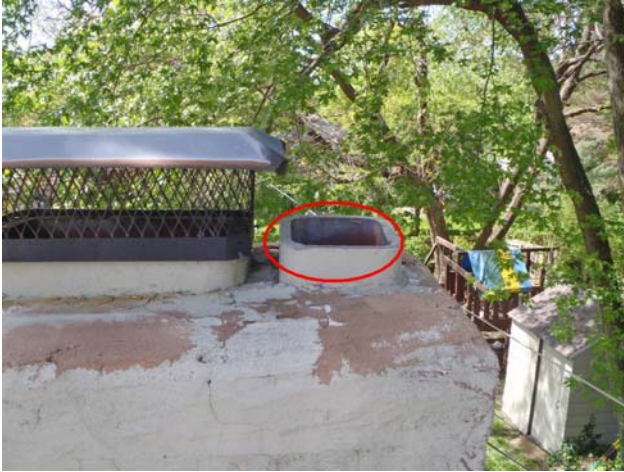
- **Repair:** A rain cap and vermin screen should be installed on the masonry chimney and the chimney flue should be checked for damage.

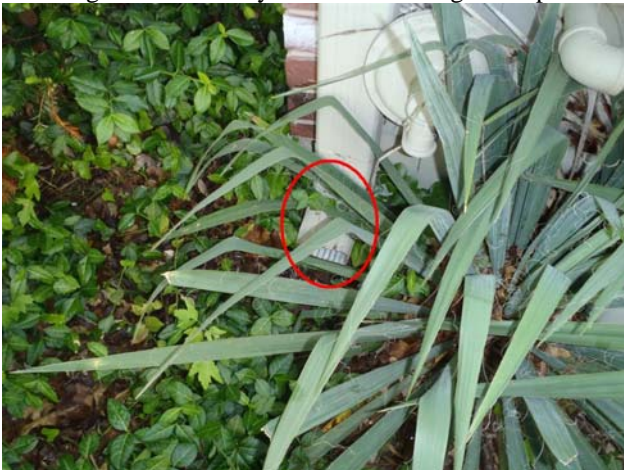
- **Repair:** The gutters require cleaning to avoid spilling roof runoff around the building – a potential source of water entry or water damage. **REPAIRED**
- **Repair:** The downspout(s) should discharge water at least five (5) feet from the house. Storm water should be encouraged to flow away from the building at the point of discharge. **REPAIRED**

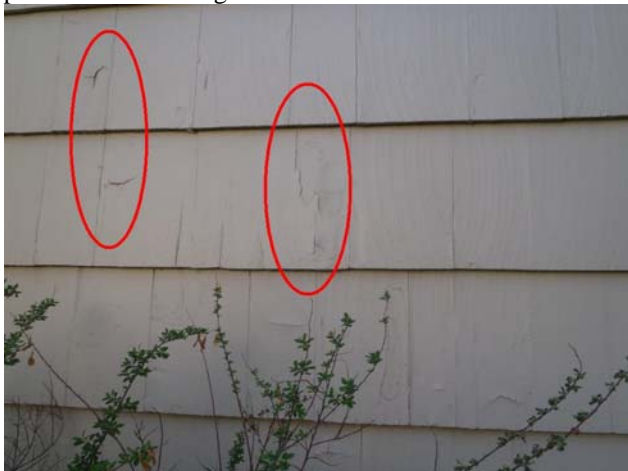
- **Repair:** The birds nest should be removed from the downspout and cable wiring on the back of the house to prevent insect infestation.
- **Repair:** The exterior siding paint is peeling and/or worn thin in localized areas. These areas should be painted to prevent water damage or rot in the future. **REPAIRED**

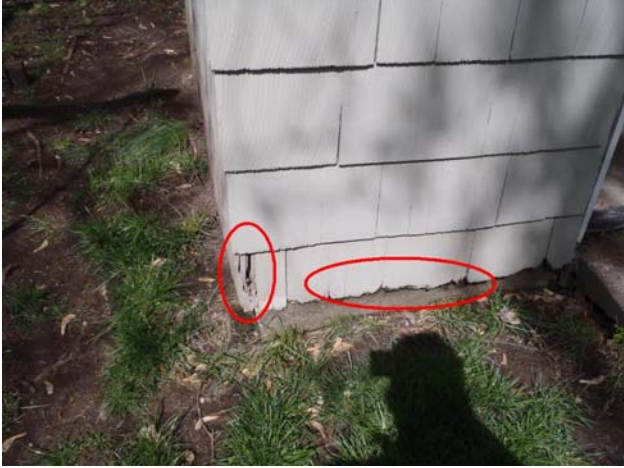
- **Repair:** Localized rot was observed in the siding (i.e. storage building.) Following repair of the damaged areas (which should be combined with exterior painting/maintenance) proper maintenance of the siding and control of water from roof or surface runoff can avoid further damage.

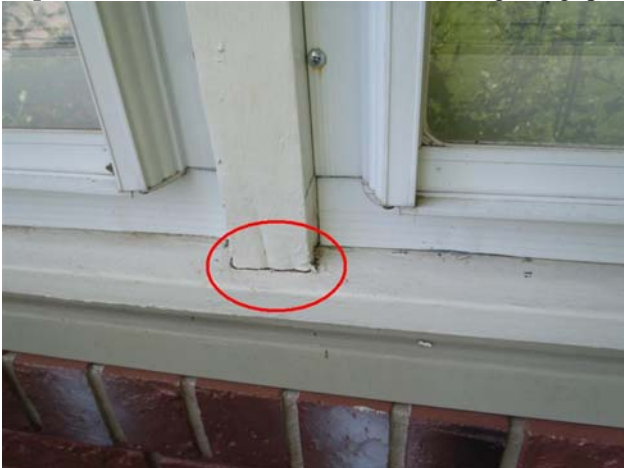
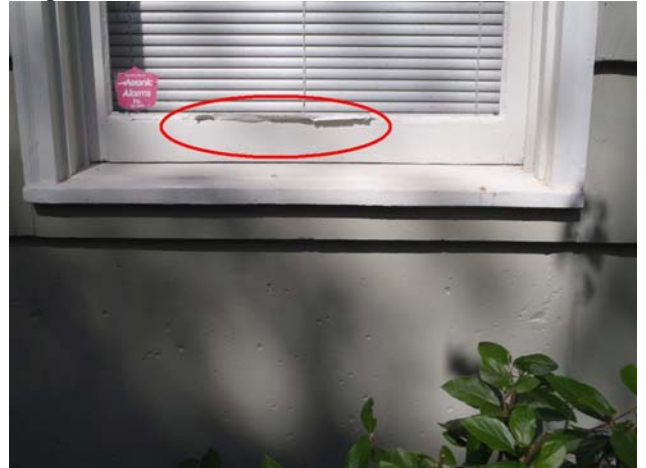
- **Repair:** The window frames require localized painting and caulking (i.e. front window and garage window.)
- **Repair:** Some of the windows are in need of glazing (putty) improvements.

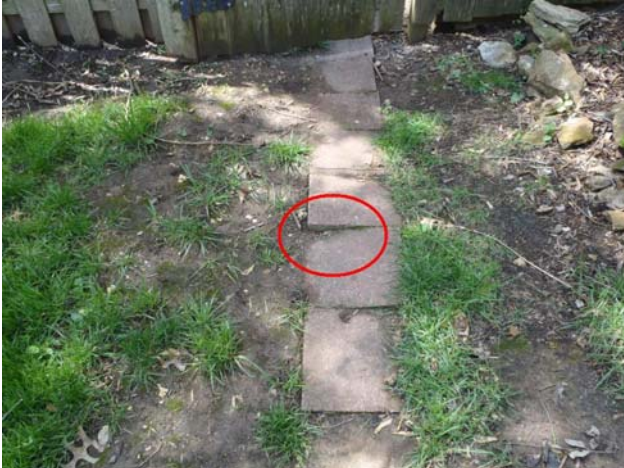
- **Monitor:** The driveway has settled and cracked. Persisting movement may result in the need for repairs.
- **Repair, Safety Issue:** The side paver walkway and driveway presents a trip hazard. This condition should be altered for improved safety.

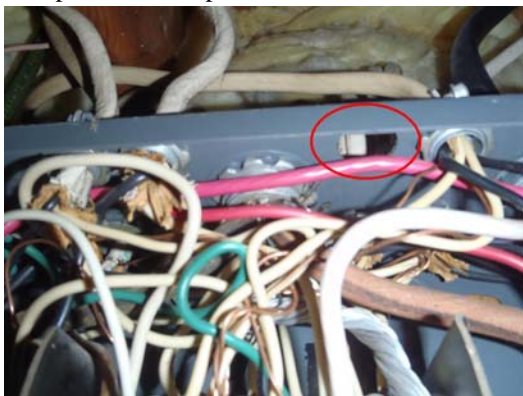
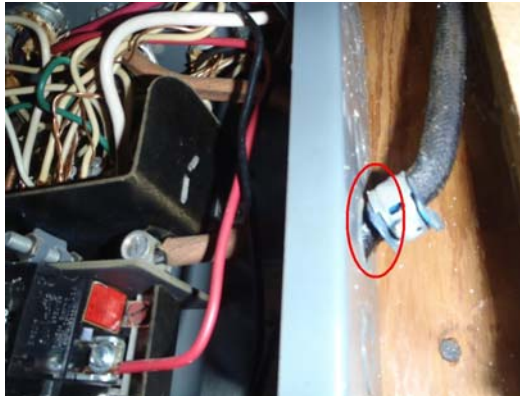
- **Repair:** Oversized breaker within the main distribution panel for the air condition should be replaced. The data plate on the unit specifies a maximum breaker size of 35 Amps and the one in the panel is 40 Amps. **REPAIRED (Repairs completed on 6/3/11 by licensed electrician)**
- **Repair:** Any openings in the main panel should be covered. **REPAIRED**
- **Repair:** Cable clamps (sometimes referred to as bushings or grommets) are required where wiring passes into the main distribution panel. Cable clamps serve to protect the wiring from the metal edges of the panel openings. The loose cable clamp should be repaired. **REPAIRED**

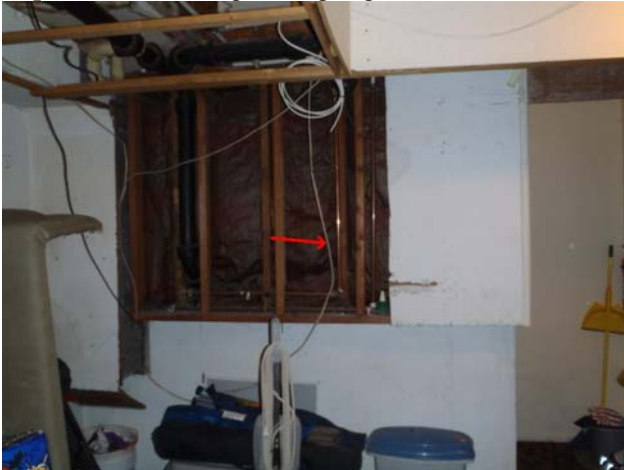
- **Repair:** Loose wiring in the garage and basement should be secured.

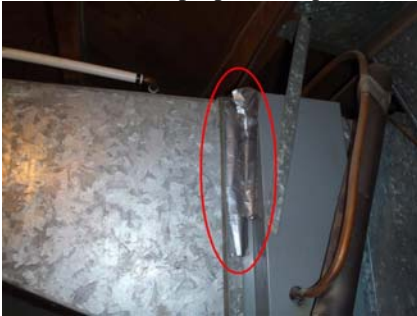
- **Improve:** Loose fitting joints and/or openings in the ductwork should be improved. Duct tape is not the appropriate material for this purpose, despite its name.
