# Star Home Inspection Services

## *Home Inspection Report*

**5875 W 199th St, Stilwell, KS 66085**

**Inspection Date: 3/20/2009**

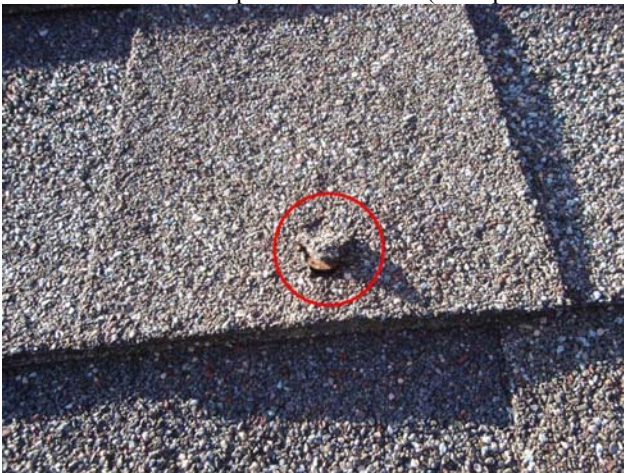
- **Repair:** Exposed nail heads were observed in the roofing shingles and/or ridge caps. All exposed nail heads should be caulked to reduce the potential of leaks (example near valley over front porch). **Repaired**

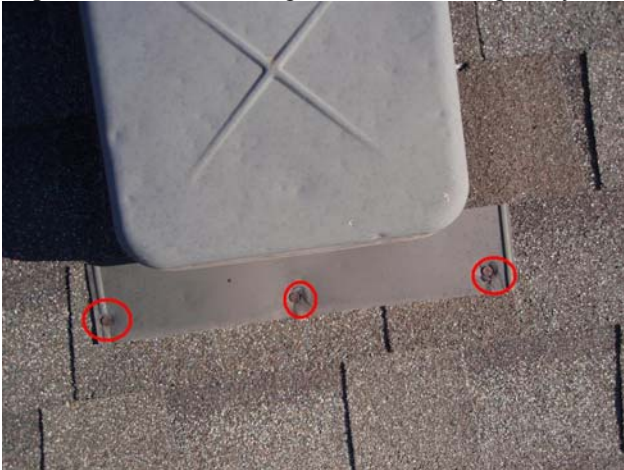
- **Repair:** Nail heads are exposed at the flashing. They should be sealed to reduce risk of leaks. **Repaired**

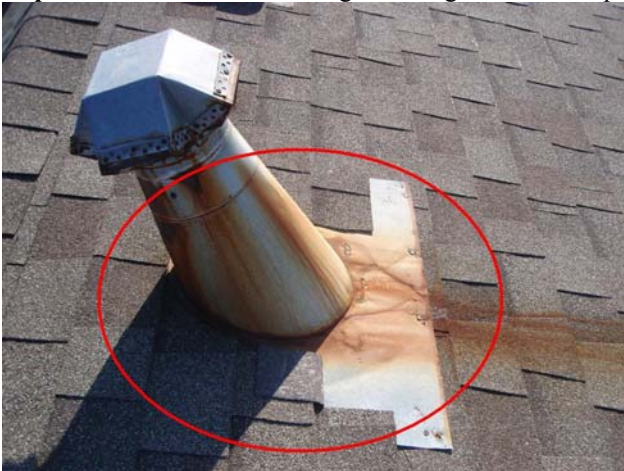
- **Improve:** Furnace vent flashing is rusting. It should be painted to extend its life. **Repaired**

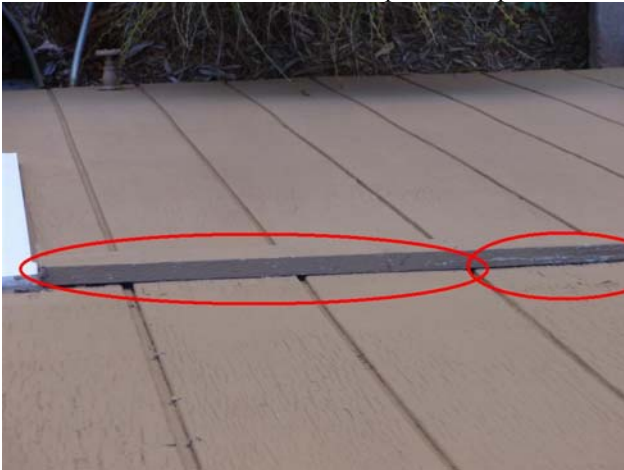
- **Repair:** The exterior siding top horizontal trim should be caulked and the bottom edge of the siding should be painted. These areas should be caulked and painted to prevent water damage or rot in the future.

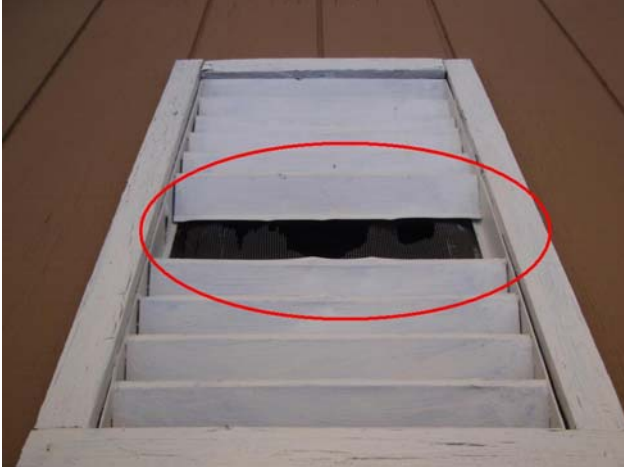
- **Repair:** Localized rot was observed in the trim around siding (example at northeast corner siding trim near garage). Following repair of the damaged areas (which should be combined with exterior painting/maintenance) proper maintenance of the siding and control of water from roof or surface runoff can avoid further damage.
- **Repair:** Wood/soil contact at the base of the siding should be eliminated (examples near front walkway and back outbuilding). Rotted or damaged siding that is uncovered should be repaired. These areas are at risk of additional hidden damage.
- **Repair:** The gable vent is damaged. **Repaired**

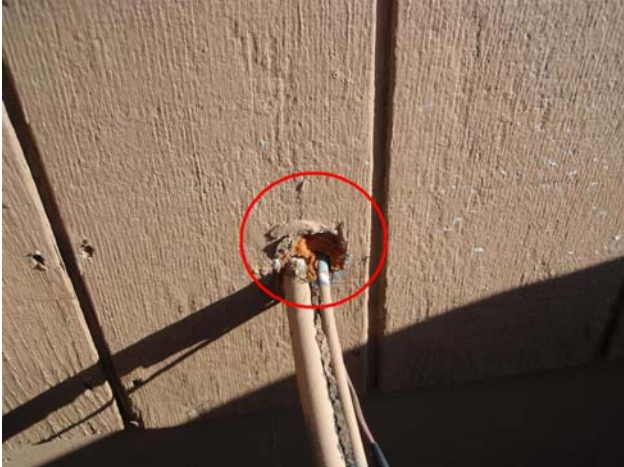
- **Repair:** The opening where the air conditioner refrigerant lines enter the siding should be better sealed. **Repaired**

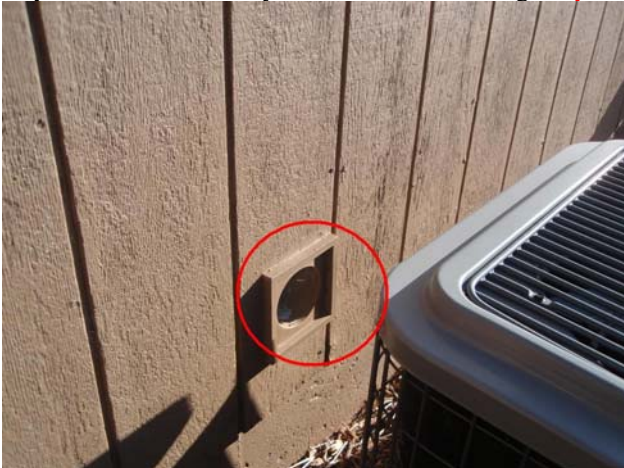
- **Repair:** The exterior dryer vent cover is missing. **Repaired**

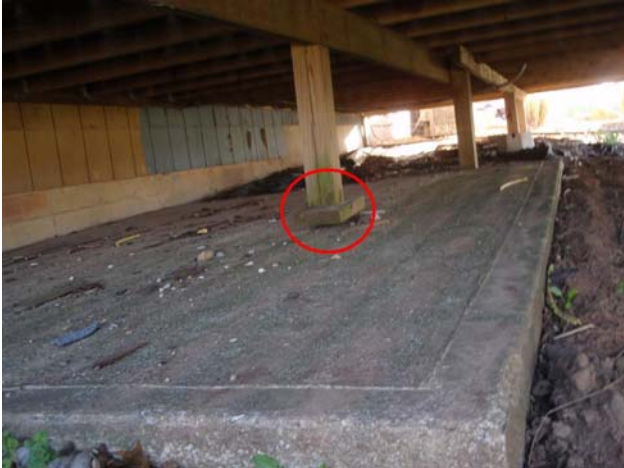
- **Repair:** The deck should be painted, stained or sealed to improve durability.
- **Repair, Safety Issue:** A deck railing baluster is missing and needs repair. **Repaired**
- **Repair:** The support under the deck is not supporting the deck. This should be repaired. **Repaired**

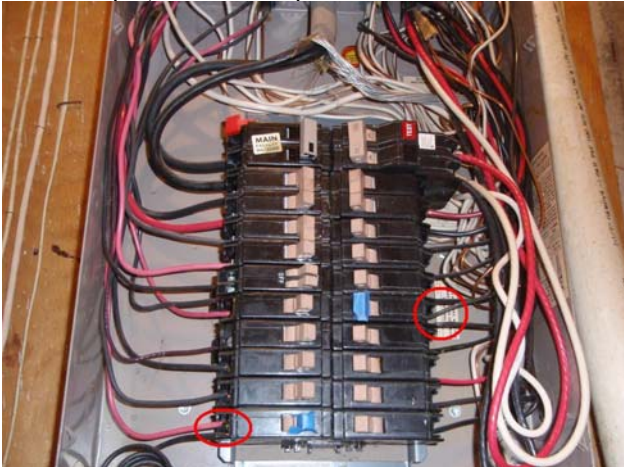
- **Repair:** Circuits within the main distribution panel (marked with "bleue tape") that are doubled up (referred to as "double taps") should be separated. Each circuit should be served by a separate fuse or breaker.

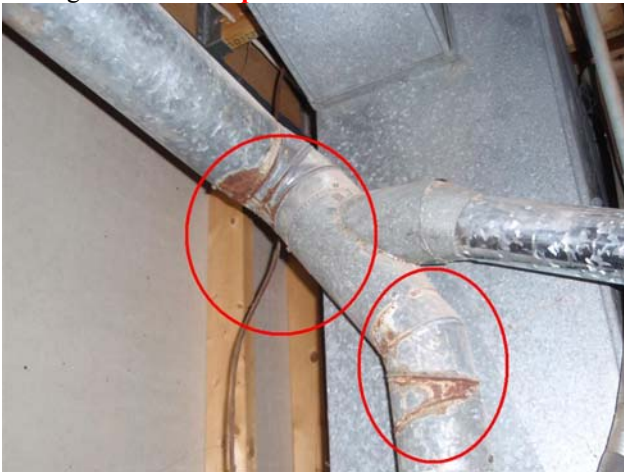
- **Repair, Safety Issue:** The exhaust vent ductwork is rusting. This condition should be evaluated by a qualified licensed heating technician. **Repaired**
