Home Inspection Report

5917 Noland Rd, Shawnee, KS 66216

Inspection Date: 12/31/2008

Report Number: 12312008-1A

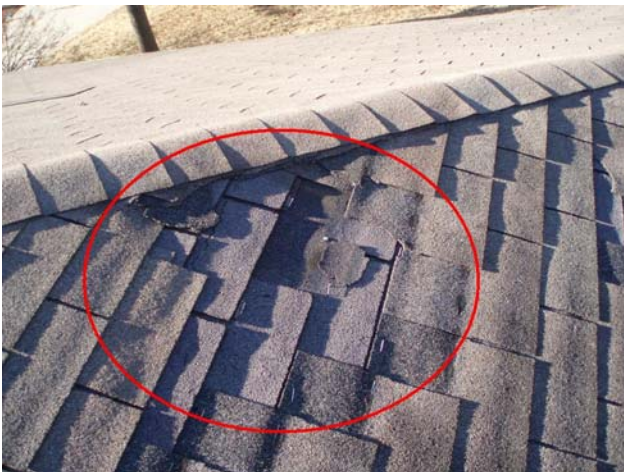
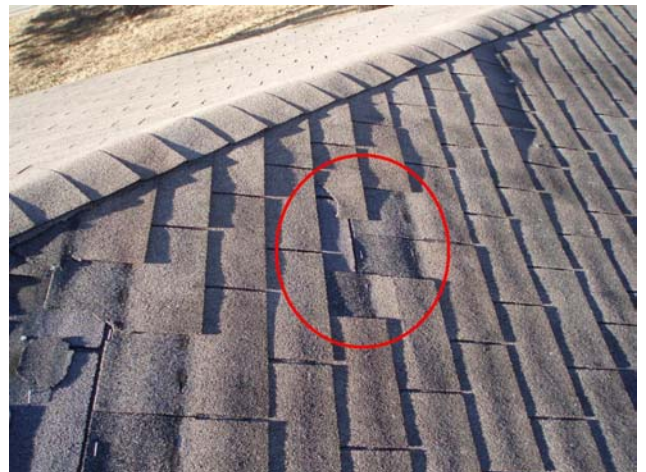
- **Major Concern, Repair:** Missing tabs was observed. Repairs are needed. The roofing is near the end of its life. Minor repairs might be possible to extend the roof life and to defer leaks. Damaged or missing roofing material should be repaired. All roof penetrations should be examined and sealed as necessary. Expect to replace the roof soon. Older roofs are, by their nature, a high maintenance roof. Annual inspection and repair should be anticipated. In addition, the older flashings should be monitored. In some cases, a deteriorated flashing can result in expensive repairs, because sections of the roofing have to be removed. As a rule of thumb, replacement of the entire roof covering may be logical if more than ten percent of the roof requires repair.

- It is recommended that the present layers of roofing materials be removed prior to re-roofing. This adds cost of demolition and debris removal to the re-roof cost.

- Replace the roof flashing materials (example at roof vents and chimney flashings) when re-roofing to avoid leaks in these areas.

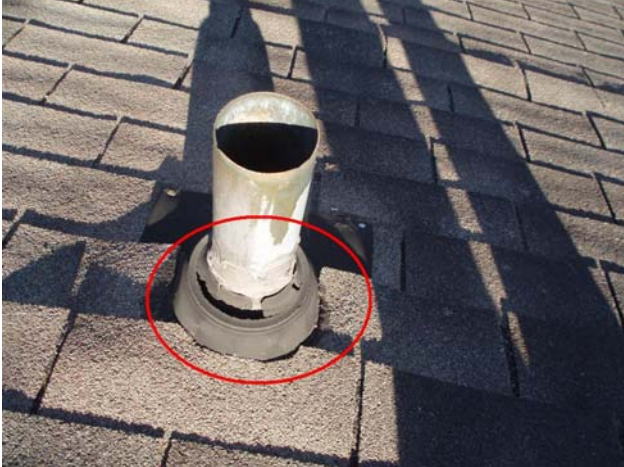
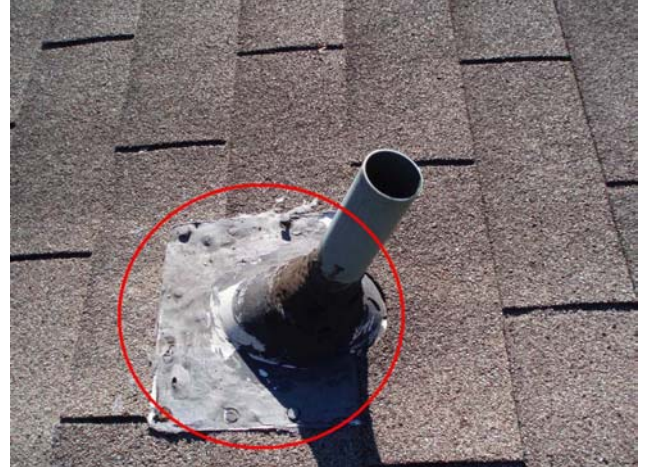
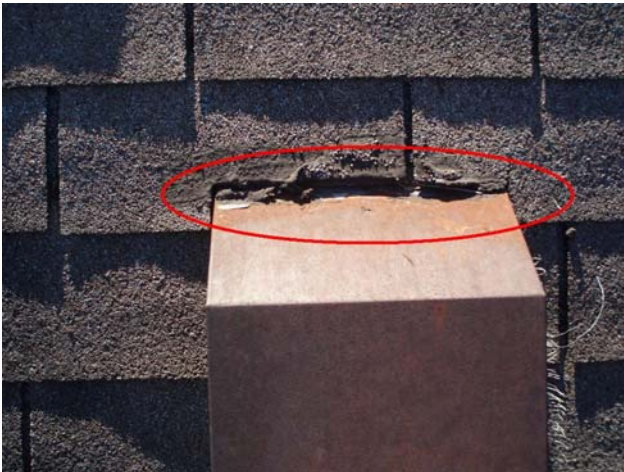
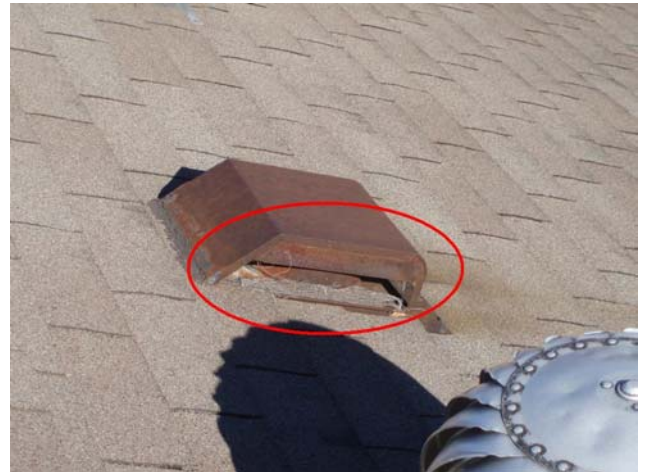
Flashings

- **Monitor, Repair:** The plumbing and roof vent flashing is old and should be monitored. If leaks occur it may be possible to patch leaky flashing; otherwise replacement will be needed. Exposed flashing nail heads should be caulked. Rusted roof vents should be painted to extend their lives. Screens on some roof vents are damaged.
- **Monitor:** The plumbing vent flashing is vulnerable and should be carefully monitored for leaks.
- **Repair:** The plumbing vent flashing boot is split making it vulnerable to leaks. It's recommended that the boot be caulked or the flashing replaced.

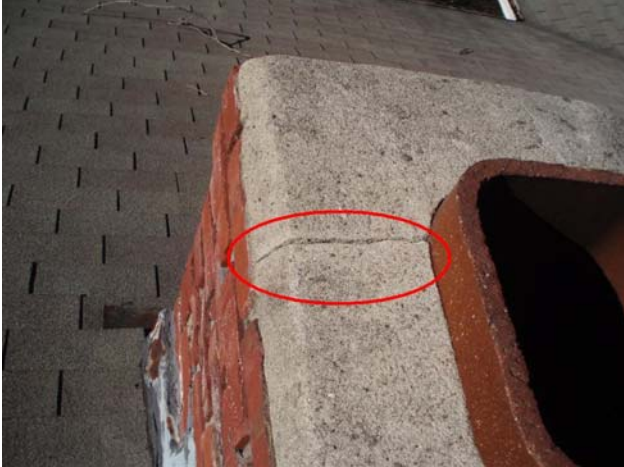
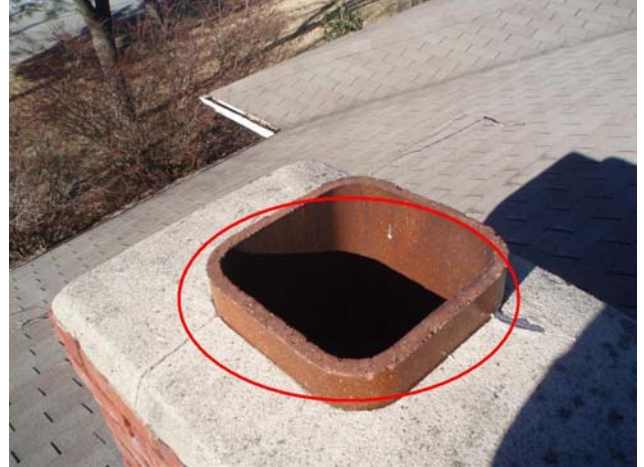
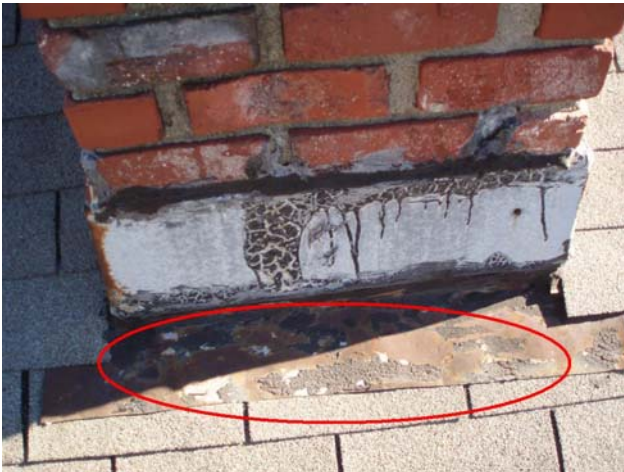
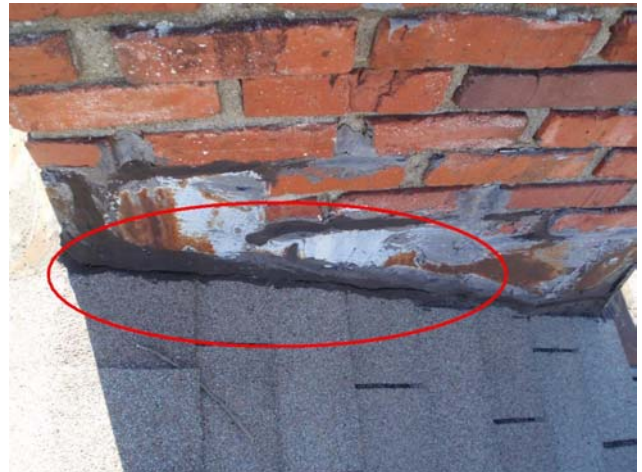
Chimneys

- **Repair:** The cap of the masonry chimney is cracked. These cracks should be sealed or caulked to prevent damage from freezing water.
- **Repair:** A rain cap and vermin screen should be installed on the masonry chimney and the chimney flue should be checked for damage. Damaged flues can be unsafe.
- **Repair:** The chimney flashing is rusting. It should be painted to extend its life.
- **Repair:** The chimney flashing should be caulked to avoid leaks.

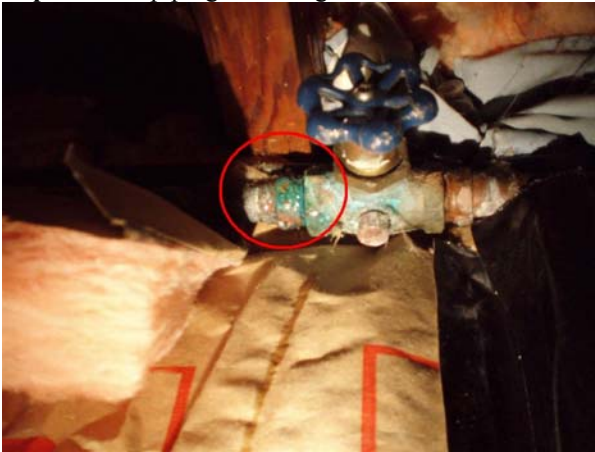
- **Repair:** The piping is leaking at the shutoff handle at basement ceiling near water heater.

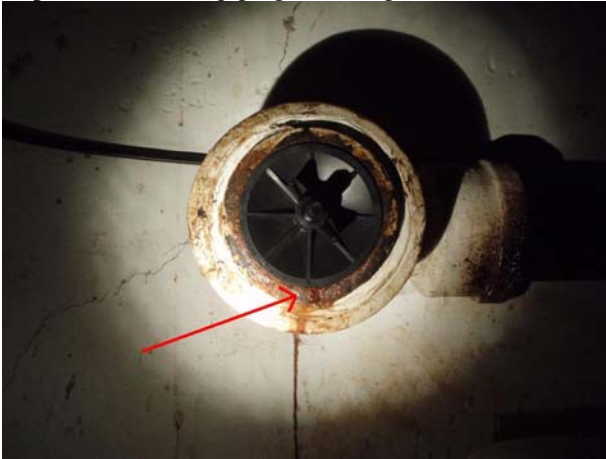
- **Repair:** The waste piping is leaking at southwest corner of basement.

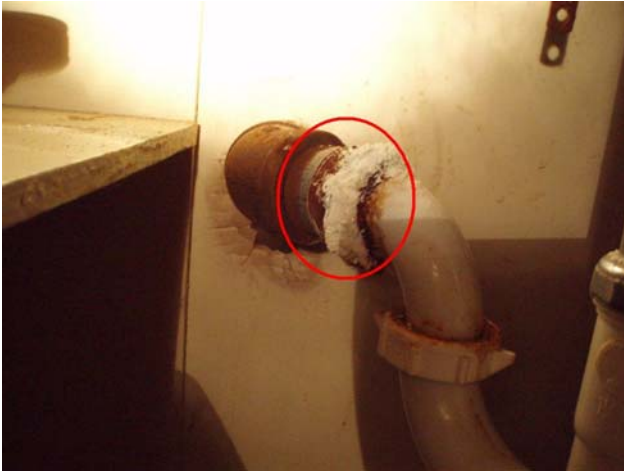
- **Monitor:** The trap under the entry way bathroom sink is in suspect condition (mineral buildup at piping connection). This area should be monitored.
