**Star
Home
Inspection Services**

Home Inspection Report

5922 Charlotte St, Kansas City, MO 64110

Inspection Date: 06/15/2009

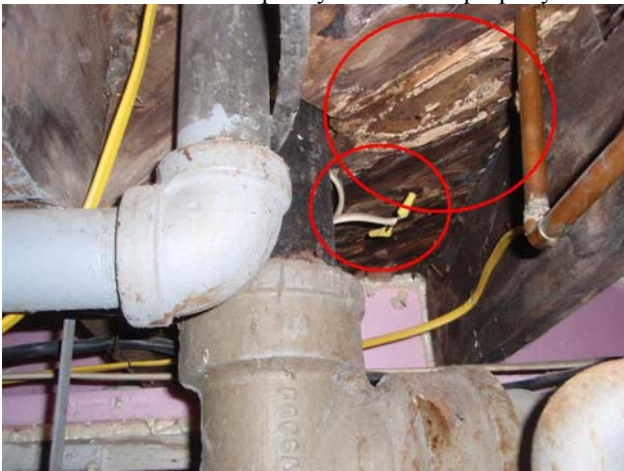
- **Monitor:** Minor damaged subflooring (supporting layer of flooring atop floor joists and below finish flooring or carpeting) was found below the hall bath. Since only minor limited areas of damage exist this repair can be deferred until combined with other carpentry work at the property.

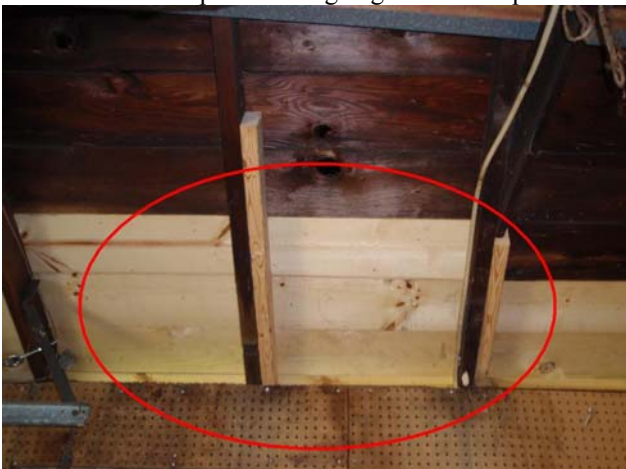
- **Monitor:** Prior repairs to the garage roof solid plank sheathing are evident.

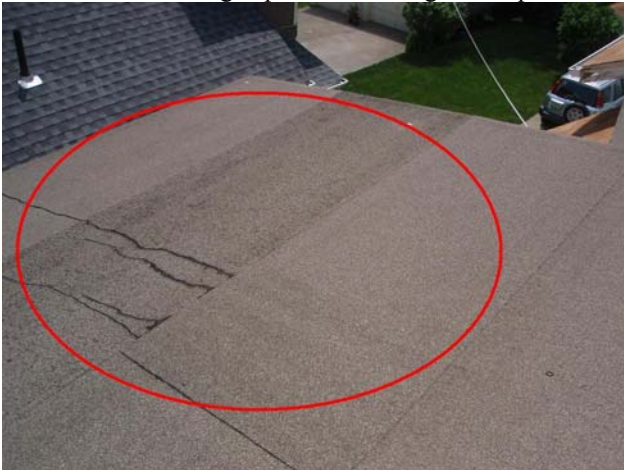
- **Note:** Rolled roofing is prone to leaking and requires close monitoring and higher than normal maintenance.

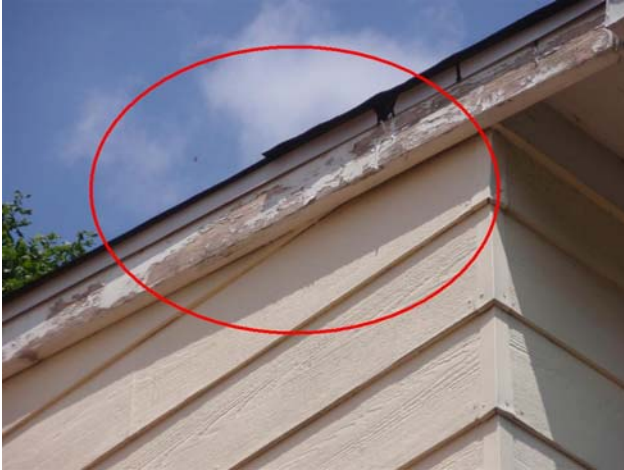
- **Monitor, Repair:** Localized damage (missing soffit board) was observed in the soffit for the detached garage). Improvement is not necessary at present, although this condition should be repaired when exterior painting or maintenance are planned.
- **Repair:** The eaves are peeling and they should be painted to prevent water damage and rot.

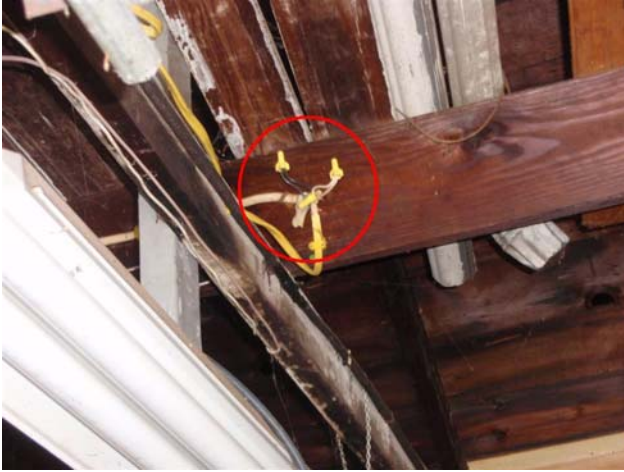
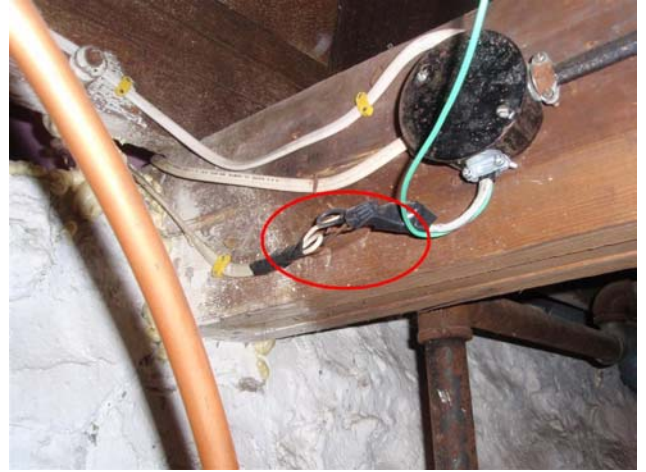
- **Repair:** Improper electrical connections should be repaired. All electrical connections should be made inside junction boxes fitted with cover plates (examples at detached garage and at basement ceiling).

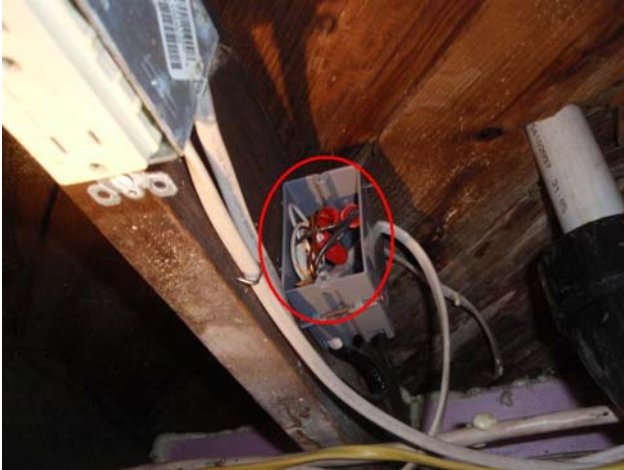
- **Repair:** All junction boxes should be fitted with cover plates, in order to protect the wire connections (examples at basement ceiling).
