**Star
Home
Inspection Services**

Home Inspection Report

601 NE Burning Tree St Lees Summit, MO 64064

Report Number: 04052010-3L

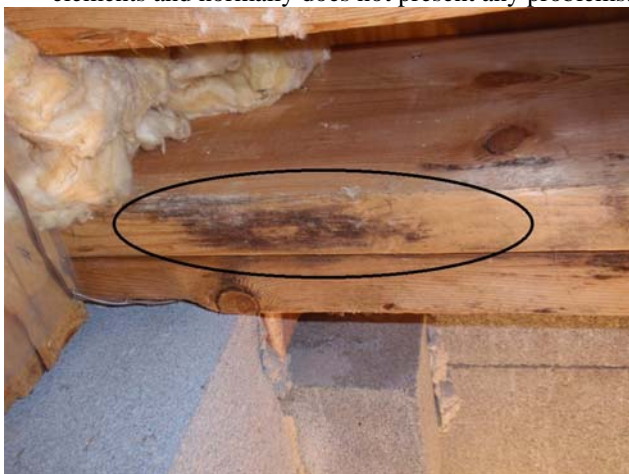
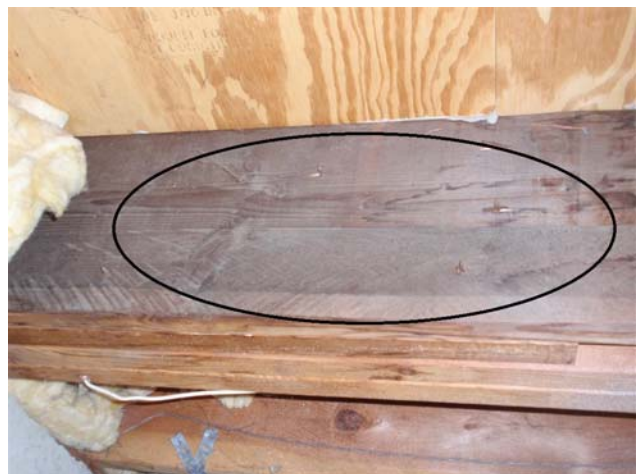
- **Monitor:** Construction mold was visible on some floor joists. This is mold that grows on the lumber while lying in the weather during construction. Most homes have some level of this mold and it goes dormant once removed from the elements and normally does not present any problems.

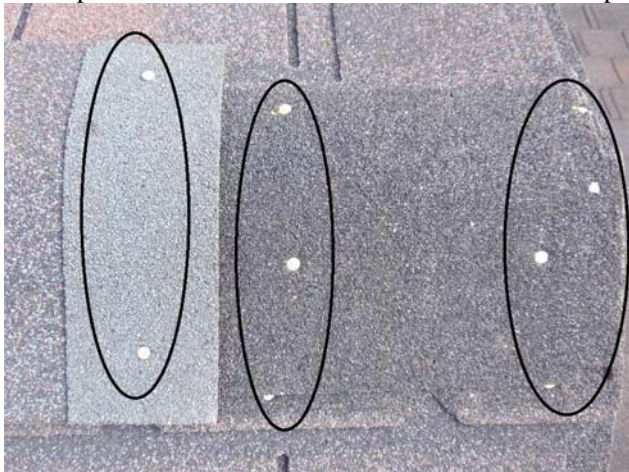
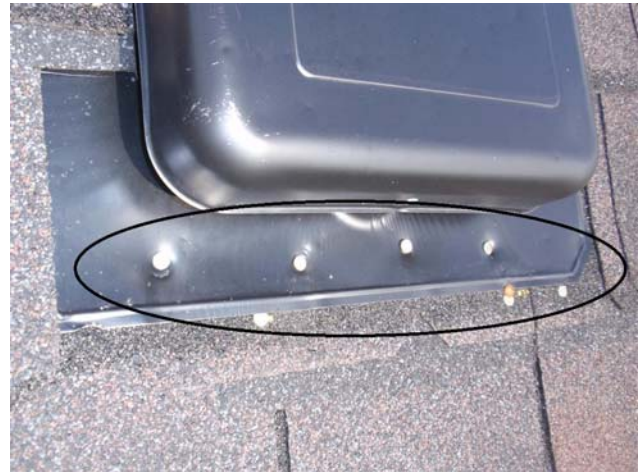
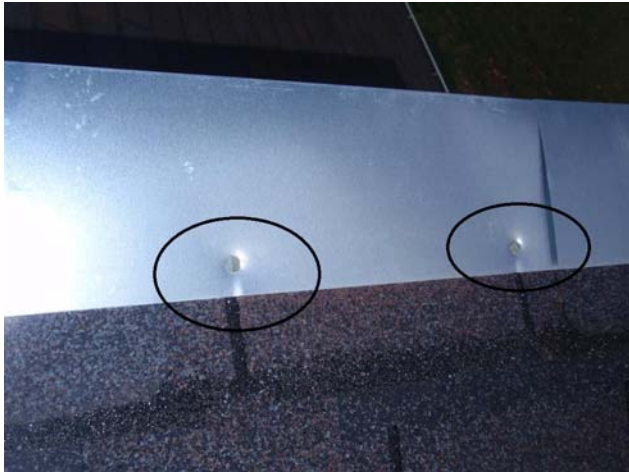
- **Recommend:** Exposed nail heads were observed in the roofing shingles and/or ridge caps, vents and flashjongs. All exposed nail heads should be caulked to reduce the potential of leaks.

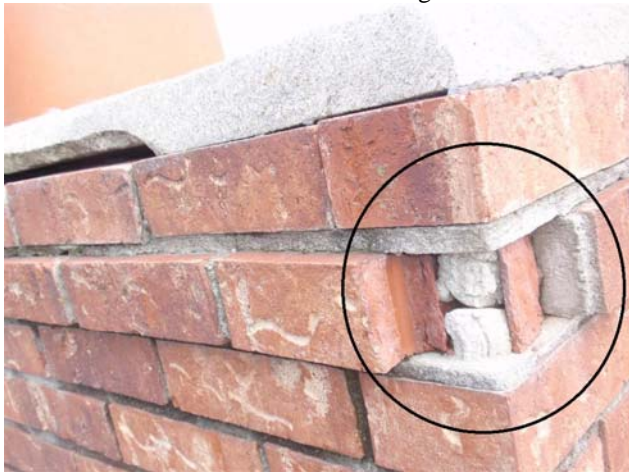
- **Repair:** The masonry chimney needs re-pointing (replacing the mortar between the bricks) and the replacement of one corner brick to avoid further damage.

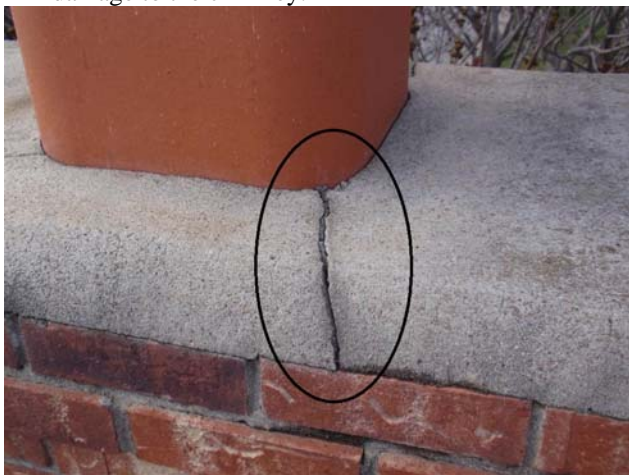
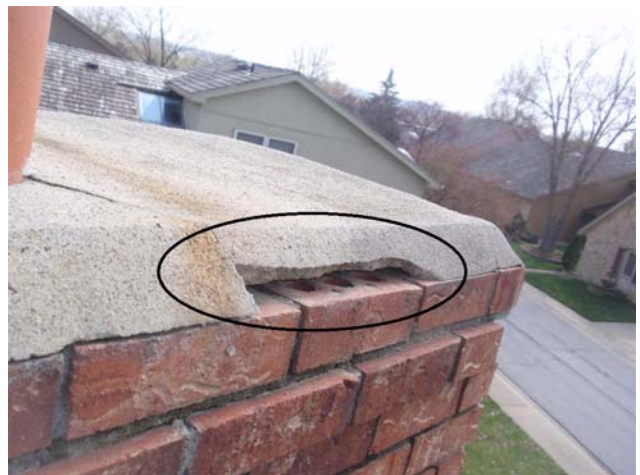
- **Repair:** The cap of the masonry chimney is cracked and/or damaged. This should be repaired to prevent further damage to the chimney.

- **Recommend:** Due to the notes made on the chimney in the Roofing section, it's recommended the fireplace and chimney be inspected and cleaned prior to operation.

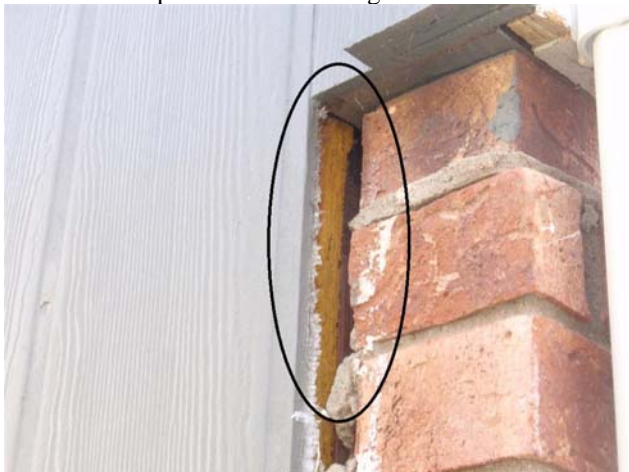
- **Repair:** The gap between the siding and exterior brick wall on the northeast corner needs to be caulked or filled with mortar to prevent water damage

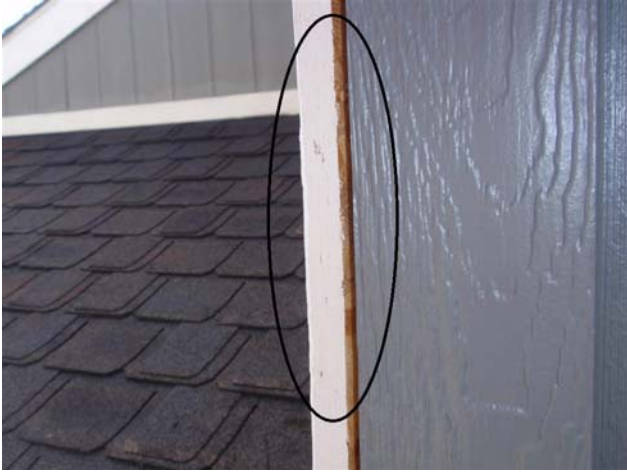
- **Repair:** The siding trim needs caulking improvements in localized areas to prevent water damage and rot. Picture was taken on the southeast corner above the lower roof.

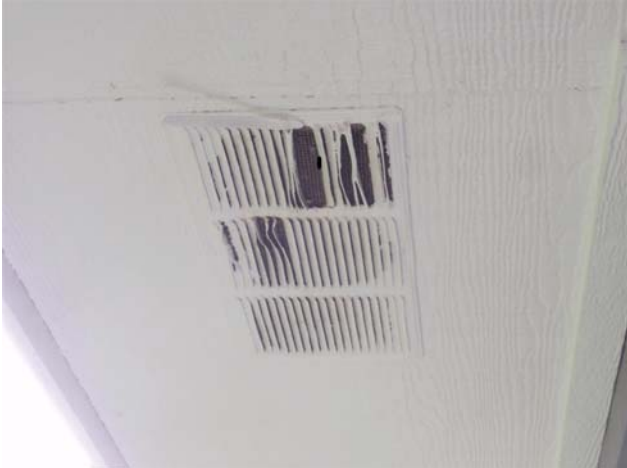
- **Monitor, Repair:** One soffit vent cover on the rear of the house is damaged. Repair is discretionary.

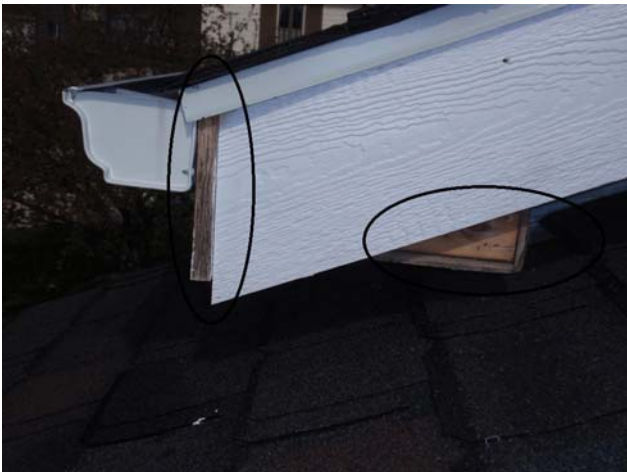
- **Repair:** The end of the fascia and soffit on the upper roof over the garage needs to be painted to prevent water damage and/or rot.

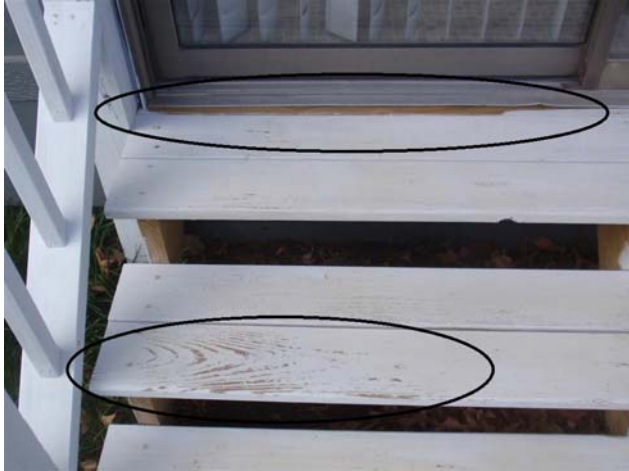
- **Repair:** The rear porch steps needs another coat of paint. It was also observed that the porches and steps are painted only on the outside surfaces.

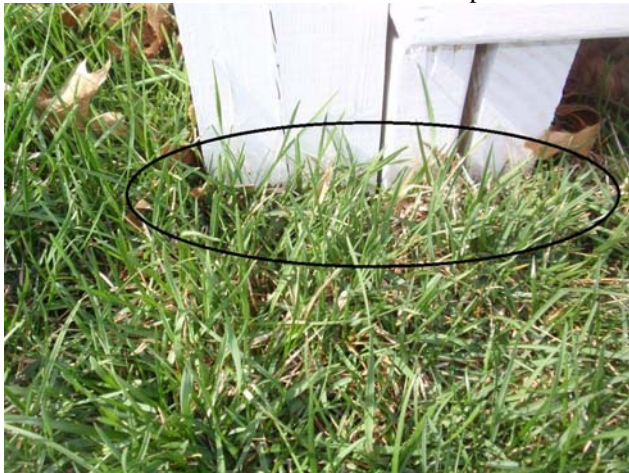
- **Monitor, Repair:** The support posts for the rear steps are below the soil. This configuration is prone to rot. Raising above soil level is recommended. The potential of rot could already be present.

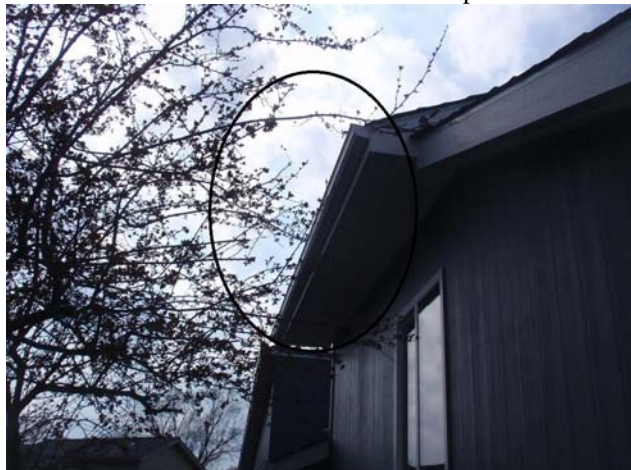
- **Monitor:** Tree branches should be kept trimmed away from the house to avoid damage to the building.

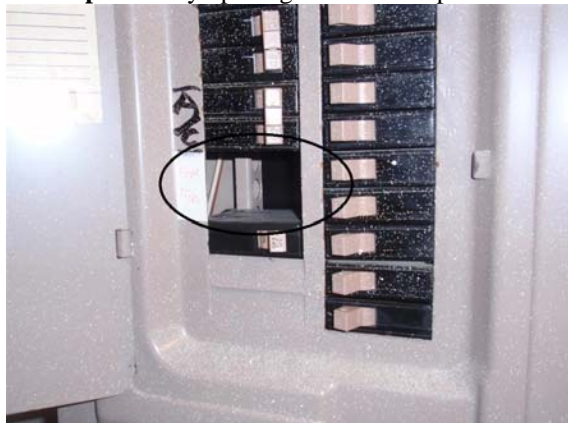
- **Repair:** Oversized breaker within the main distribution panel for the air condition should be replaced. The data plate on the unit specifies a maximum breaker size of 35 Amps and the one in the panel is 50 Amps.
- **Repair:** Any openings in the main panel should be covered.

Energy Source:	•Electricity
Central System Type:	•Air Cooled Central Air Conditioning •Manufacturer: Trane •Serial Number: 8164YF94F
Size of Circuit:	•Circuit Size: Minimum Circuit Size 21 Amps/Maximum Circuit Breaker Size 35 Amps •Breaker Size In Main Panel: 50 Amps
Through-Wall Equipment:	•Not Present

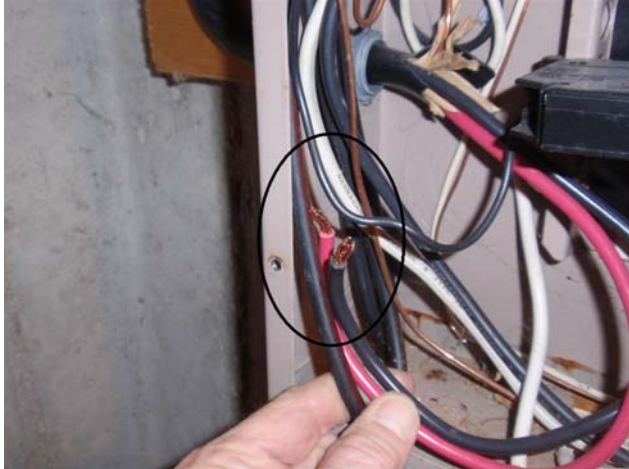
- **Repair:** One cable in the electrical panel is not connected to a breaker and the wires are not capped.

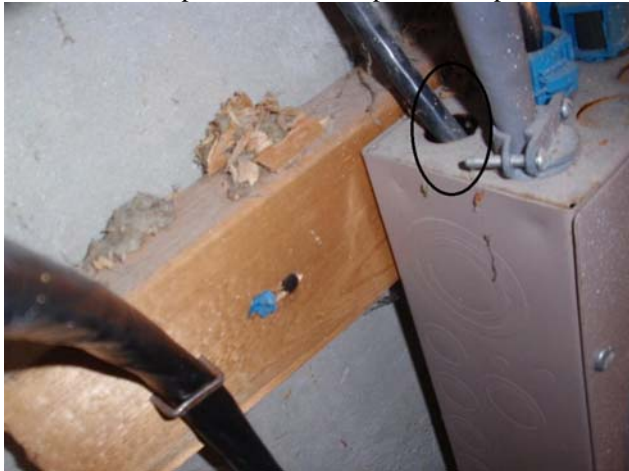
- **Repair:** Cable clamps (sometimes referred to as bushings or grommets) are required where wiring passes into the main distribution panel. Cable clamps serve to protect the wiring from the metal edges of the panel openings.

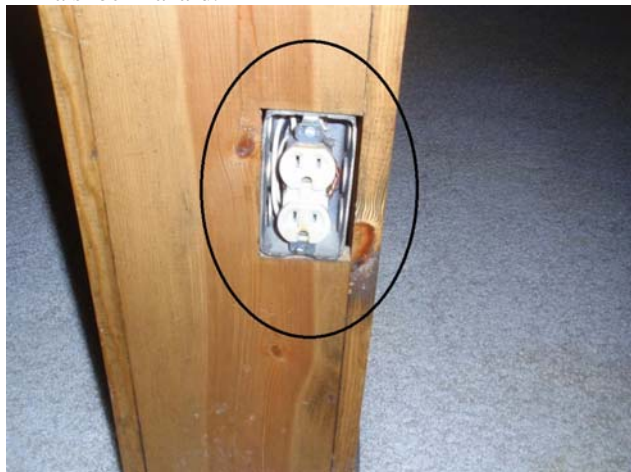
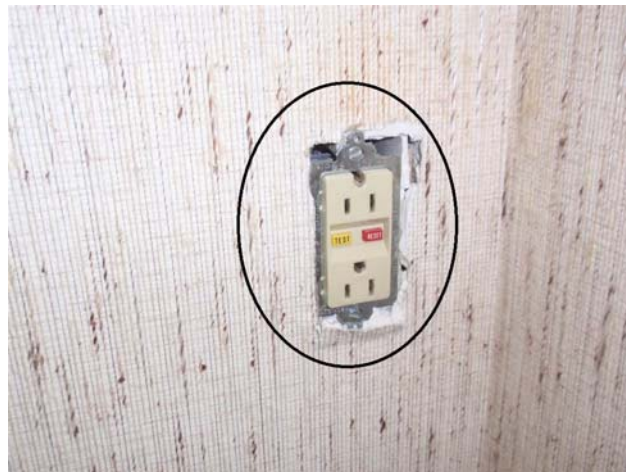
- **Repair:** Outlets on the southwest corner of the house and in the living room are inoperative. These outlets and circuits should be investigated and repaired as needed.
- **Repair:** An outlet in the living room has reversed polarity (i.e. it is wired backwards). This outlet and the circuit should be investigated and repaired as necessary.
- **Repair:** Ungrounded 3-prong outlets on the rear of the house marked with blue tape should be repaired. In some cases a ground wire may be present in the electrical box and simply needs to be connected. If no ground is present “repair” can be as simple as replacing with two-holed outlets.

-
- **Repair:** Missing outlet cover plates in the basement bath and on the basement support pole should be replaced to avoid a shock hazard.

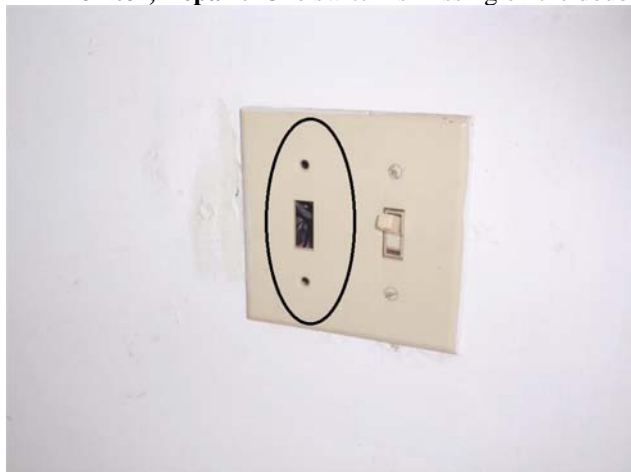
- **Monitor, Repair:** The function of the light switches in the living room and master bedroom marked with blue tape is unknown.
- **Monitor, Repair:** One switch is missing on the double switch by the garage overhead door.

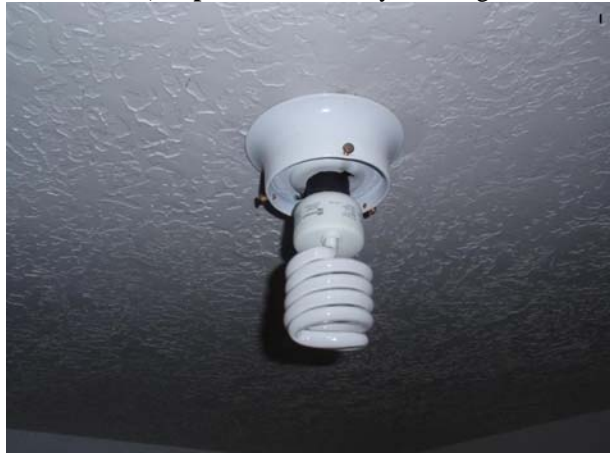
- **Repair:** The exterior garage light is inoperative. If the bulbs are not blown, the circuit should be repaired.
- **Monitor, Repair:** The laundry room light fixture is missing the glass cover. Repair is discretionary.

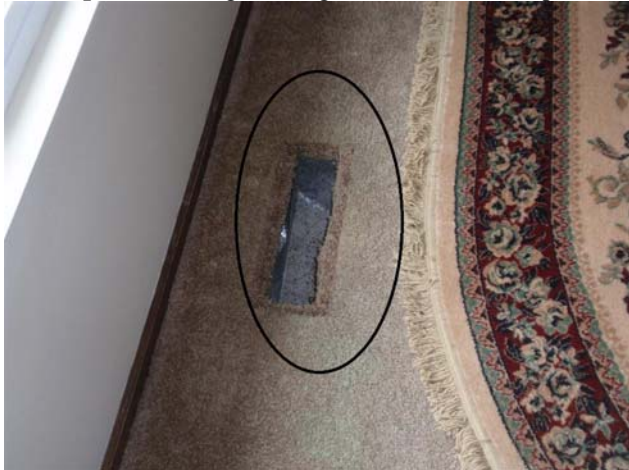
- **Repair:** Missing vent register(s) should be replaced.

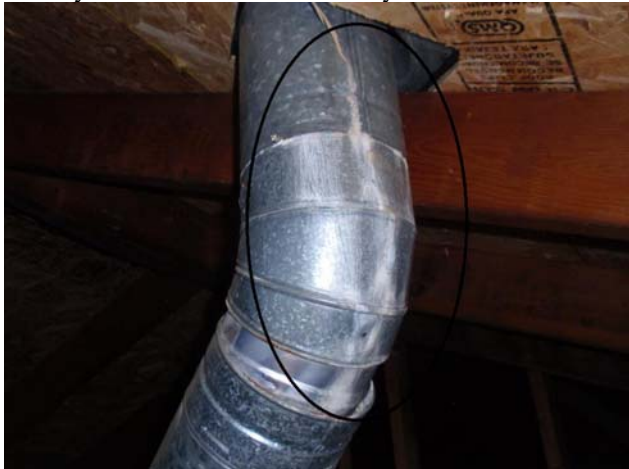
- **Monitor:** While in the attic water stains were observed on the lower sections of the furnace flue. The insulation below the elbow also showed signs of past moisture. It appears that rain blew in under the rain cap and came down the interior of the flue until it got to the first joint where it then transferred to the outside surface and dripped off the elbow. This is a common condition in 80% of homes but very seldom is enough to penetrate completely through the insulation to the drywall below. Monitor for any additional wetness after rains.

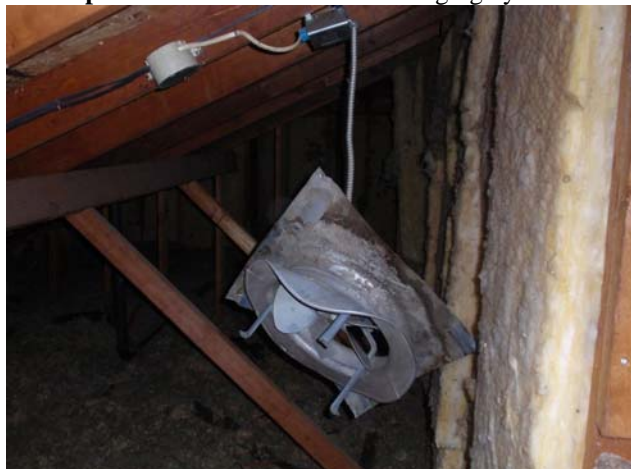
- **Repair:** The old exhaust fan is hanging by the conduit in the attic. The fan should be removed.

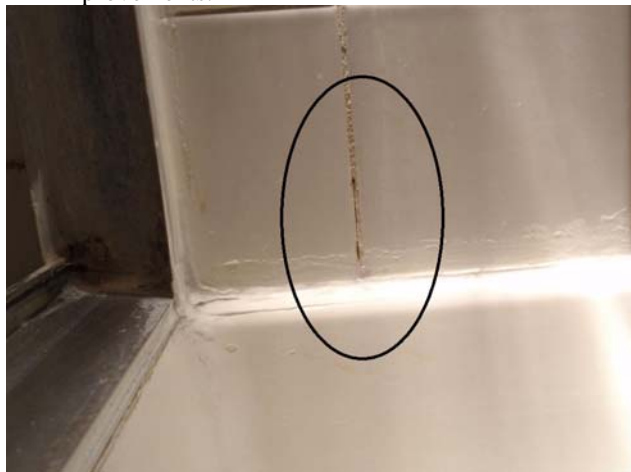
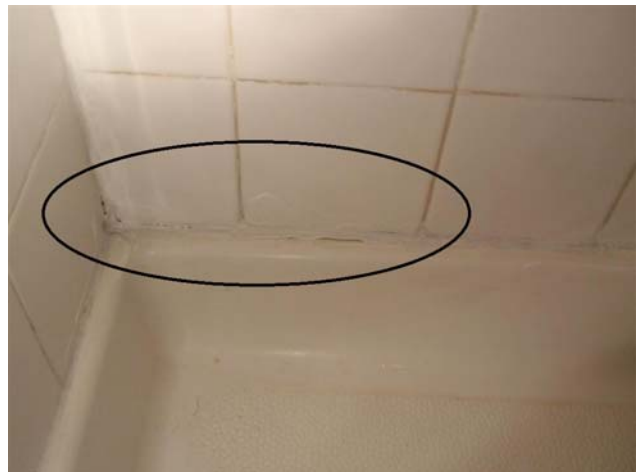
- **Repair:** The basement sink drain plug is inoperative and needs repair.
- **Repair:** The hallway bathroom toilet is loose. The wax seal should be replaced and toilet better secured.
- **Improve:** Cracked, deteriorated and/or missing shower stall grout and caulk in the master bedroom shower needs minor improvements.

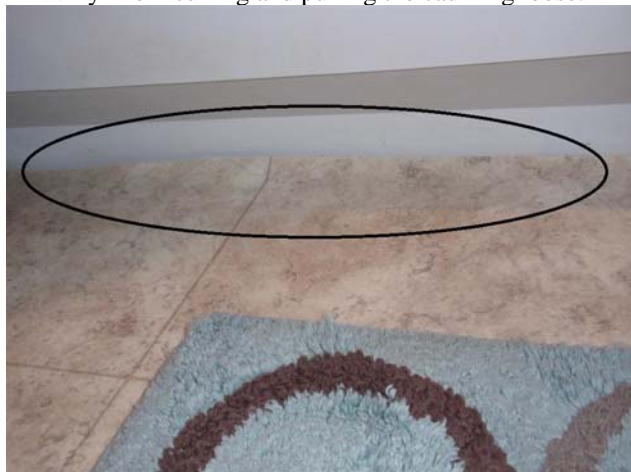
- **Improve:** Cracked, deteriorated and/or missing bathtub and shower enclosure caulk in the hallway bathroom could be improved along the floor. With vinyl flooring it's recommended a quarter round molding be installed to prevent the vinyl from curling and pulling the caulking loose.

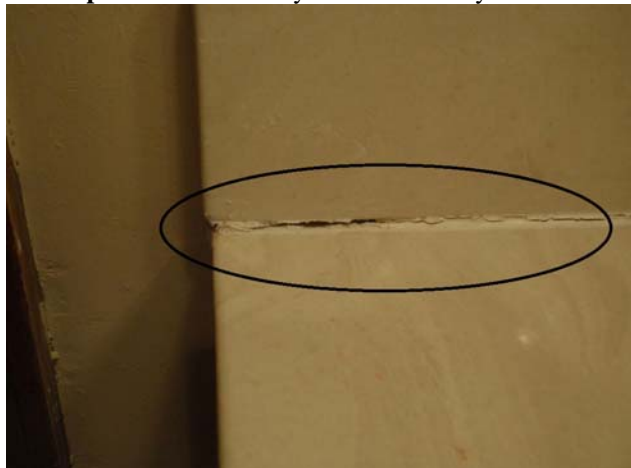
- **Improve:** The hallway bathroom vanity needs some minor caulking improvements.

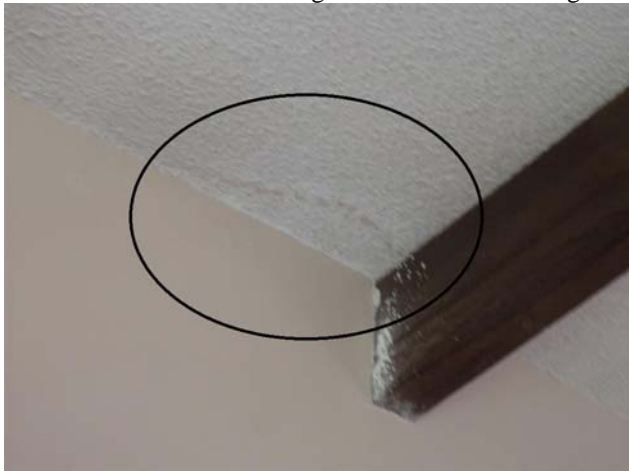
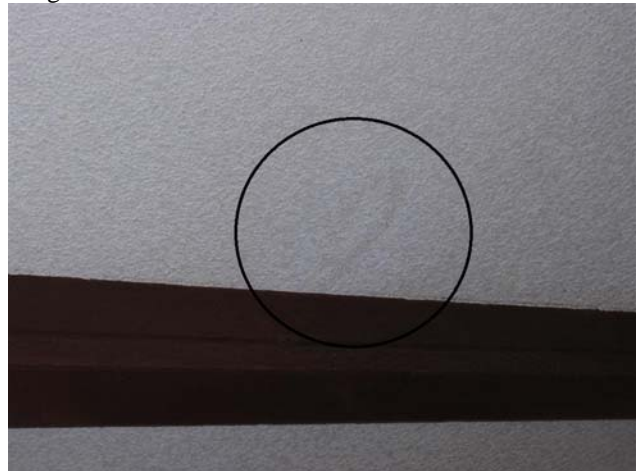
- **Monitor:** Water staining was noted on the living room ceiling.

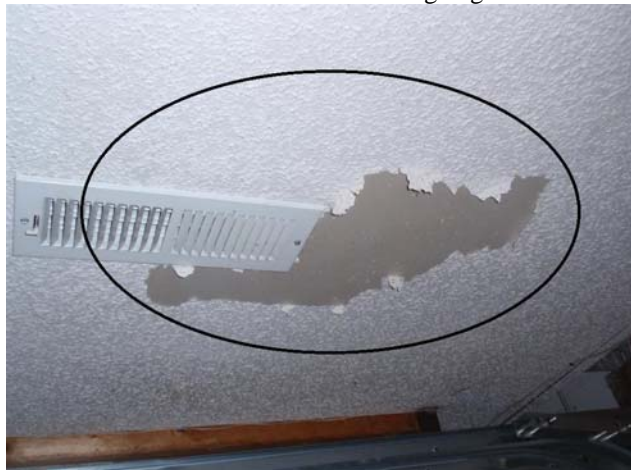
- **Monitor, Repair:** The textured ceiling in the garage is peeling. This is most likely caused from condensation from the duct and is difficult to control in a garage when humidity is high and the doors are open.

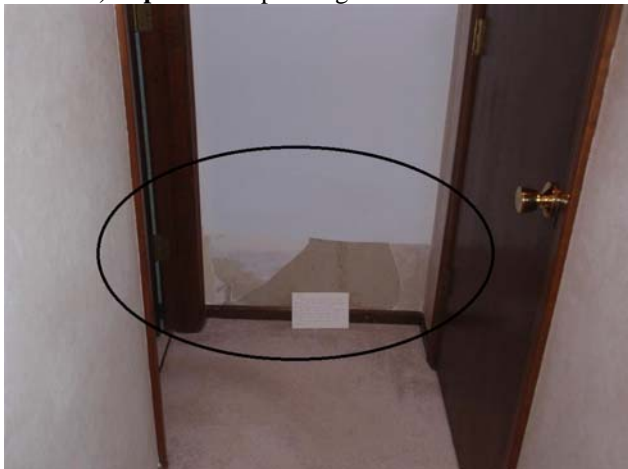
- **Monitor:** Typical drywall and/or plaster flaws were observed that could include loose tape, minor cracks, rough seams, peeling paper, nail popping, minor patching, loose or bulging plaster, etc. Any repairs would be discretionary.
- **Monitor, Repair:** The painting in the master bedroom bath hallway is incomplete.
