**Star
Home
Inspection Services**

Home Inspection Report

6010 Cherokee Dr, Fairway, KS 66205

Report Number: 10142008-2A

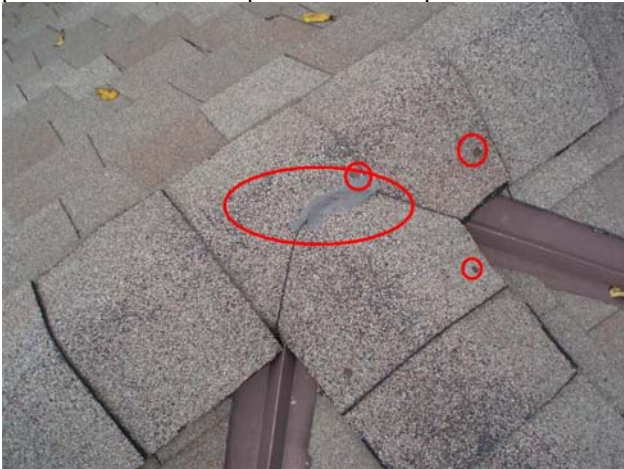
- **Monitor:** Prior repairs to the roofing are evident at ridge where small area has been caulked. This would suggest that problems have been experienced in the past. This area should be monitored.

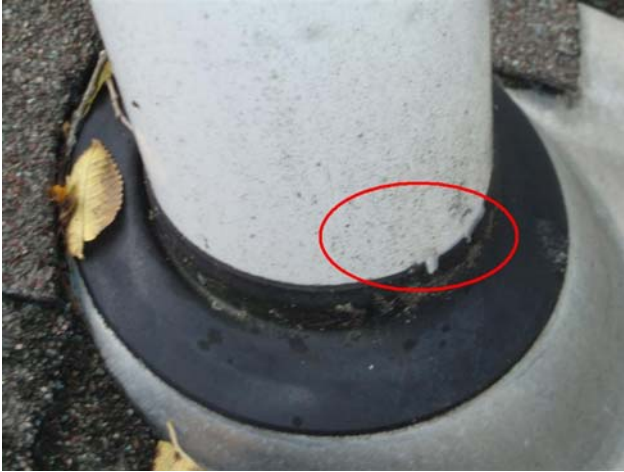
- **Monitor, Repair:** The plumbing vent flashing boot (2) are split making them vulnerable to leaks. It's recommended that the boot be caulked or the flashing replaced.

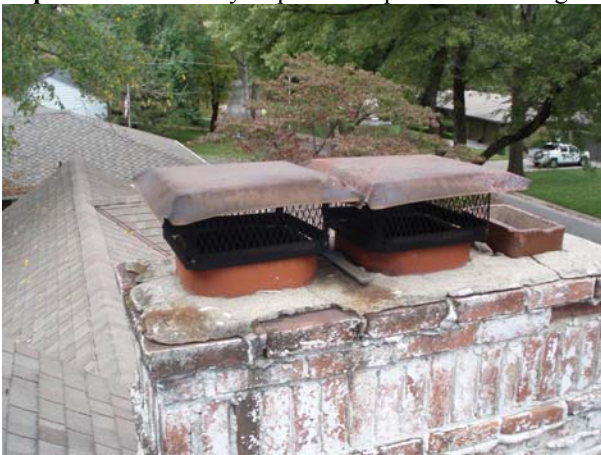
- **Monitor:** The masonry chimney shows evidence of spalling (surface deterioration of the masonry). Repair is not necessary at this time but this condition should be monitored.
- **Repair:** The masonry cap of the masonry chimney should be replaced and the chimney flue should be checked for damage. Damaged flues can be unsafe.
- **Repair:** The chimney requires a cap to avoid damage.

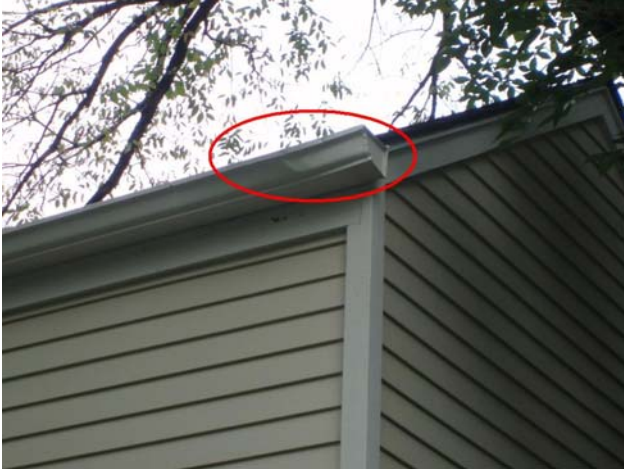
- **Repair:** The gutters require cleaning to avoid spilling roof runoff around the building – a potential source of water entry or water damage.
- **Monitor, Repair:** Minor damage to the back gutter was noted.

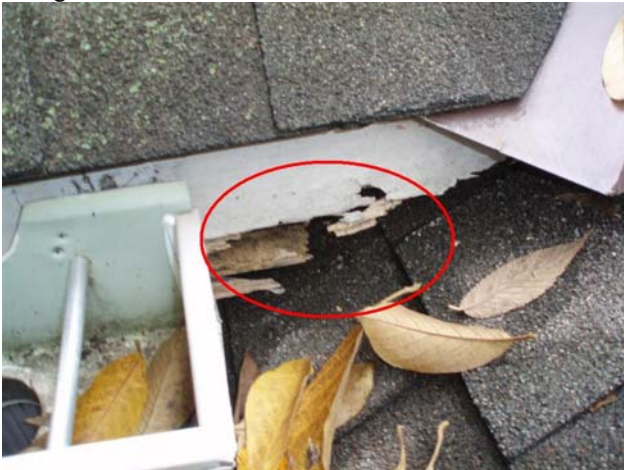
- **Repair:** Localized rot was observed in the fascia (the wooden board to which the gutter is typically fastened). Following repair of the damaged areas (which should be combined with exterior painting/maintenance) proper maintenance of the siding and control of water from roof or surface runoff can avoid further damage.

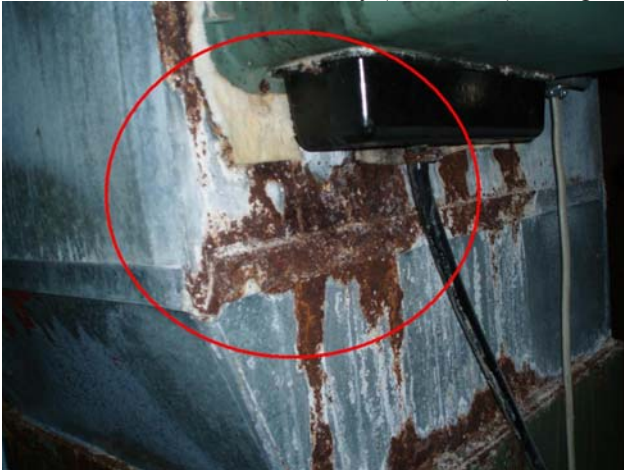
- **Monitor:** Given the age of the furnace, it may be near the end of its useful life. You should reserve funds to be ready to purchase a new furnace.
- **Repair:** The humidifier has lacked maintenance. Cleaning and repairs should be undertaken. Watch out for humidifier leaks into the furnace where costly (and hidden) damage can occur. Rust was observed on ductwork around humidifier.
