**Star
Home
Inspection Services**

Home Inspection Report

611 NE Thames Ct, Lees Summit, MO 64086

Inspection Date: 3/19/2009

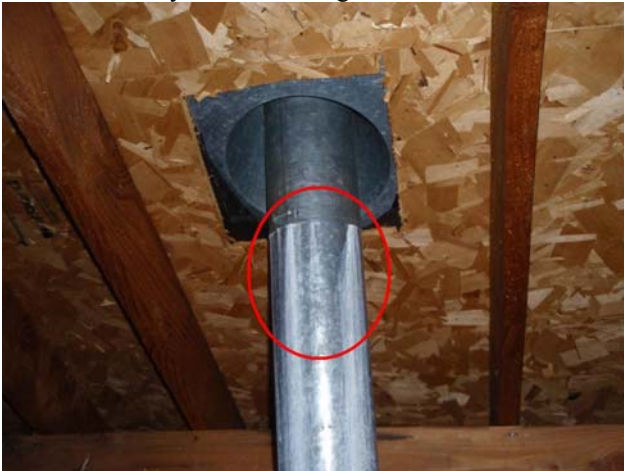
- **Monitor:** Previous water staining was noted on furnace exhaust vent pipe in attic. This is a common condition which can be caused by a hard blowing rain storm.
