Star Home Inspection Services

Home Inspection Report

618 Huntington Rd, Kansas City, MO 64113

Report Number: 05182009-1A

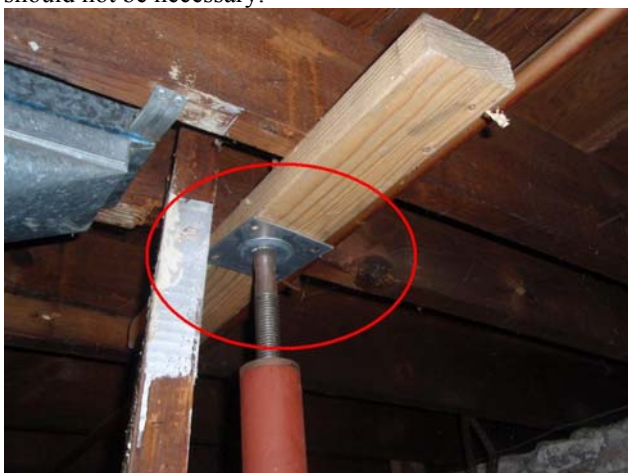
- **Monitor:** Additional steel support posts have been installed in the basement. This suggest some sagging of the floor may have occurred in the past. These areas should be monitored. In the absence of any sign of ongoing movement, repair should not be necessary.

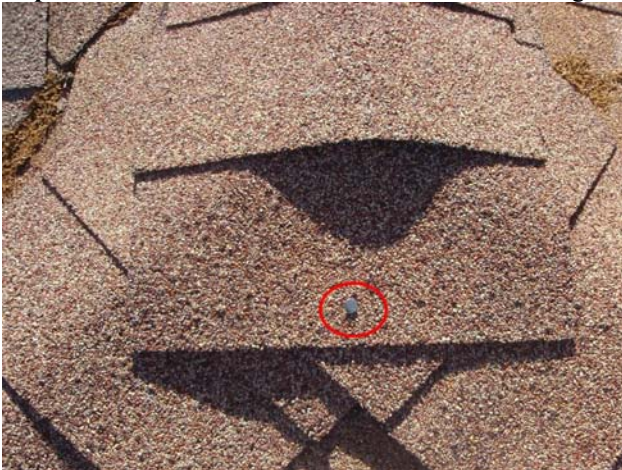
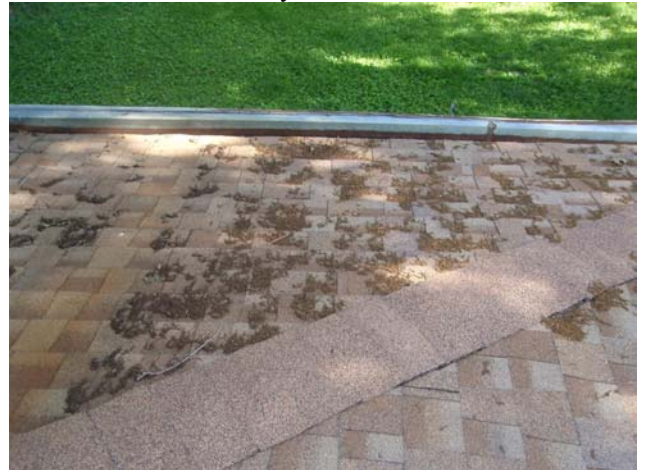
- **Repair:** Exposed nail heads were observed in the roofing shingles and/or ridge caps. All exposed nail heads should be caulked to reduce the potential of leaks.
- **Improve:** Debris should be removed from the roofing to reduce risk of leaks and early roof wear.

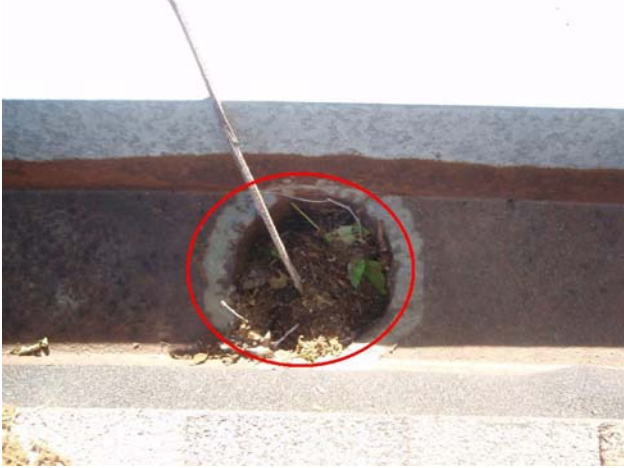
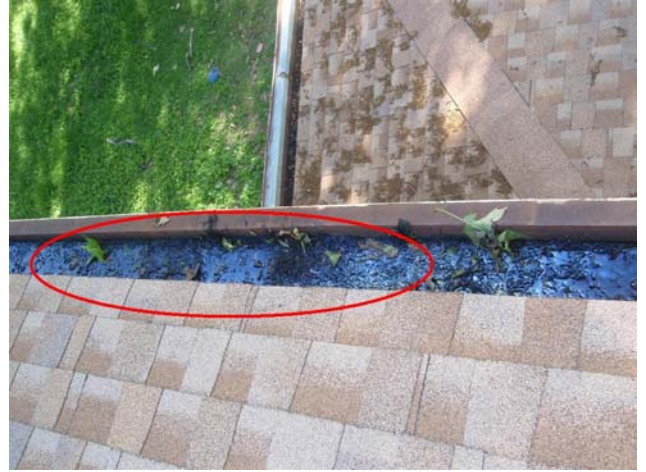
- **Repair:** The gutters require cleaning to avoid spilling roof runoff around the building – a potential source of water entry or water damage.

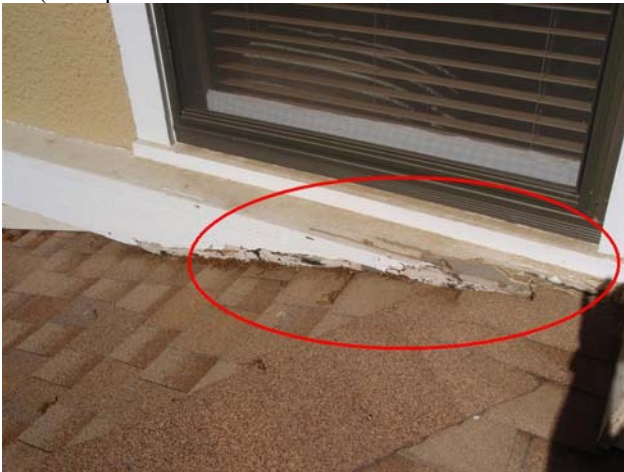
- **Repair:** The exterior stucco siding paint is peeling and/or worn thin in localized areas. These areas should be painted to prevent water damage or rot in the future (example at chimney stucco).
- **Repair:** The paint on the trim around the siding is peeling. These areas should be painted to prevent water damage and rot (example at trim below windows at 2nd floor on east side of house).

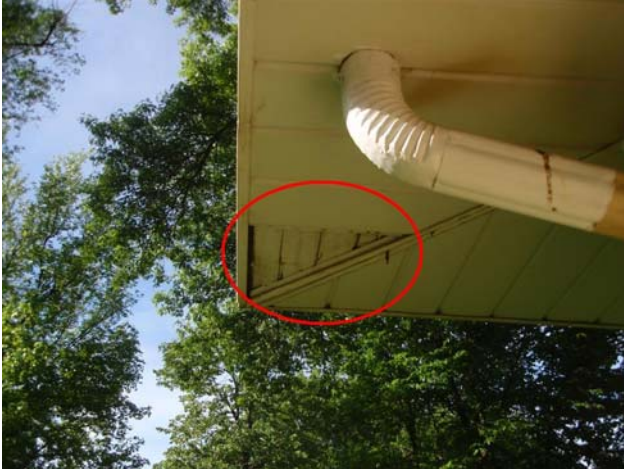
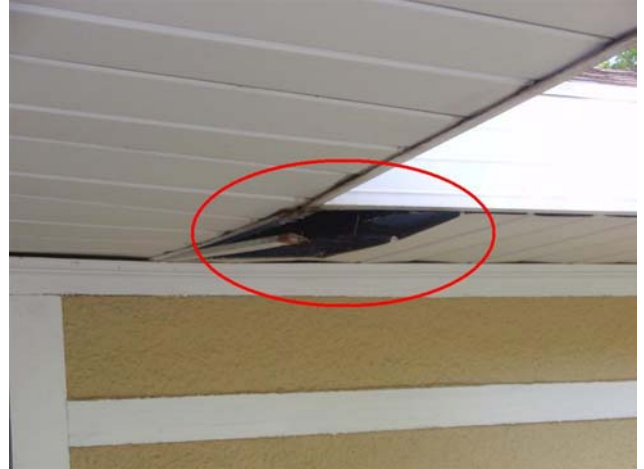
- **Monitor:** Localized damage to the aluminum cover was observed in the fascia (the wooden board to which the gutter is typically fastened) and the soffit.

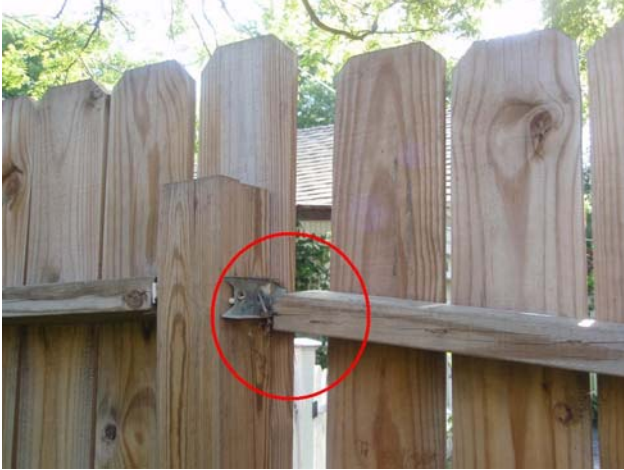
- **Repair:** The fencing is in good condition. Minor repairs are needed.

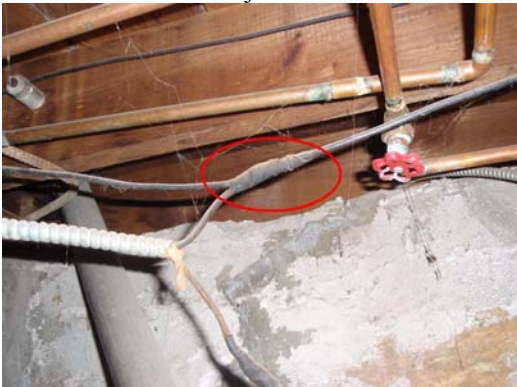
- **Repair:** Improper electrical connections should be repaired (examples at basement ceiling). All electrical connections should be made inside junction boxes fitted with cover plates.
