**Star
Home
Inspection Services**

Home Inspection Report

6205 W 77th St Prairie Village, KS 66208

Report Number: 12312009-1A

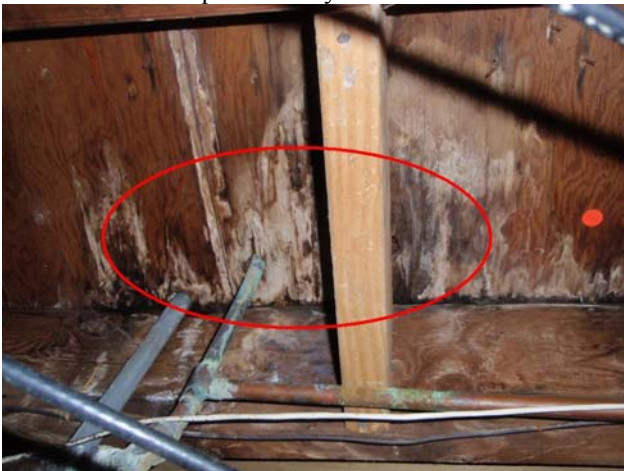
- **Monitor, Repair:** Water staining and minor subflooring damage (supporting layer of flooring atop floor joists and below finish flooring or carpeting) was found (i.e. at water heater closet subflooring). Where only limited areas of damage exist this repair can be deferred until combined with other carpentry work at the property. Beware of damaged subfloor below carpet as it may be unsafe.

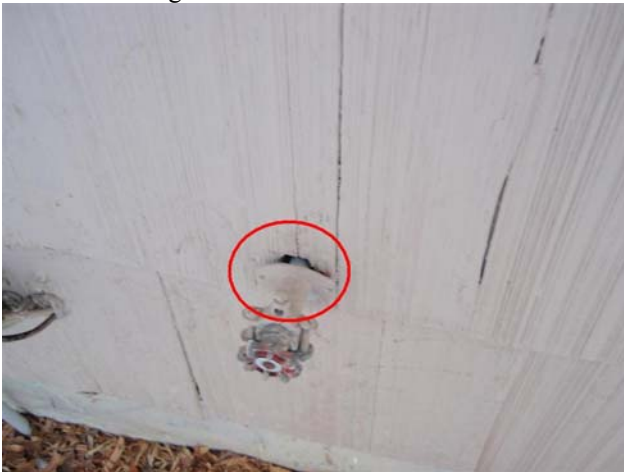
- **Repair:** Any openings in the exterior siding should be sealed. An example is where the back hose bib line enters the house. Caulking is needed.

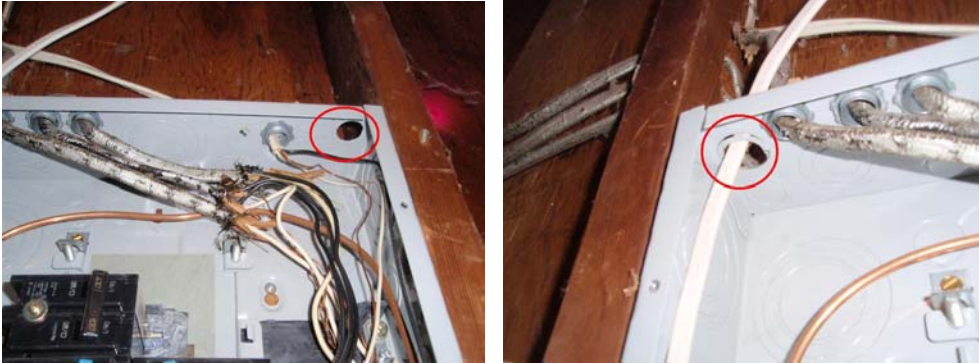
- **Repair:** Oversized breaker within the main distribution panel for the air condition should be replaced. The data plate on the unit specifies a maximum breaker size of 25 Amps and the one in the panel is 30 Amps.
- **Repair:** Any openings in the main panel should be covered.
- **Repair:** Cable clamps (sometimes referred to as bushings or grommets) are required where wiring passes into the main distribution panel. Cable clamps serve to protect the wiring from the metal edges of the panel openings.

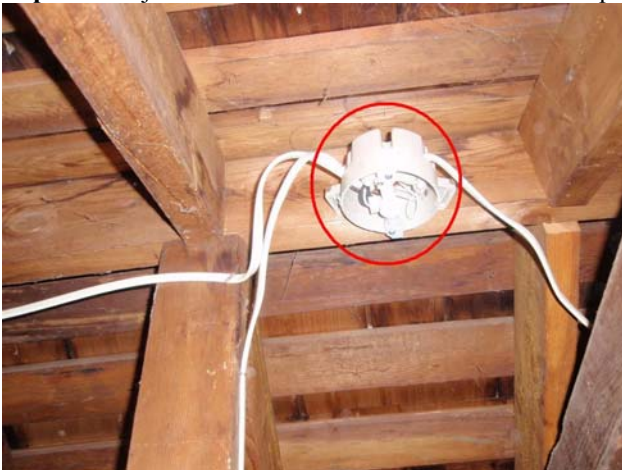
- **Repair:** All junction boxes should be fitted with cover plates, in order to protect the wire connections (i.e. attic).

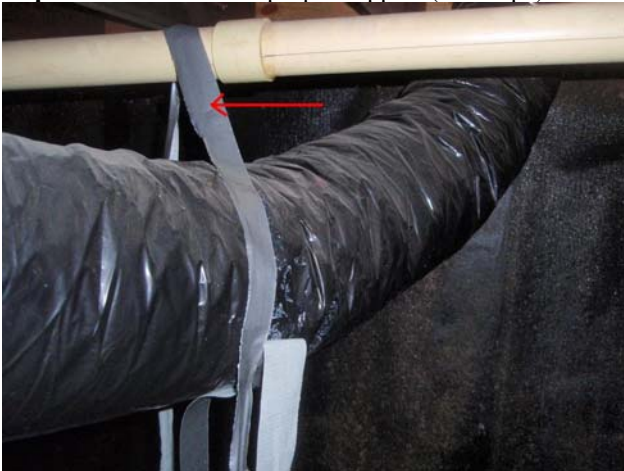
- **Improve:** Loose and improper support (duct tape) for ductwork in the crawl space should be improved.

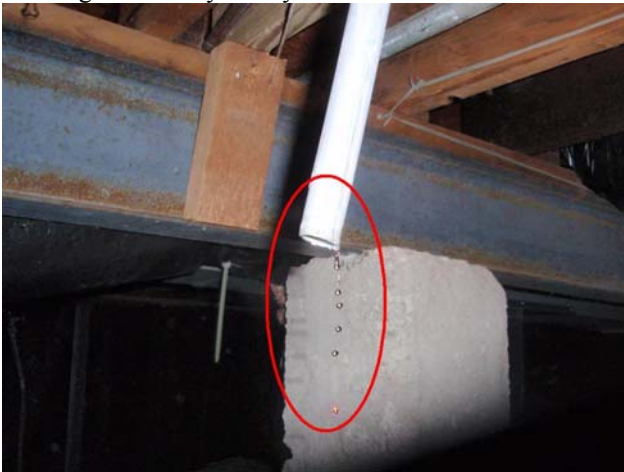
- **Monitor:** Water heaters have a typical life expectancy of 7 to 12 years. The existing unit is approaching or has exceeded this age range. One cannot predict with certainty when replacement will become necessary.
- **Repair:** The Temperature and Pressure Relief (TPR) Valve serving the water heater is leaking. Minor repairs or cleaning can usually rectify this condition.
