**Star
Home
Inspection Services**

Home Inspection Report

6214 W 128th St Overland Park, KS 66209

Inspection Date: 04/22/2011

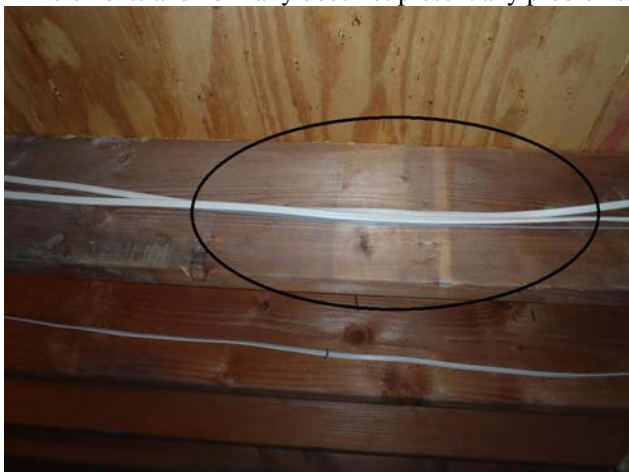
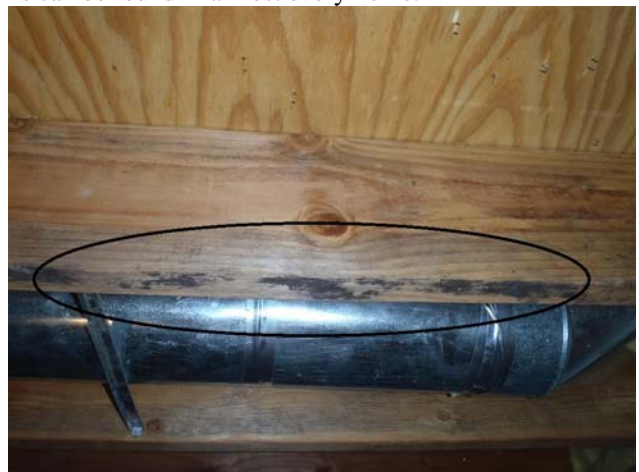
- **Monitor:** Construction mold was visible on some floor joists. This is mold that grows on the lumber while lying in the weather during construction. Most homes have some level of this mold and it goes dormant once removed from the elements and normally does not present any problems. This can be found in almost every home.

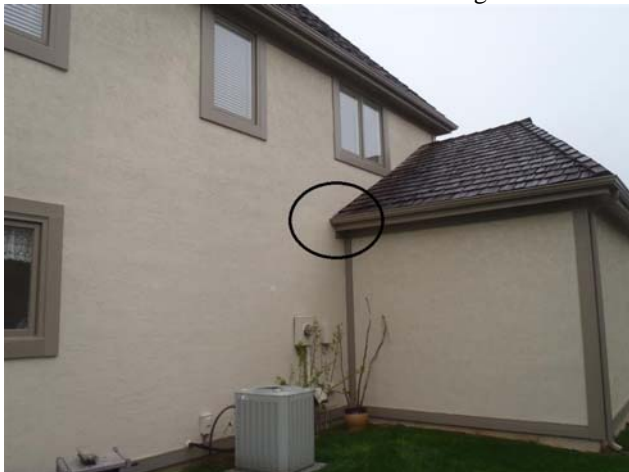
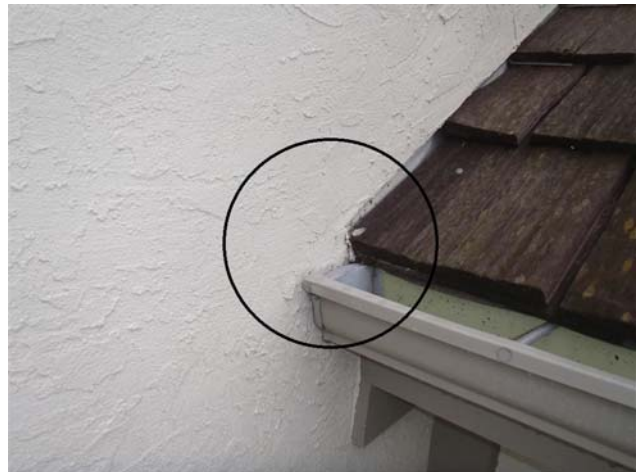
- **Monitor:** Some kickout flashing do not appear to be present. Kickout flashing help prevent moisture from entering the wall where the gutter butts up next to the wall. This area should be monitored and if any stucco work is planned it would be advisable to have the kickout flashing installed.

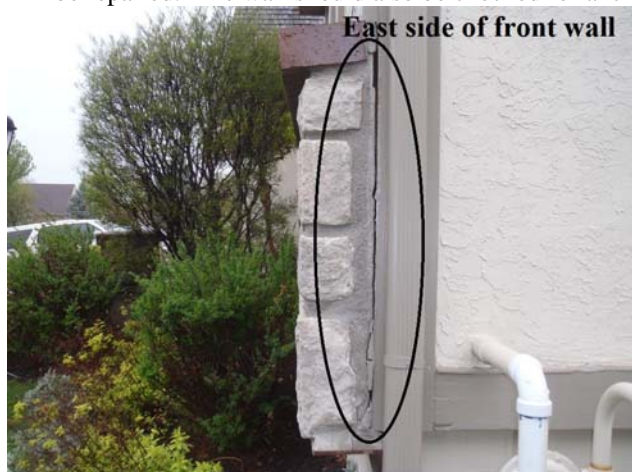
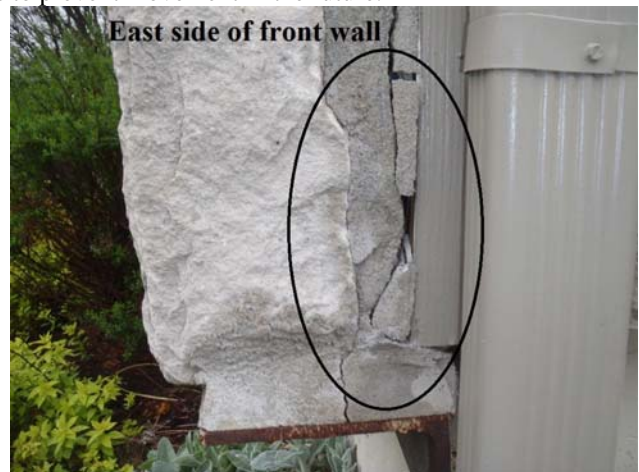
- **Repair:** The some veneer wall on the front of the house has moved slightly. It's recommended the mortar on the ends be repaired. The wall should also be checked for anchors to prevent movement in the future.

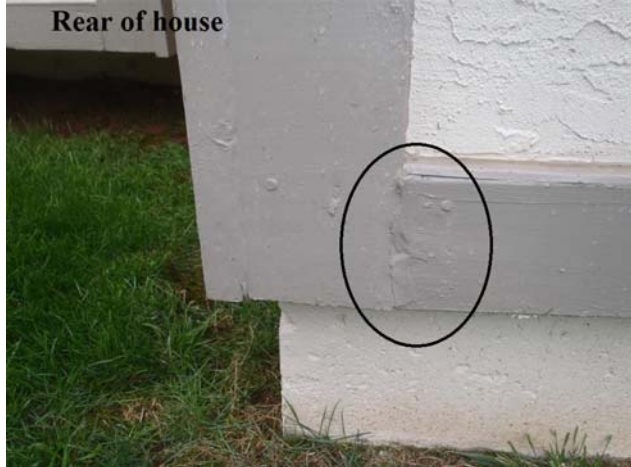
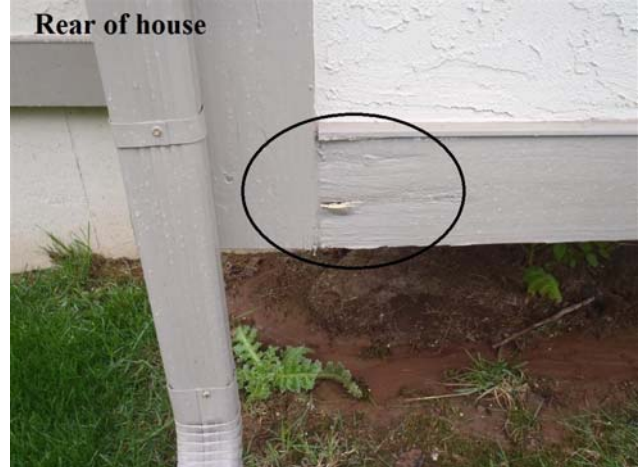
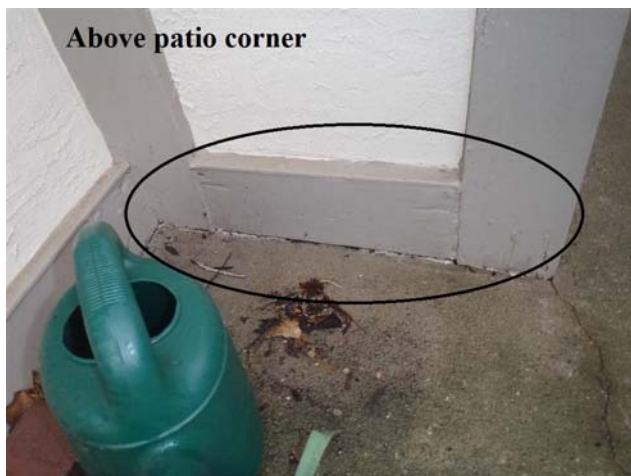
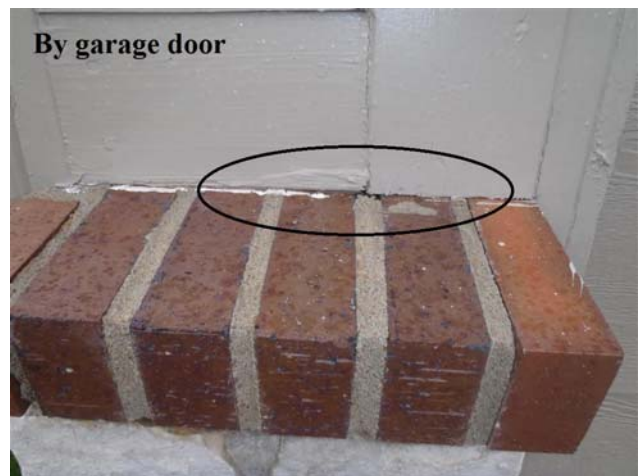
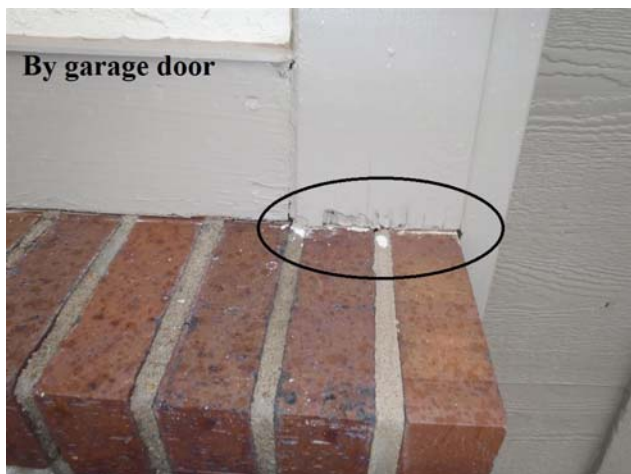
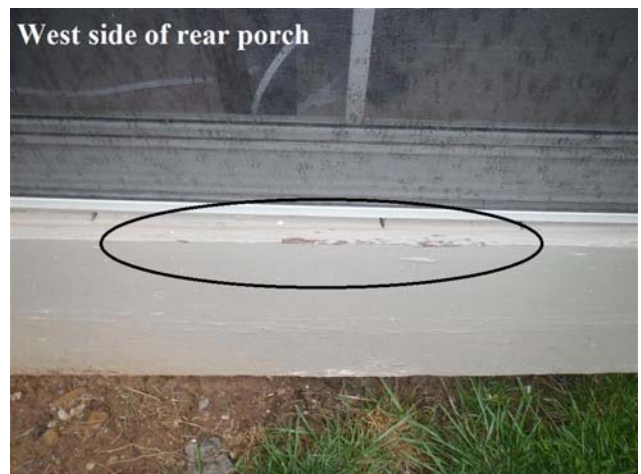
- **Repair:** Localized rot was observed in the trim around the siding, some of which have been previously repaired. Following repair of the damaged areas (which should be combined with exterior painting/maintenance) proper maintenance of the siding and control of water from roof or surface runoff can avoid further damage. It's recommended that a thorough "inventory" be taken by a competent siding/window repair technician to ascertain exactly how many areas will need to be repaired or replaced. Further evaluation by a specialist may well identify additional areas that are not pictured. Other areas of trim need painting.

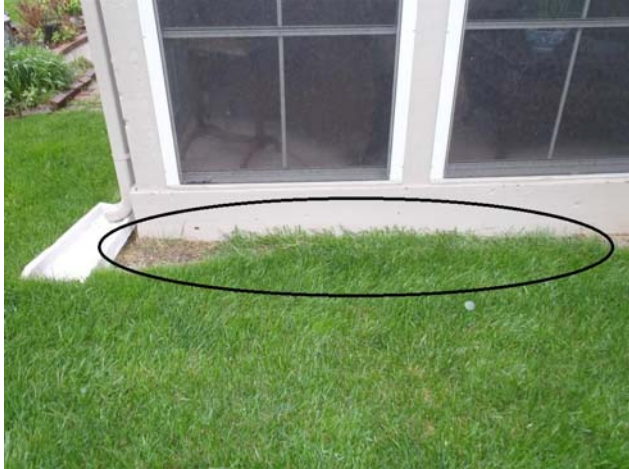
- **Repair:** Wood/soil contact at the base of the rear porch siding should be eliminated. Rotted or damaged siding that is uncovered should be repaired. These areas are at risk of additional hidden damage and termite activity.

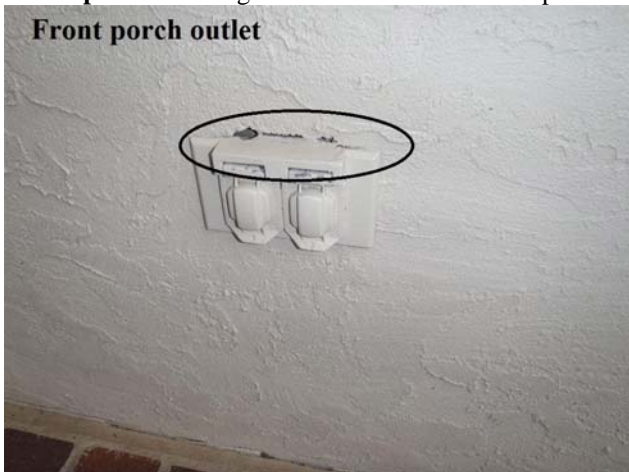
Front porch outlet

- **Repair:** Caulking is needed around the front porch electrical outlet

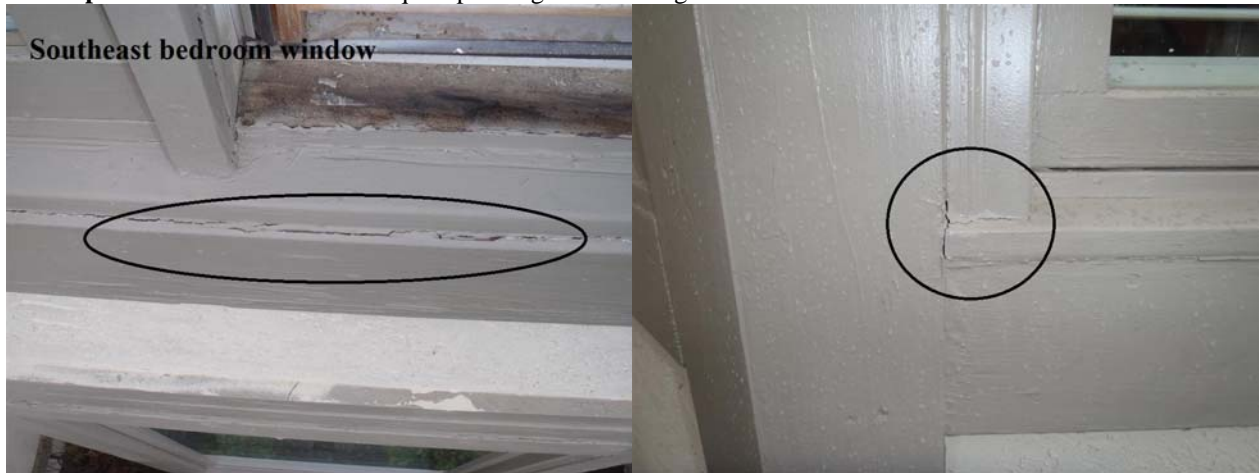
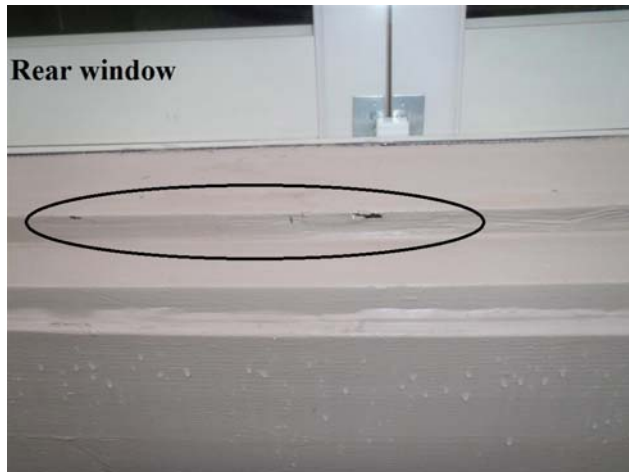
- **Repair:** The window frames require painting and caulking.

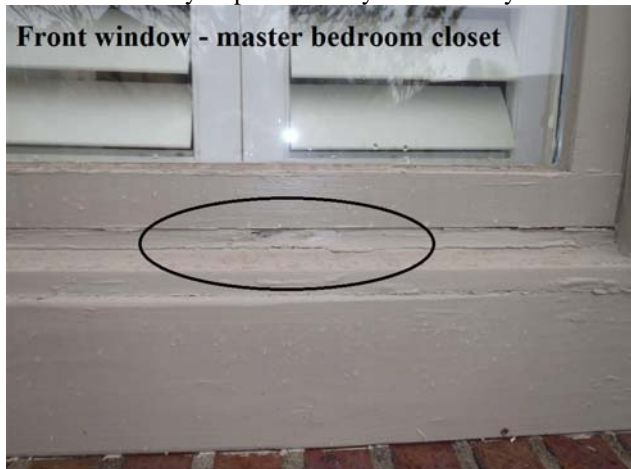
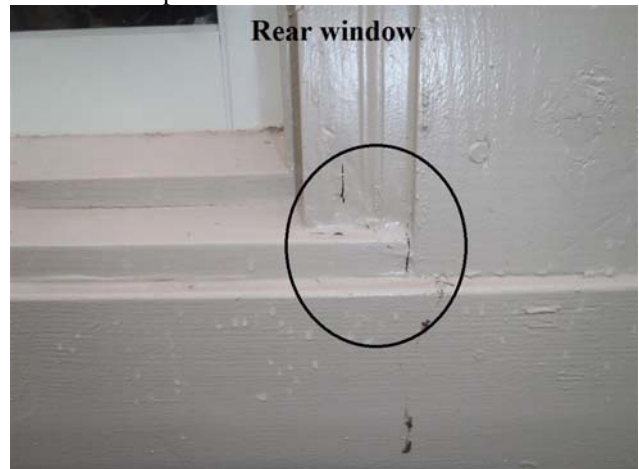
- **Repair:** Localized evidence of rot was visible on window trim/frame. Repair to the window frame can usually be accomplished by a skilled carpenter. It's recommended that a thorough "inventory" be taken by a competent siding/window repair technician to ascertain exactly how many areas will need to be repaired or replaced. Further evaluation by a specialist may well identify additional areas that are not pictured.

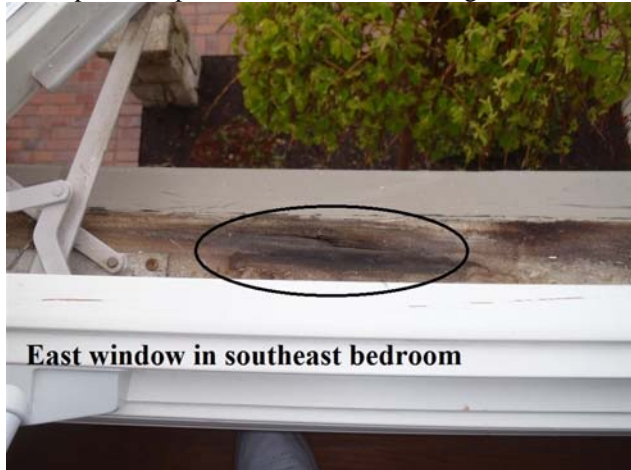
- **Repair:** The interior surface of the southeast bedroom east casement window frame is rotting. These areas should be repaired to prevent further water damage and rot.

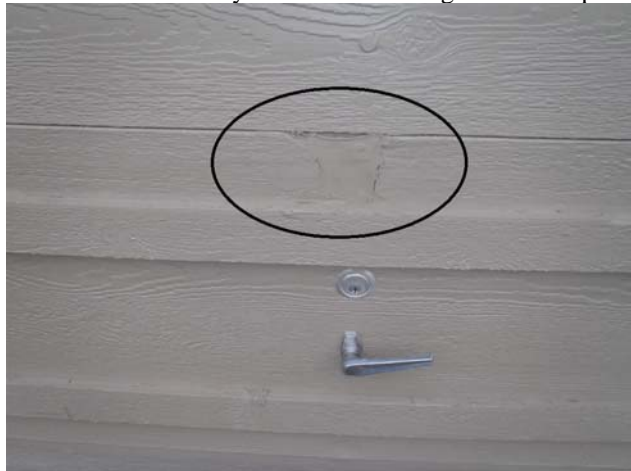
- **Monitor:** The overhead garage door shows evidence of water damage that has been repaired. These areas should be monitored closely. Maintain with a good coat of paint and keeping any cracks or open areas closed up.

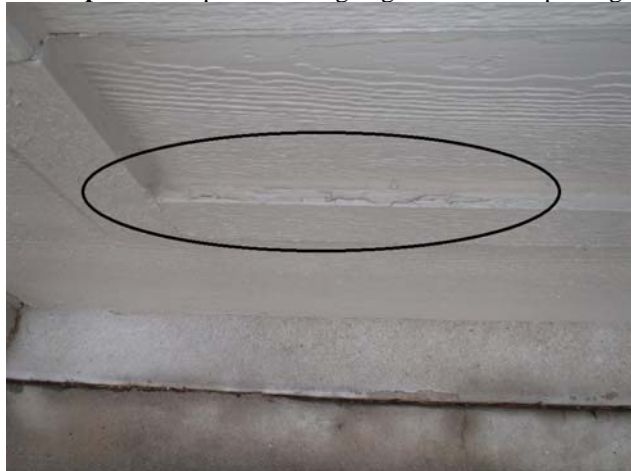
- **Repair:** The paint on the garage door trim is peeling and requires painting and caulking.

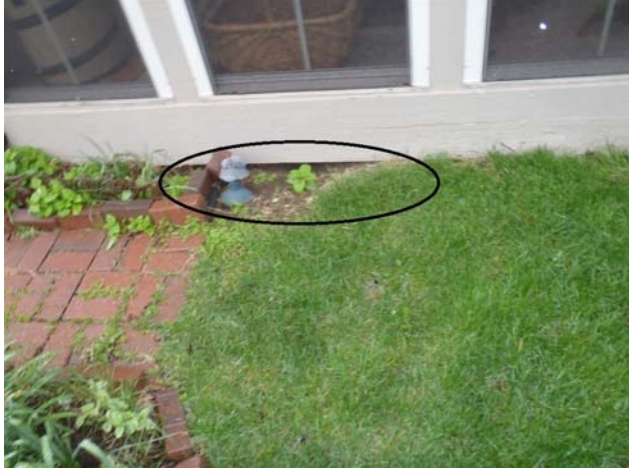
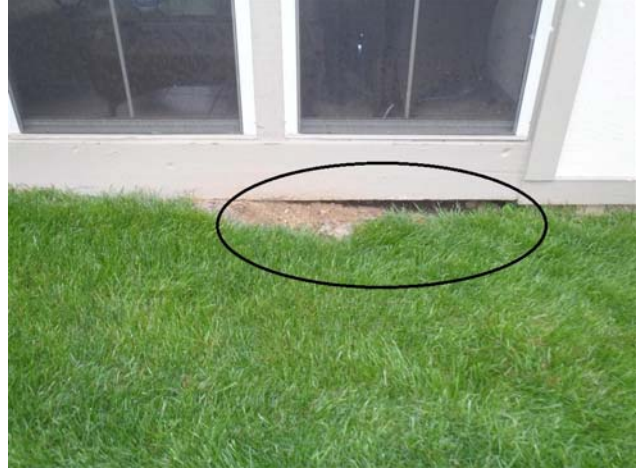
- **Monitor:** There are signs of possible vermin activity under the rear porch.

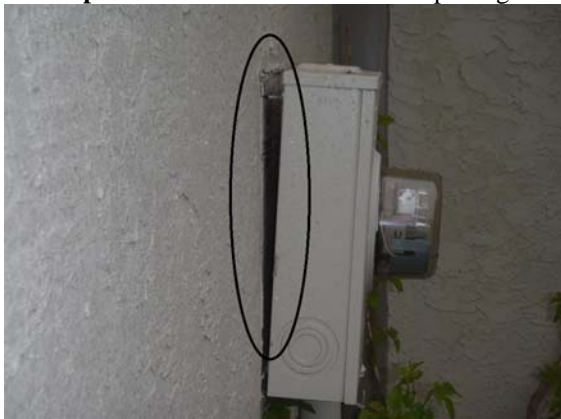
- **Repair:** The soil has settled and is pulling the meter off the house. Repairs are needed.

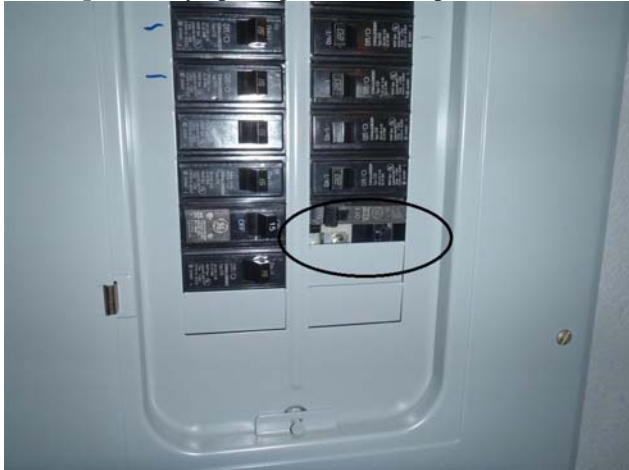
- **Repair:** Any openings in the main panel should be covered.

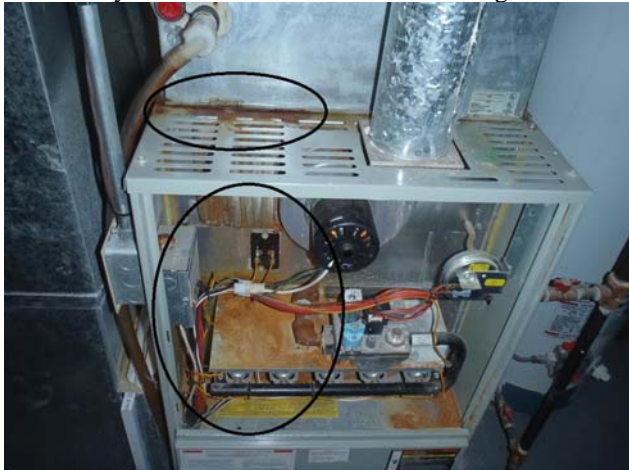
- **Monitor:** The condensate tray or line has leaked in the past causing water to run down into the furnace and resulting in a considerable amount of rust. The unit had regular service within the past 10 days and is operating normally. Monitor closely when the air conditioner is running to make sure the tray is draining properly.

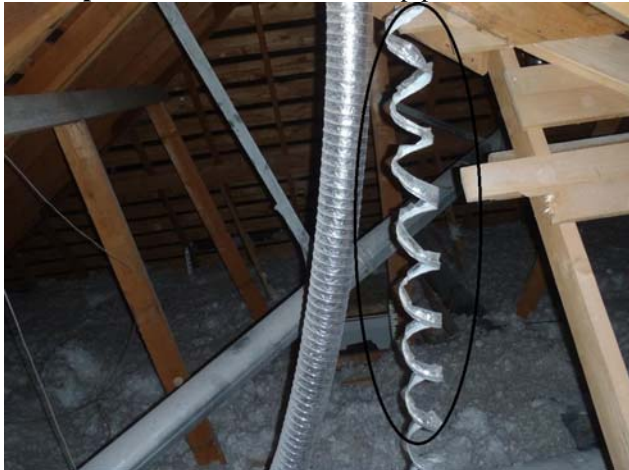
- **Repair:** One bathroom exhaust pipe in the attic is damaged. Repair is recommended.

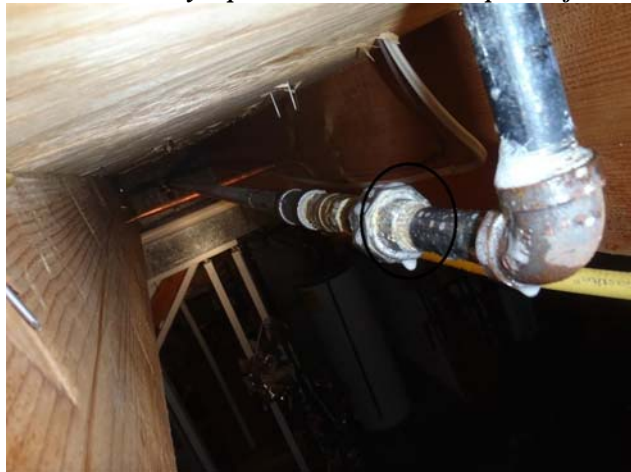
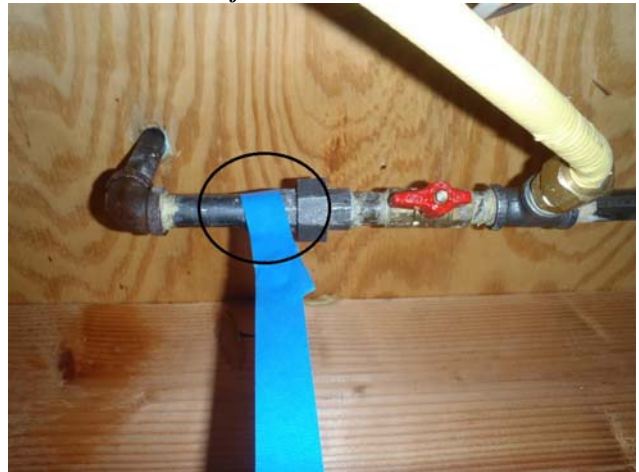
- **Repair, Safety Issue:** *A gas leak was detected with a TIF 8800 gas/carbon monoxide detector and confirmed with soapy water in a fitting by the gas grill shut off in the basement and has been marked with blue tape. This is a safety concern. It is recommended that the gas utility, HVAC company or plumber be engaged as soon as possible to make the necessary repairs. The current occupants of the home should also be notified.*

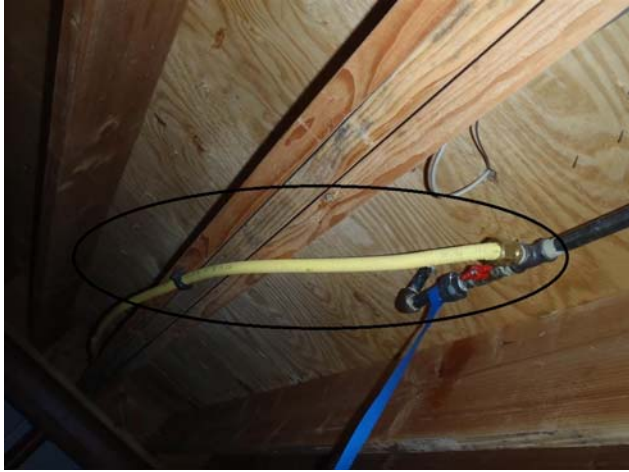
- **Monitor, Repair:** In the 2009 update of the National Fuel Gas Code, systems containing CSST flexible pipe material needs to be bonded to the electrical service grounding electrode at the point where the gas service enters the house. Refer to the attached documentation provided by Missouri Gas Energy explaining this in detail. The requirements for the Kansas gas utility company servicing this area may differ but should be investigated.

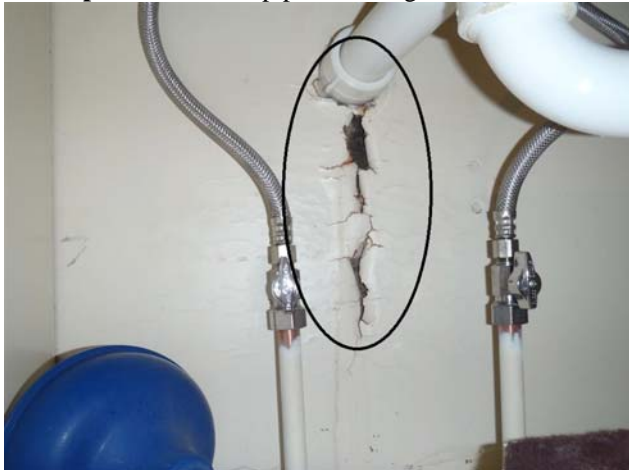
- **Repair:** The drain pipe is leaking under the left Jack and Jill bath sink and has damaged the wall.

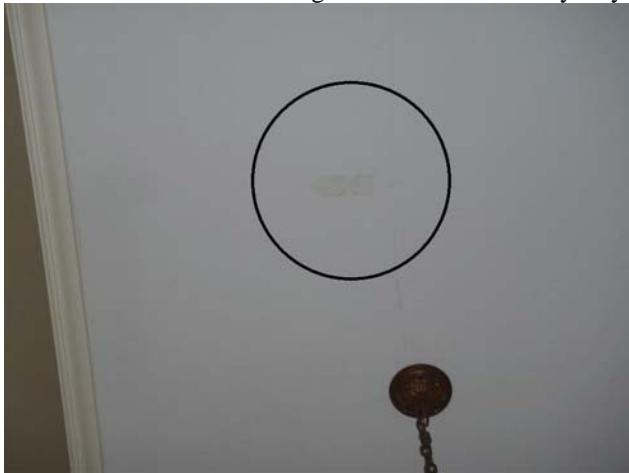
- **Monitor:** Water staining was noted on the entry way ceiling.

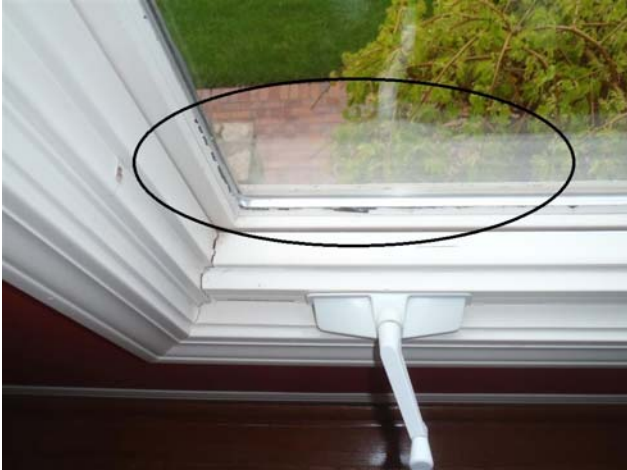
- **Monitor, Repair:** Some minor interior window trim is peeling. Repair is discretionary.

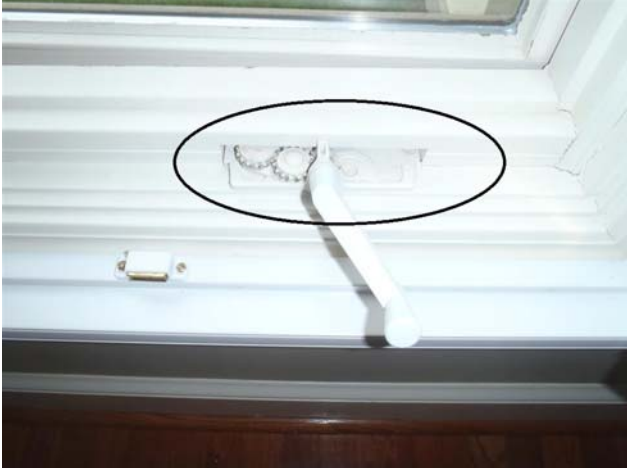
- **Monitor, Repair:** The east living room window would not close without pushing if from outside. Improvement can be undertaken as desired.
- **Repair:** Window crank cover is missing on a couple of windows.

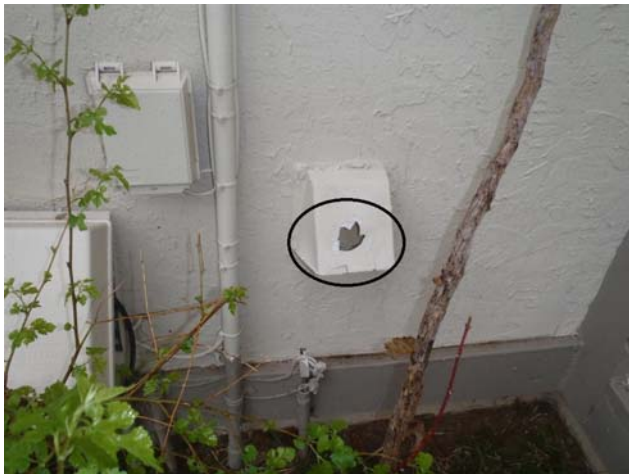
- **Repair, Safety Issue:** A damaged exhaust vent was observed. It should be repaired and protected against vermin entry. Blocked exhaust vents can be a fire risk.
