**Star
Home
Inspection Services**

Home Inspection Report

622 SW Westview Dr Grain Valley, MO 64029

Inspection Date: 08/18/2010

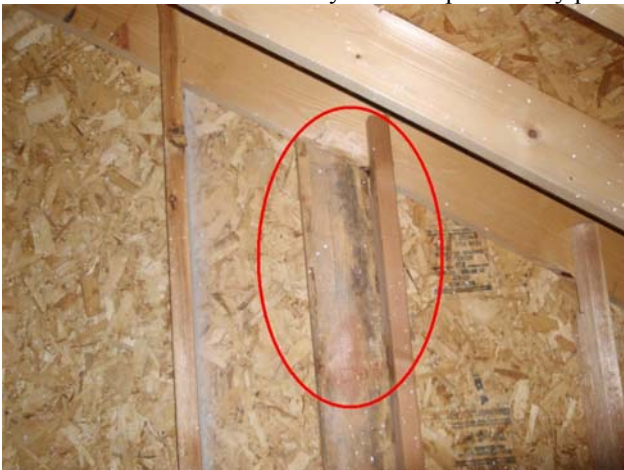
- **Monitor:** Construction mold was visible on some wall framing in the attic. This is mold that grows on the lumber while lying in the weather during construction. Most homes have some level of this mold and it goes dormant once removed from the elements and normally does not present any problems.

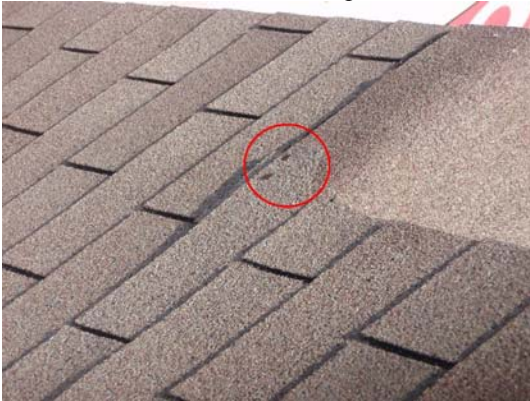
- **Recommend:** Exposed nail heads were observed in the roofing shingles and/or ridge caps. All exposed nail heads should be caulked to reduce the potential of leaks.

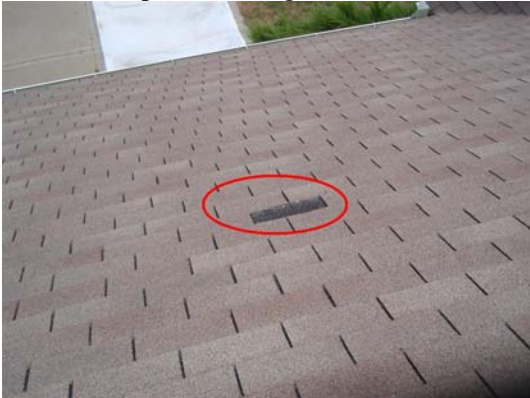
- **Monitor, Repair:** Missing tabs were observed. Repairs are recommended.

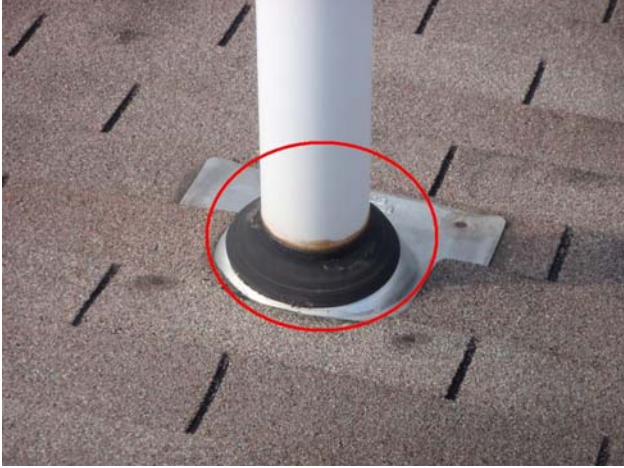
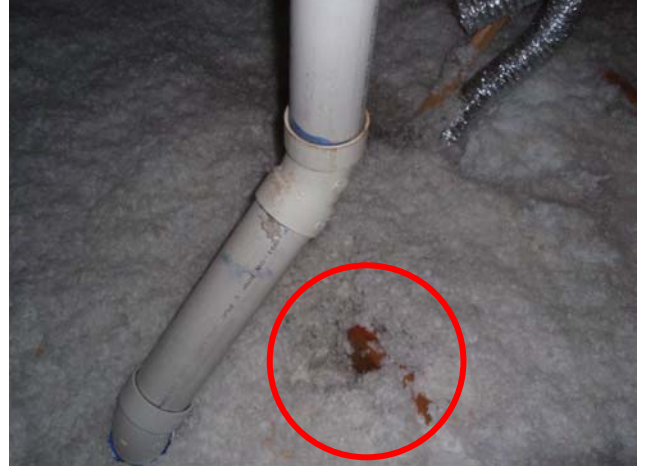
- **Monitor:** The plumbing vent flashing boots are vulnerable and have leaked in the past (stains on insulation in attic were observed below plumbing vent) and should be watched carefully for leaks.

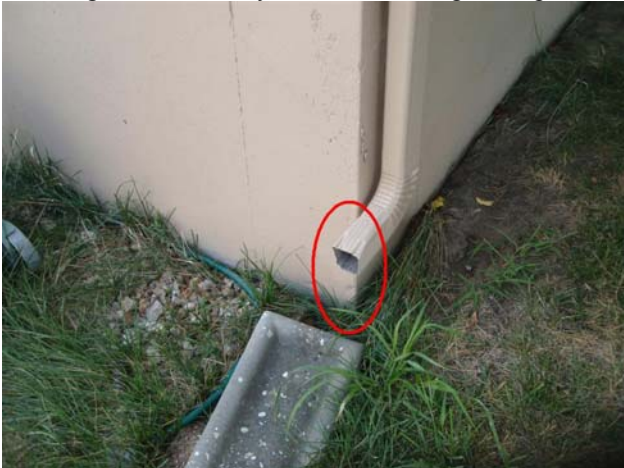
- **Repair:** The downspout(s) should discharge water at least five (5) feet from the house. Storm water should be encouraged to flow away from the building at the point of discharge.

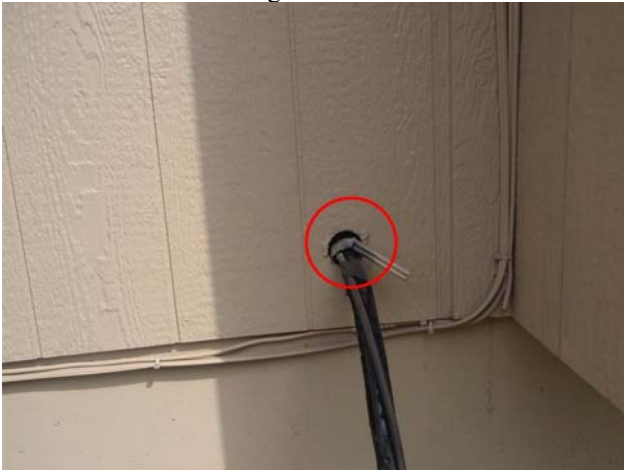
- **Monitor:** Siding of this type requires monitoring and maintenance. It has a tendency to pop out past nail heads creating a space where two panels join together. Re-securing and caulking the seams and nail holes is standard maintenance for this type of siding.
- **Repair:** Any openings in the exterior siding should be sealed. An example is where the air conditioner refrigerant lines enter the house. Caulking is needed.

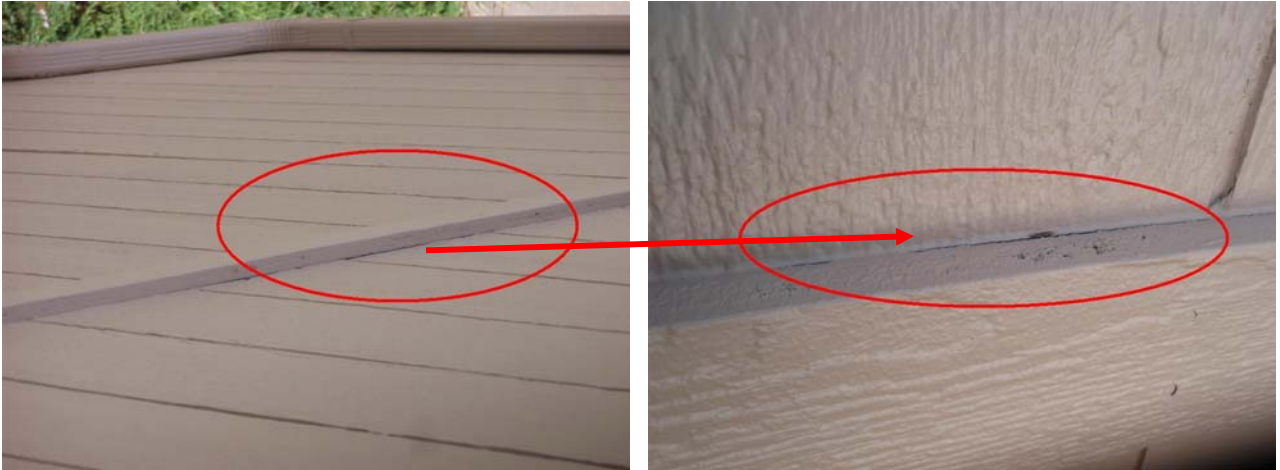
- **Repair:** The siding trim needs caulking improvements in localized areas to prevent water damage and rot (i.e. horizontal trim at east side.)

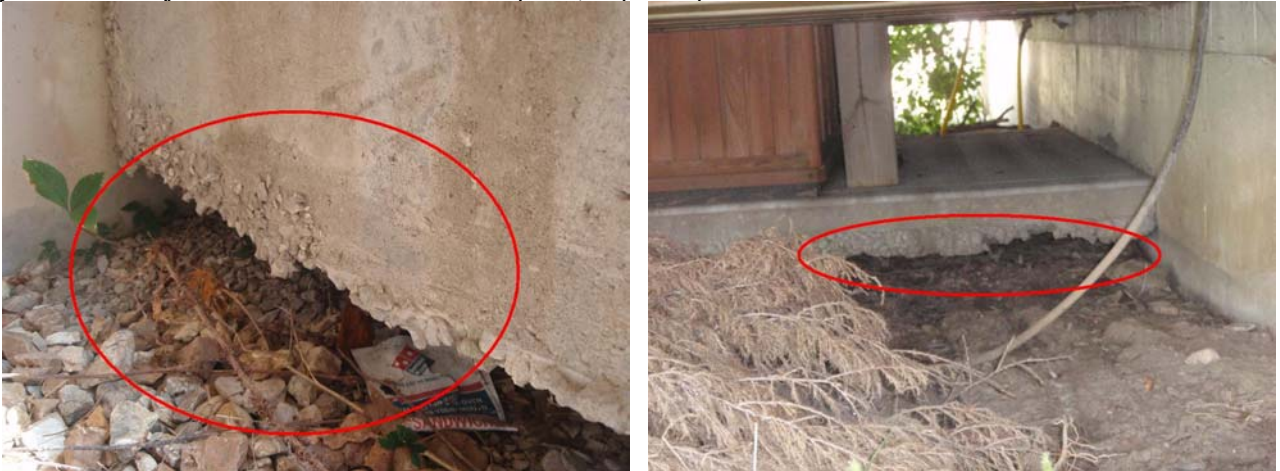
- **Repair:** The grading should be improved to promote the flow of storm water away from the house. This can often be accomplished by the addition of top soil. The ground should slope away from the house at a rate of one inch per foot for at least the first five feet. At least eight (8) inches of clearance should be maintained between soil level and the bottom of exterior wall siding. *It should be understood that it is impossible to predict whether moisture penetration will pose a problem in the future.* The void under the front porch, steps and patio under the deck should be filled.

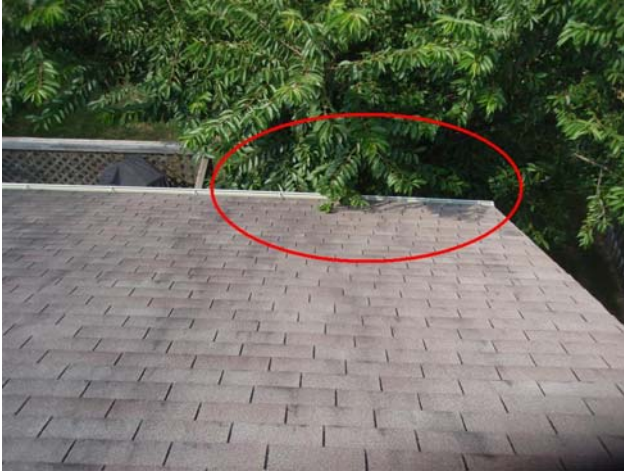
- **Repair:** Tree branches should be trimmed away from the house to avoid damage to the building.

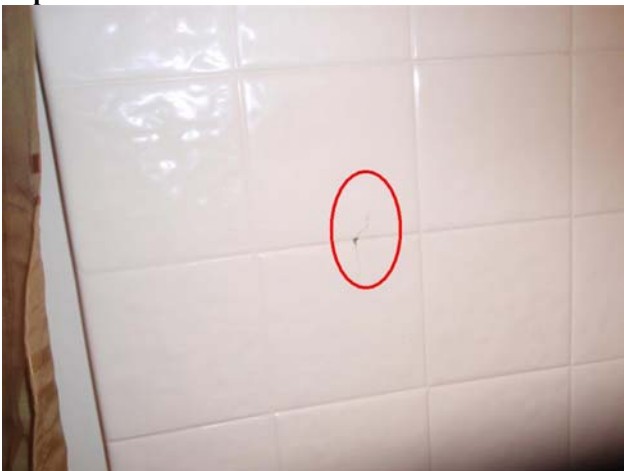
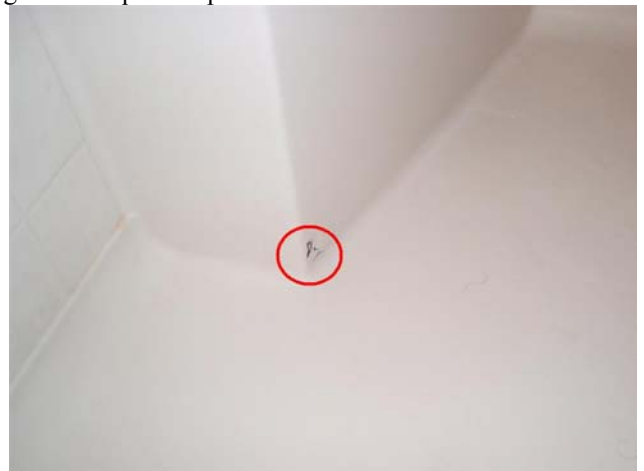
- **Repair:** The kitchen sprayer nozzle is inoperative and needs repair.
- **Repair:** The master bath drain plugs are missing and needs repair.
- **Repair:** The master bath and hall bath shower stall is damaged and requires repair.
