**Star
Home
Inspection Services**

Home Inspection Report

6225 W 87th St, Overland Park, KS 66207

Report Number: 01192009-1A

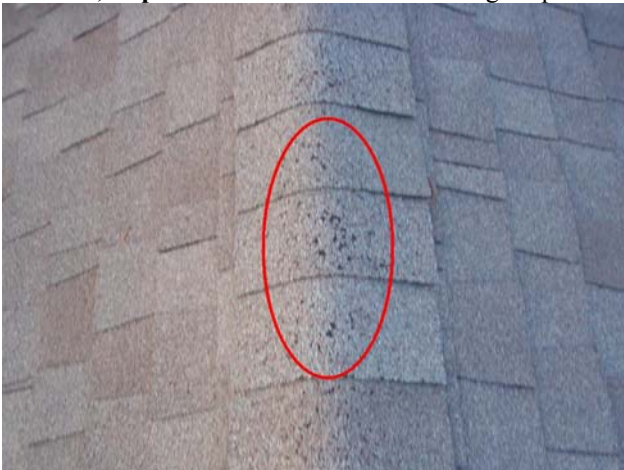
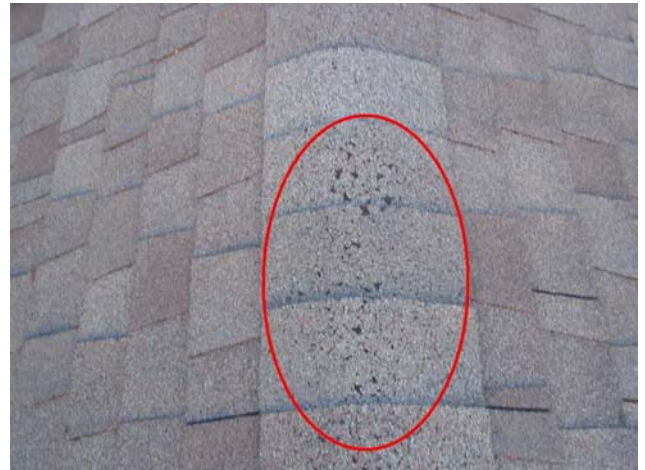
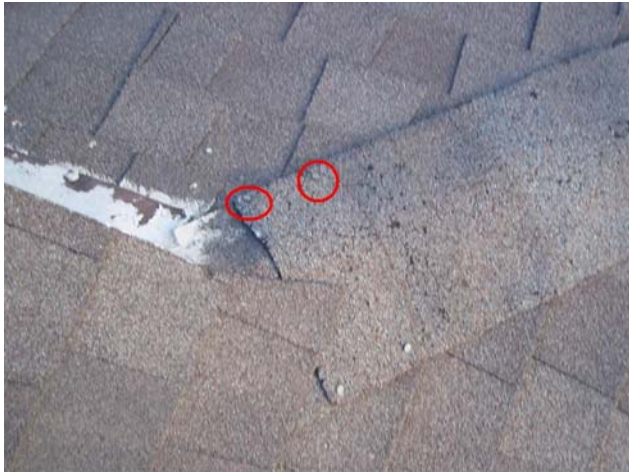
Sloped Roofing

- **Repair:** Exposed nail heads were observed in the roofing shingles and/or ridge caps. All exposed nail heads should be caulked to reduce the potential of leaks. **Repaired**
- **Monitor:** The roofing is in fair condition. We did not see evidence of active leaks nor need for immediate major repair. Older roofs are, by their nature, a high maintenance roof. Annual inspection and repair should be anticipated. In addition, the older flashings should be monitored. In some cases, a deteriorated flashing can result in expensive repairs, because sections of the roofing have to be removed. As a rule of thumb, replacement of the entire roof covering may be logical if more than ten percent of the roof requires repair.
- **Monitor, Repair:** Surface wear noted on ridge caps.

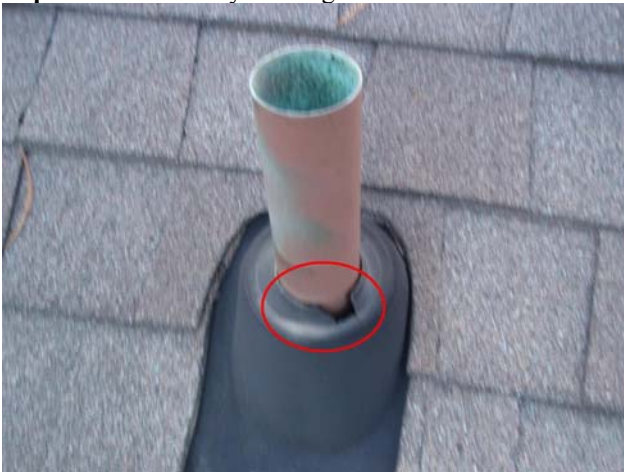
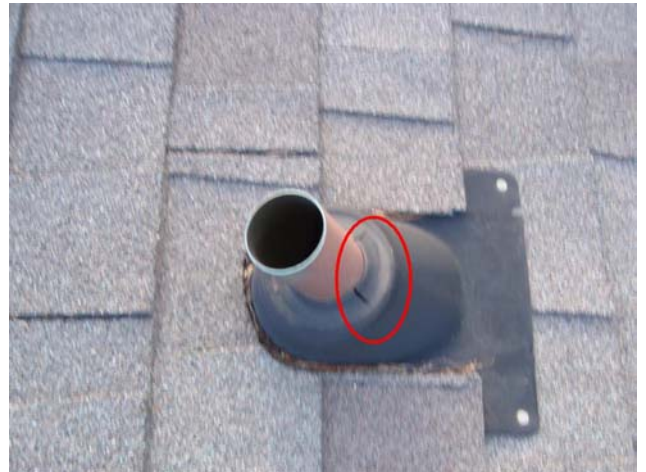
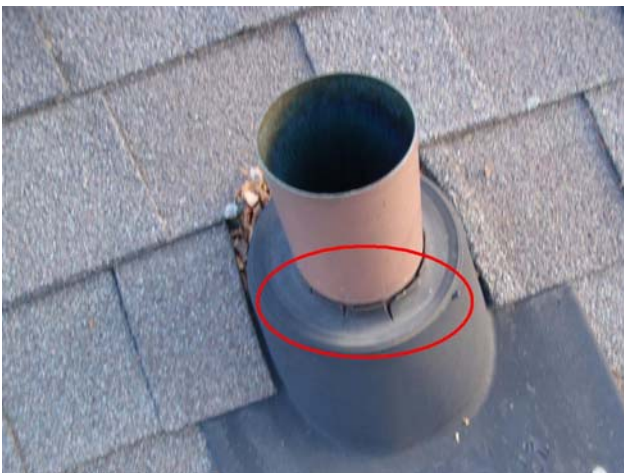
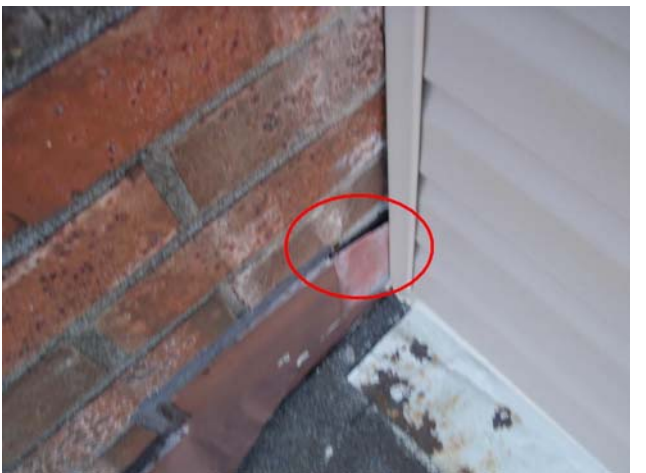
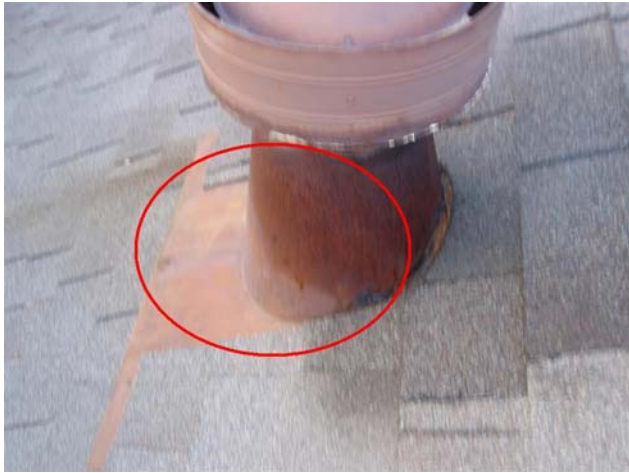
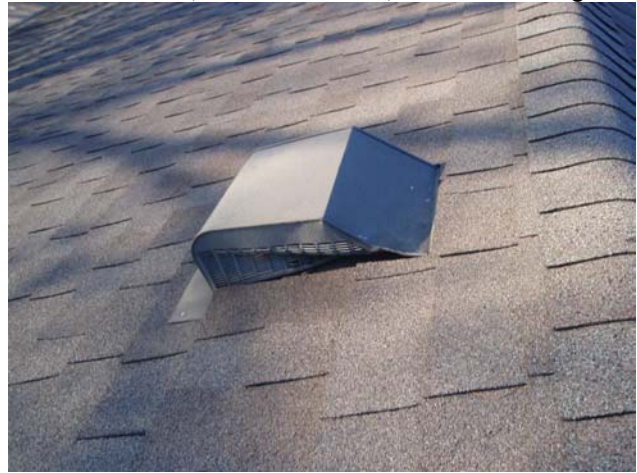
Flashings

- **Monitor, Repair:** The plumbing vent flashing boots are split making them vulnerable to leaks. It's recommended that the boots be caulked or the flashing replaced. **Repaired**
- **Repair:** The rusted furnace vent and flashing should be caulked to extend its life and avoid leaks.
- **Repair:** Nail heads are exposed at the flashing. They should be sealed to reduce risk of leaks. **Repaired**
- **Monitor:** Damage to the roof vent was observed. Repairs are discretionary
- **Repair:** The chimney flashing should be caulked.

- **Monitor, Repair:** The plumbing vent flashing boots are split making them vulnerable to leaks. It's recommended that the boots be caulked or the flashing replaced. **Repaired**
- **Repair:** The rusted furnace vent and flashing should be caulked to extend its life and avoid leaks.
- **Repair:** Nail heads are exposed at the flashing. They should be sealed to reduce risk of leaks. **Repaired**
- **Monitor:** Damage to the roof vent was observed. Repairs are discretionary.
- **Repair:** The chimney flashing should be caulked.

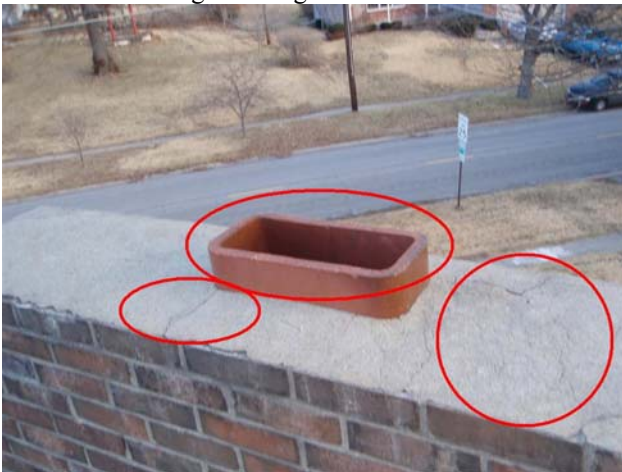
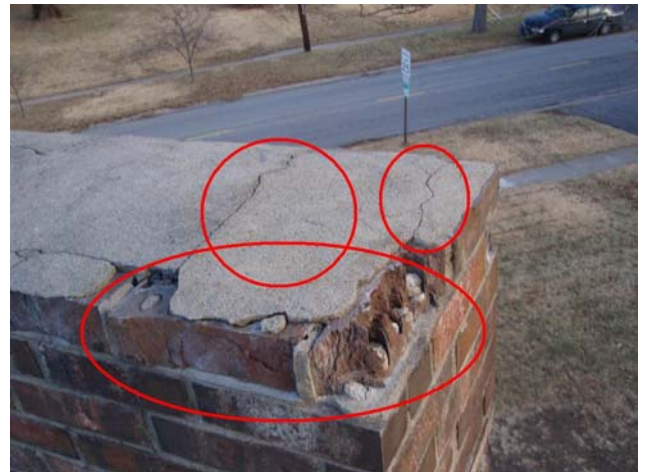
Chimneys

- **Repair:** The masonry chimney shows evidence of spalling (surface deterioration of the masonry). Repair of this chimney is needed.
- **Repair:** The cap of the masonry chimney is cracked. These cracks should be sealed or caulked to prevent damage from freezing water.
- **Repair:** A rain cap and vermin screen should be installed on the masonry chimney and the chimney flue should be checked for damage. Damaged flues can be unsafe.

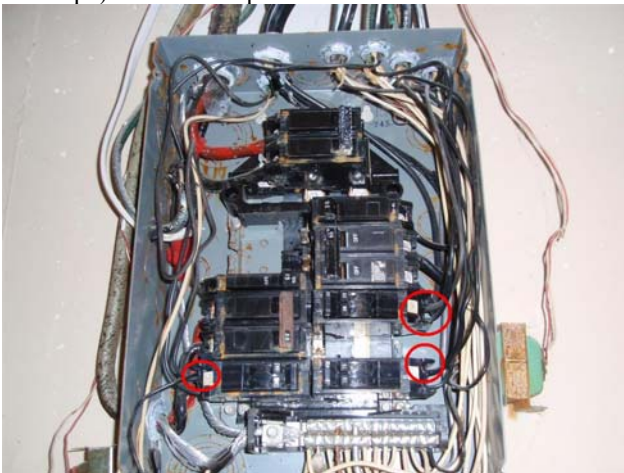
Main Panel

- **Repair:** Any openings in the main panel should be covered.
- **Repair:** Circuits within the main distribution panel that are doubled up (referred to as "double taps" and marked with blue tape) should be separated. Each circuit should be served by a separate fuse or breaker.

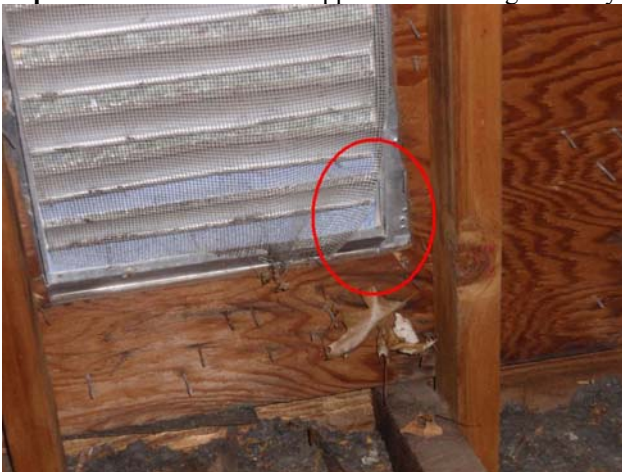
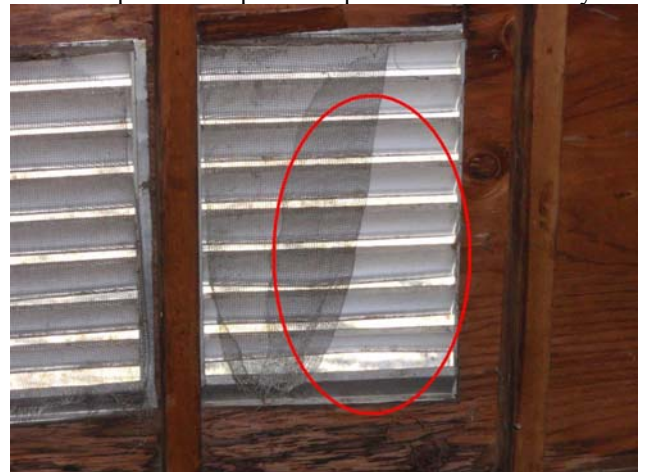
Attic / Roof

- **Repair:** Gable vent screens appear to be damaged. They should be repaired or replaced to prevent vermin activity.

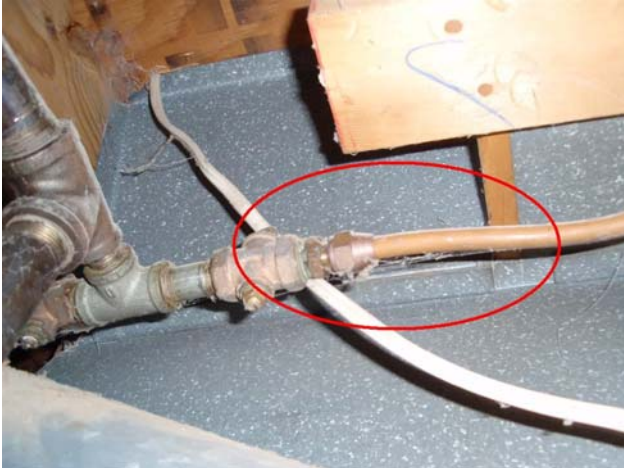
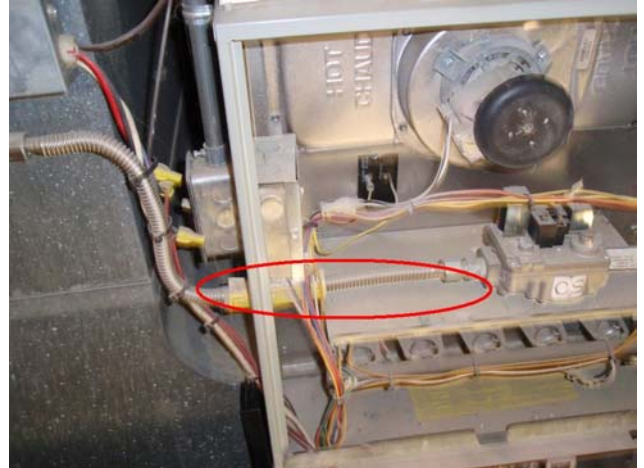
Gas Piping

- **Repair:** The gas pipe at the fireplace should be capped when not in use or fireplace extension pipe installed.
- **Repair:** Copper tubing is no longer suitable for gas piping. It’s recommended this pipe servicing the dryer and the fireplace be replaced with one of suitable material. **Dryer piping was replaced and the service company professional advised homeowner the copper tubing to the fireplace was ok as installed.**
- **Repair:** Flexible gas appliance connections should not pass through walls, floors or the appliance housing as is the case of the furnace. This connector should be replaced with one of suitable solid gas piping. **Repaired**

- **Repair:** The gas pipe at the fireplace should be capped when not in use or fireplace extension pipe installed.
- **Repair:** Copper tubing is no longer suitable for gas piping. It's recommended this pipe servicing the dryer and the fireplace be replaced with one of suitable material. **Dryer piping was replaced and the service company professional advised homeowner the copper tubing to the fireplace was ok as installed.**
- **Repair:** Flexible gas appliance connections should not pass through walls, floors or the appliance housing as is the case of the furnace. This connector should be replaced with one of suitable solid gas piping. **Repaired**
