**Star
Home
Inspection Services**

Home Inspection Report

625 N Crest Dr Raymore, MO 64083

Inspection Date: 05/20/2010

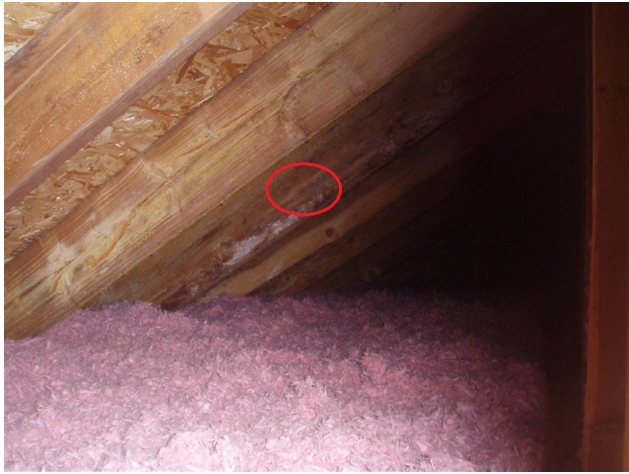
- **Monitor:** Construction mold was visible on some roof rafters. This is mold that grows on the lumber while lying in the weather during construction as evidenced by the strap marks. Most homes have some level of this mold and it goes dormant once removed from the elements and normally does not present any problems.

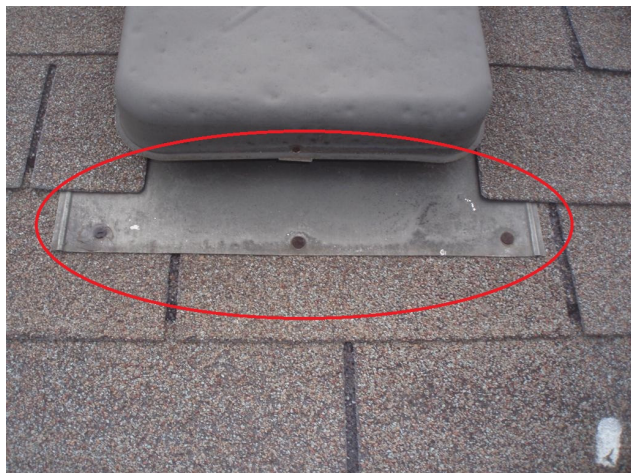
- **Recommend:** Exposed nail heads were observed in the roofing shingles and/or ridge caps. All exposed nail heads should be caulked to reduce the potential of leaks.

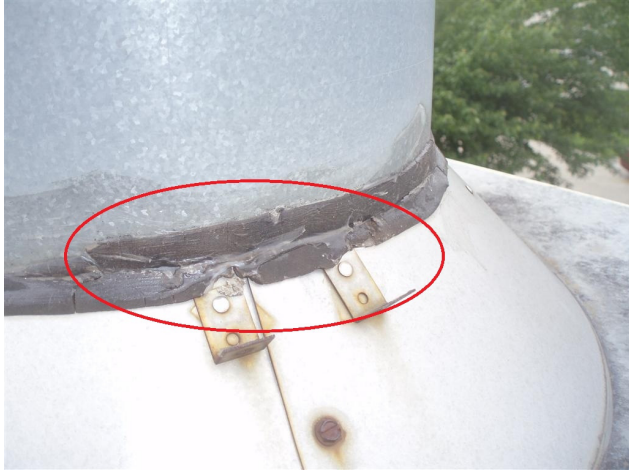
- **Repair:** The flashing around the chimney flue should be caulked to avoid leaks.

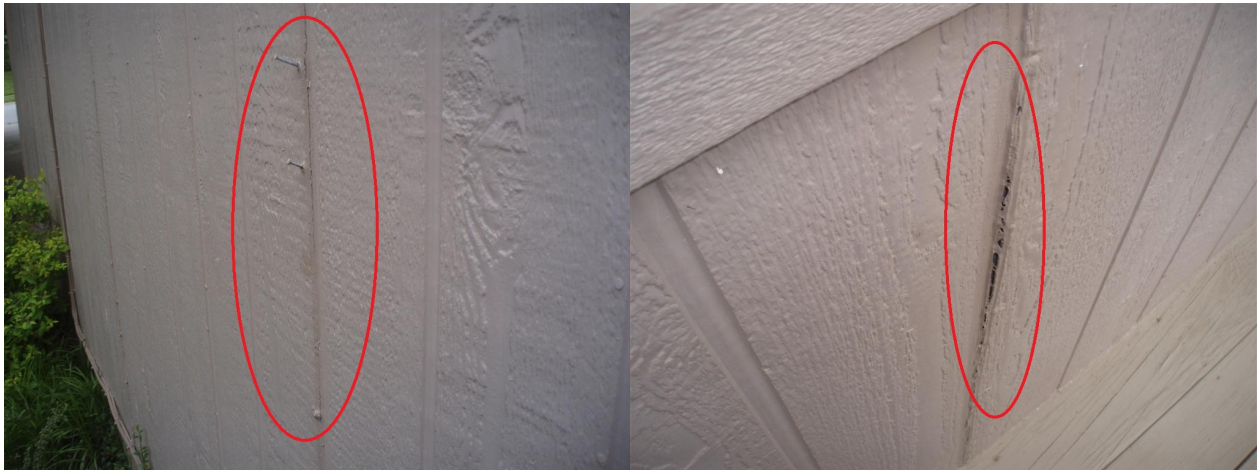
- **Repair:** The loose siding should be re-secured to avoid water and/or wind damage.

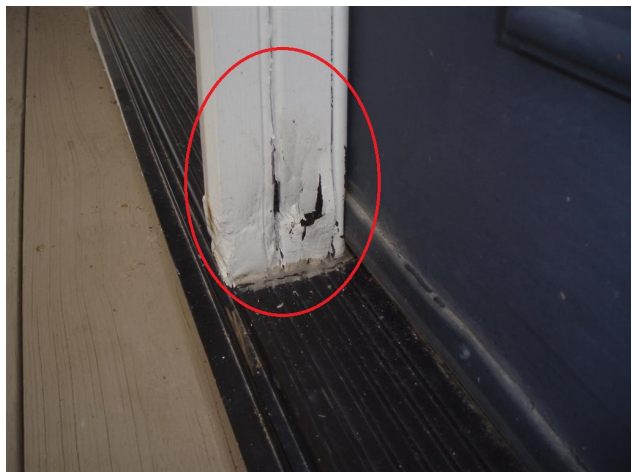
- **Repair:** Localized rot was visible on the rear French door trim/frame. Repair to the door trim and frame can usually be accomplished by a skilled carpenter. It's recommended that a thorough "inventory" be taken by a competent window/door repair technician to ascertain exactly how many areas will need to be repaired or replaced. Further evaluation by a specialist may well identify additional areas that require servicing.

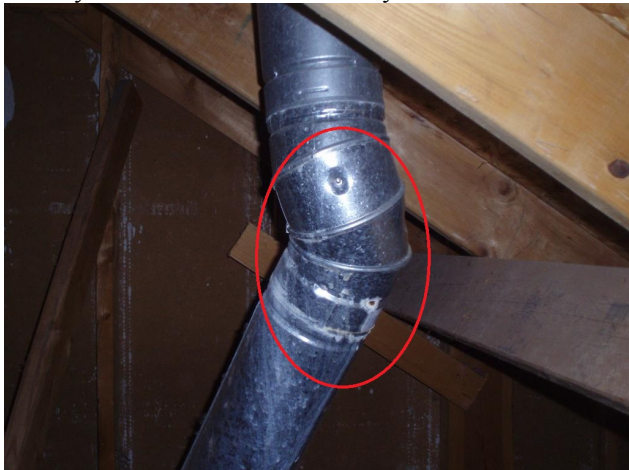
- **Monitor:** While in the attic water stains were observed on the lower sections of the furnace flue. The insulation below the elbow also showed signs of past moisture. It appears that rain blew in under the rain cap and came down the interior of the flue until it got to the first joint where it then transferred to the outside surface and dripped off the elbow. This is a common condition in 80% of homes but very seldom is enough to penetrate completely through the insulation to the drywall below. Monitor for any additional wetness after rains.

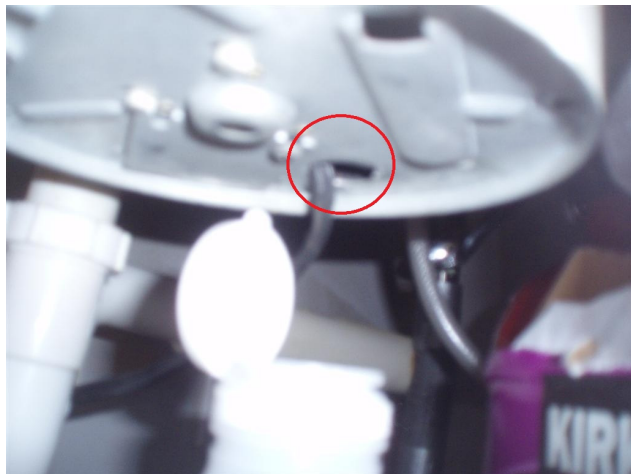
- **Repair:** The wiring entering the waste disposer should have a wire clamp. This should be improved as soon as possible.
