# Star Home Inspection Services

## *Home Inspection Report*

**6422 McCoy St, Shawnee, KS 66226**

**Inspection Date: 2/6/2009**

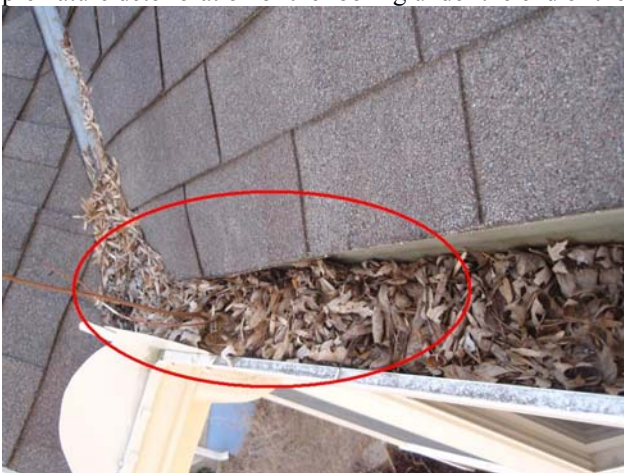
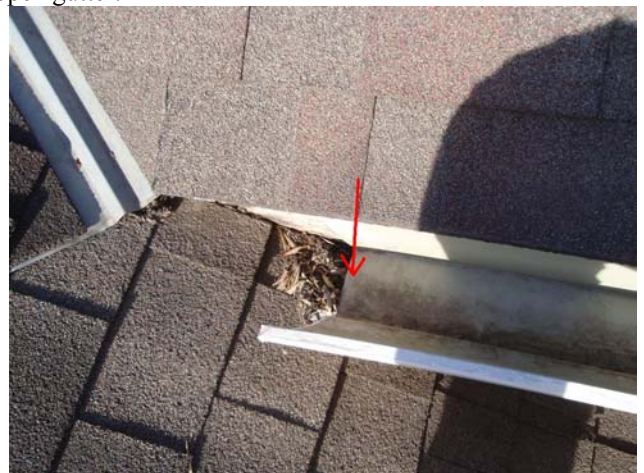
- **Repair:** The gutters require cleaning to avoid spilling roof runoff around the building – a potential source of water entry or water damage.
- **Monitor, Repair:** Gutters that discharge onto the roof should be modified to discharge directly into the gutters below through downspouts or discharge through downspouts to ground. This condition, if left unattended, can result in premature deterioration of the roofing under the end of the open gutter.

- **Improve:** Damaged downspout noted on northwest corner. This is a cosmetic condition, repairs are discretionary.

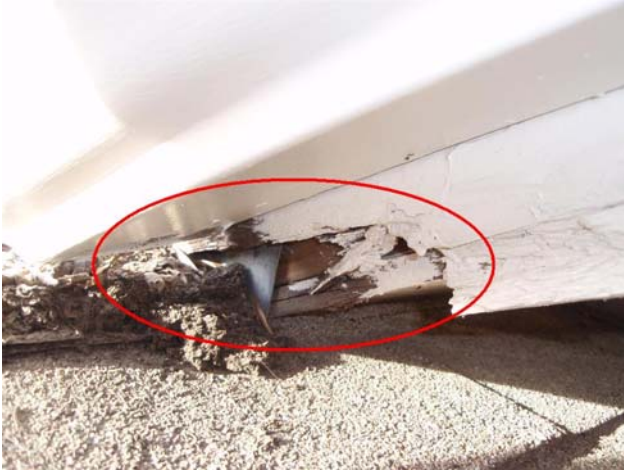
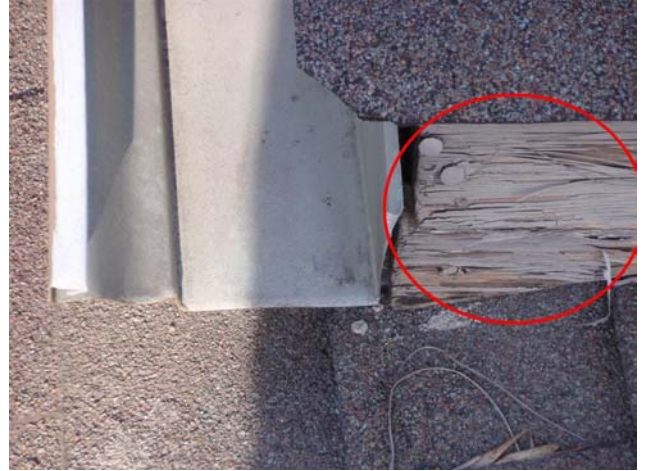
- **Repair:** Localized rot was observed in the eaves (example over the front porch). Following repair of the damaged areas (which should be combined with exterior painting/maintenance) proper maintenance of the siding and control of water from roof or surface runoff can avoid further damage. Back eave bare wood at roof should be painted.
