Star Home Inspection Services

Home Inspection Report

6446 Chouteau St, Shawnee, KS 66226

Inspection Date: 11/21/2008

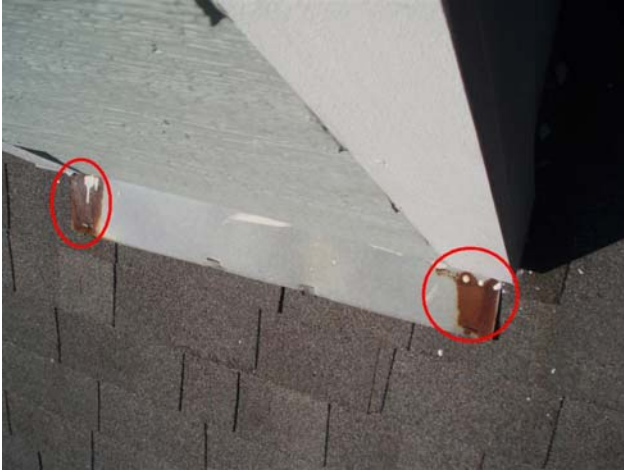
Flashings

- **Repair:** The chimney flashing is rusting. It should be painted to extend its life.

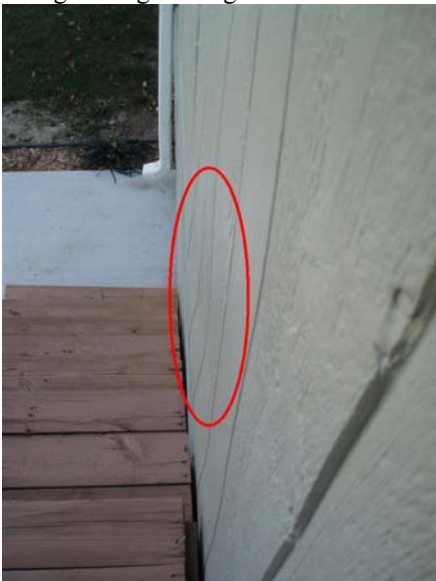
Exterior Walls

- **Monitor:** Siding of this type requires monitoring and maintenance. It has a tendency to pop out past nail heads creating a space where two panels join together. Re-securing and caulking these areas is standard maintenance for this type of siding. Siding bowing was noted at back deck steps area it is suspected this is cosmetic from original installation.

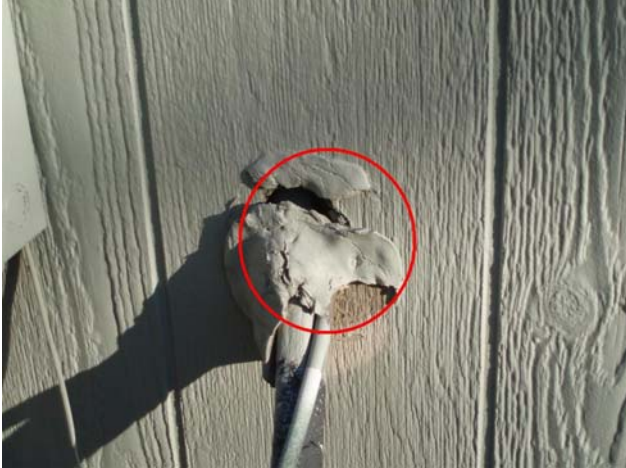
- **Repair:** Seal opening where air conditioner refrigerant line enters house at siding on south side.

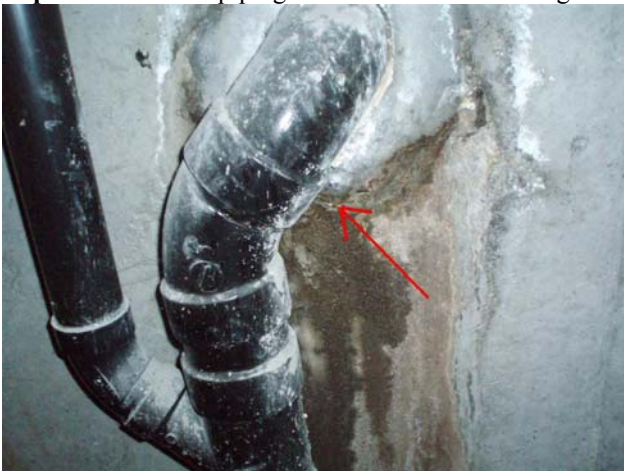
Waste / Vent

- **Repair:** The waste piping in the basement is leaking.
