**Star  
Home  
Inspection Services**

*Home Inspection Report*

**6522 Ridgeway, Kansas City, MO 64133**

**Report Number: 10012007-2A**

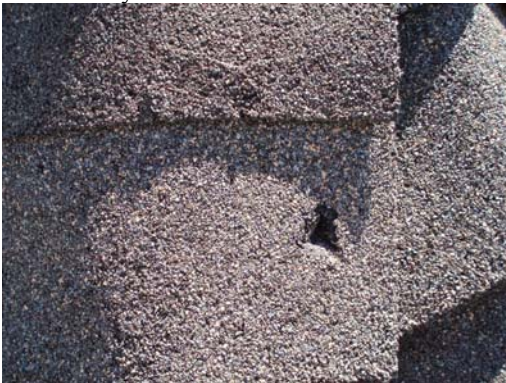
- **Repair:** Minor repairs to the roofing are needed at back peak where shingle damage was observed discovered (see picture). Damaged or missing roofing material should be repaired. All roof penetrations should be examined and sealed as necessary.

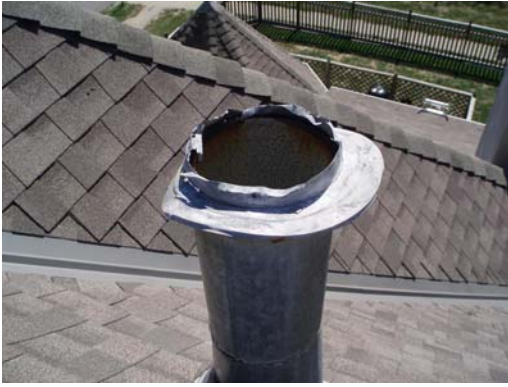
- **Repair:** Loose gutter nails on back side of house at deck gutter should be repaired.
- **Repair:** Furnace chimney cap is missing and should be repaired.

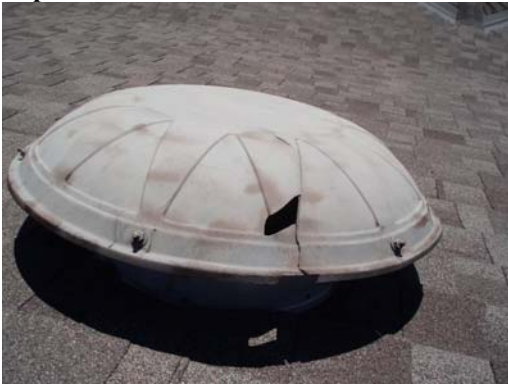
- **Repair:** Power ventilator has a hole in cover and should be repaired.

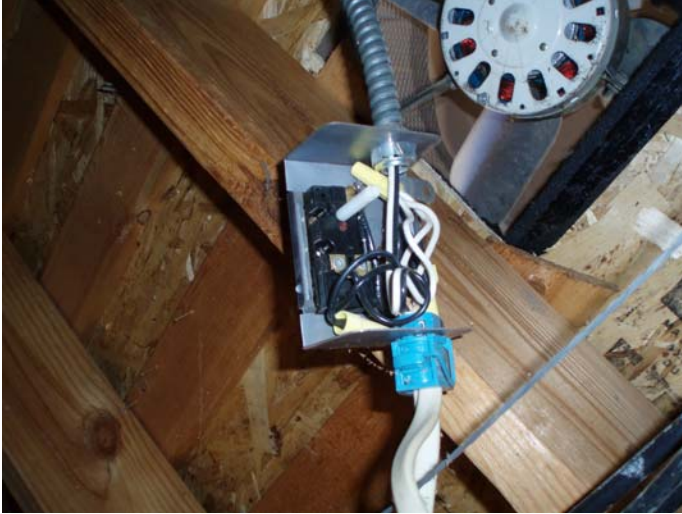
- **Repair:** The electrical junction in the attic is exposed and should be repaired.
