# Star Home Inspection Services

## *Home Inspection Report*

**6708 High Dr Mission Hills, KS 66208**

**Report Number: 04182011-2A**

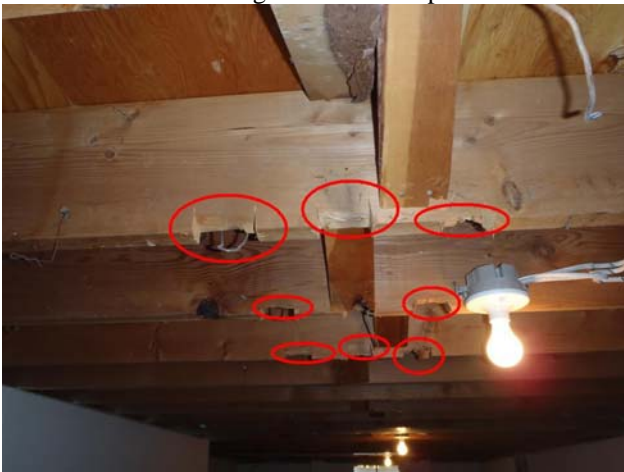
- **Monitor:** Floor joists are notched and or cut. This weakens the joist and risks structural damage; if any further movement is or cracking is observed repairs or additional support will be needed.

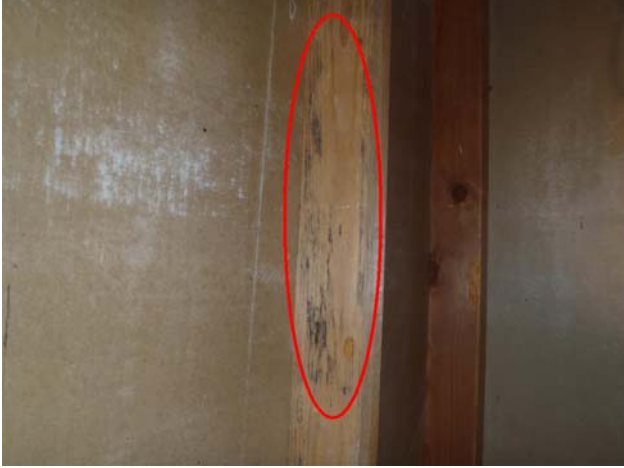
- **Monitor:** Construction mold was visible on some wall joists in the furnace room. This is mold that grows on the lumber while lying in the weather during construction. Most homes have some level of this mold and it goes dormant once removed from the elements and normally does not present any problems.

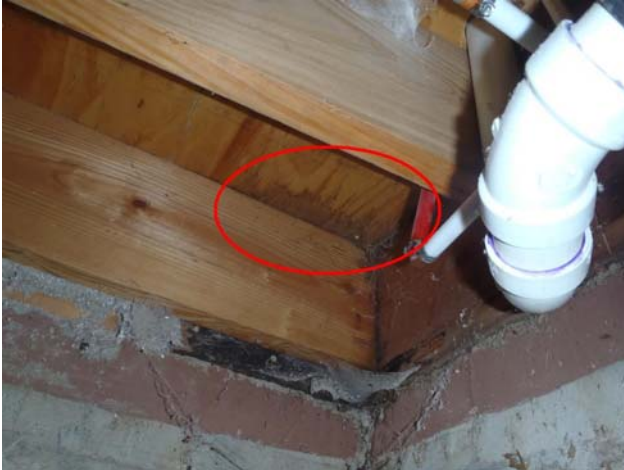
- **Monitor:** Repaired subflooring (supporting layer of flooring atop floor joists and below finish flooring or carpeting) was found. Water staining was noted on the subflooring below the southeast corner of the crawl space.

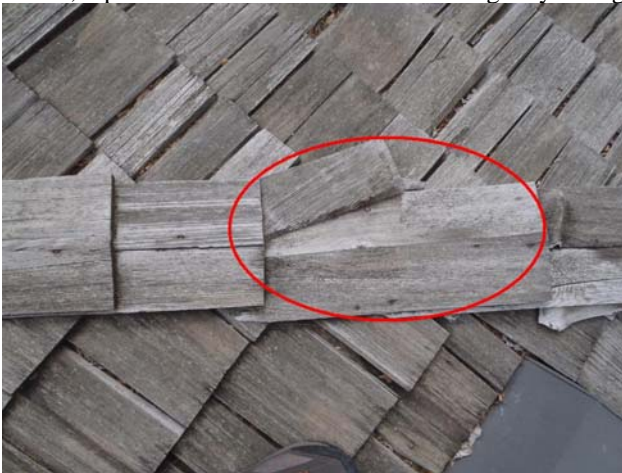
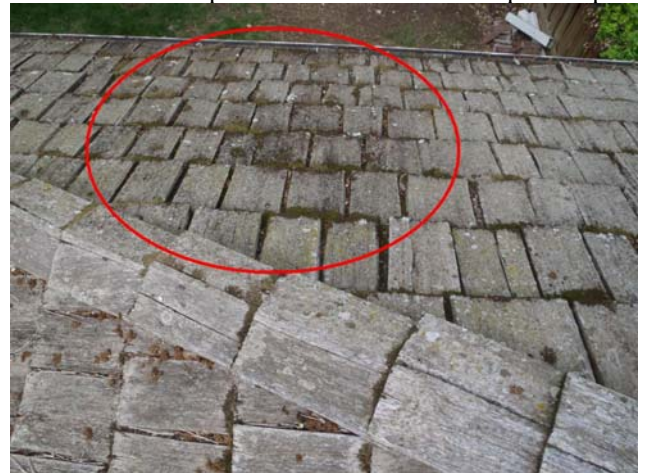
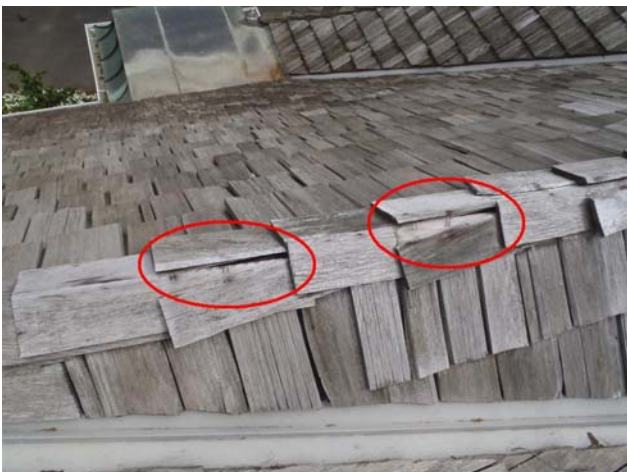
- **Repair:** The roofing is in fair condition. The roofing shows evidence of moss and organic build up in shaded areas. This condition may reduce the life expectancy of the roofing. Trimming or removing trees could improve this condition. Split, loose or damaged ridge caps of the roofing require repair. The life expectancy of wood roofs is generally 15 to 20 years with tune-ups normally needed around the 10<sup>th</sup> year. This will depend on several factors such as the quality of shingle or shake, the slope of the roof (steeper is better), the amount of exposed shingle, and the amount of sun or shade. As with all roofs, annual maintenance is needed. Cracked, curled, or displaced shingles or shakes should be repaired. As a rule of thumb, replacement of the entire roof covering may be logical if more than ten percent of the wood roof requires repair.

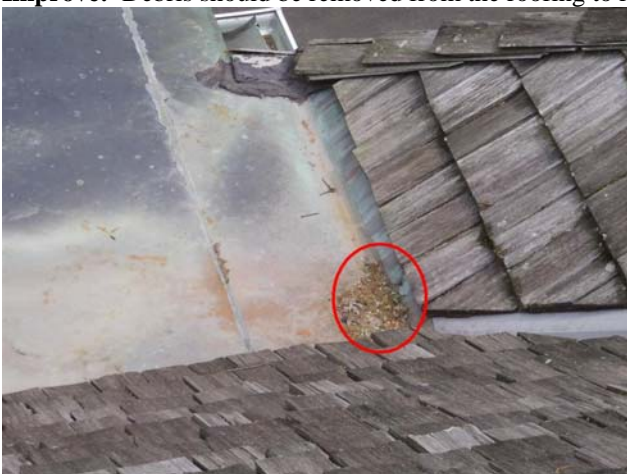
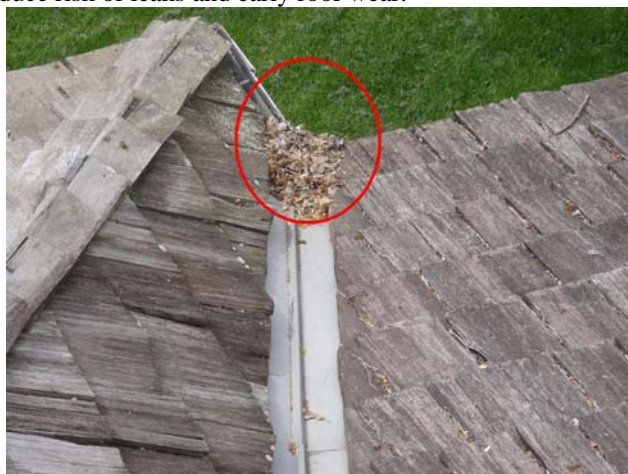
- **Improve:** Debris should be removed from the roofing to reduce risk of leaks and early roof wear.

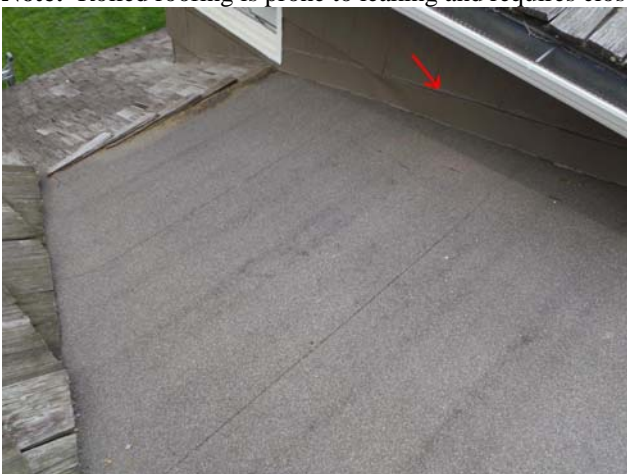
- **Note:** Rolled roofing is prone to leaking and requires close monitoring and higher than normal maintenance.

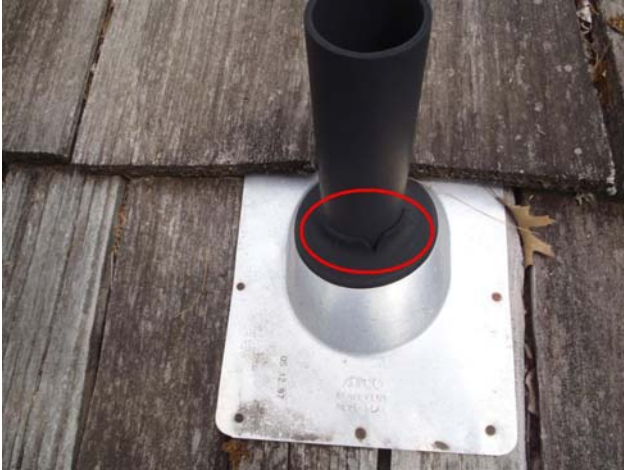
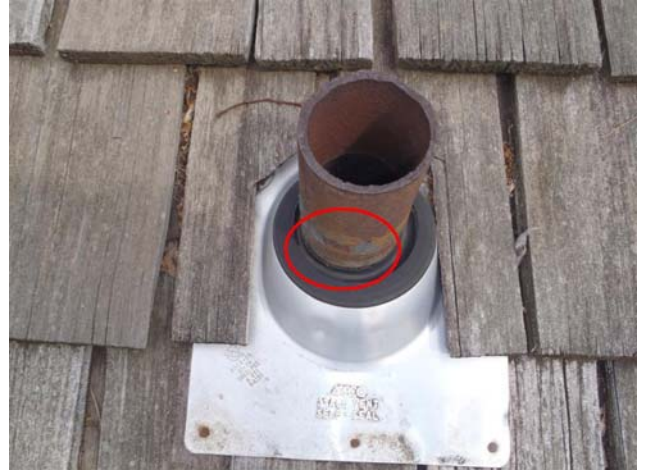
- **Monitor, Repair:** The plumbing vent flashing boot(s) are split making them vulnerable to leaks. It's recommended that the boots be caulked or the flashing replaced.

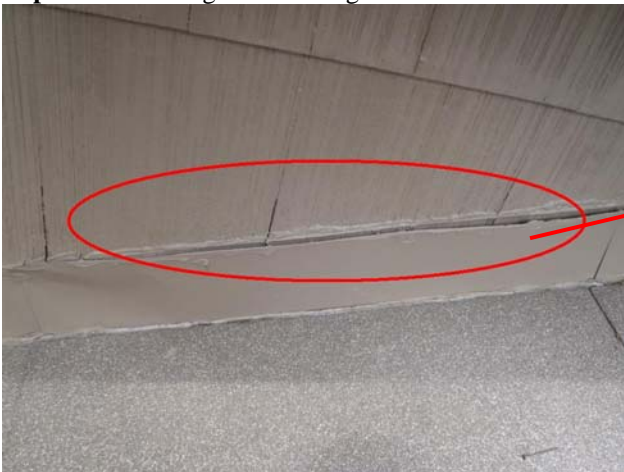
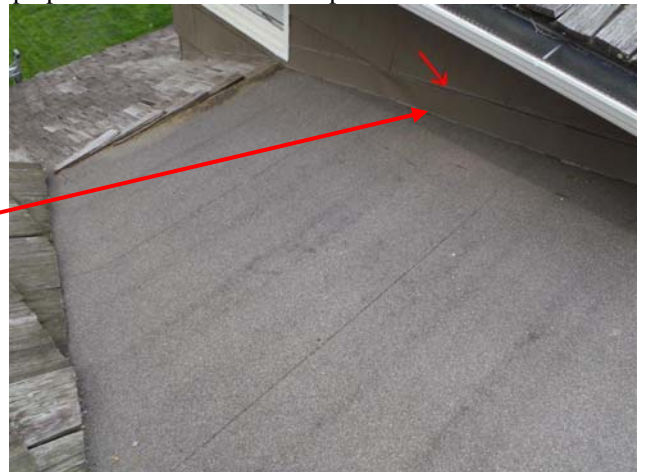
- **Repair:** The siding roof flashing near the southwest roof step up is loose and should be repaired to avoid leaks.

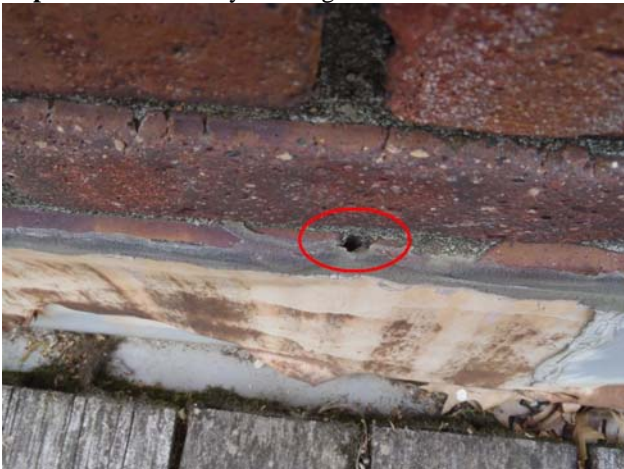
- **Repair:** The chimney flashing should be caulked to avoid leaks.

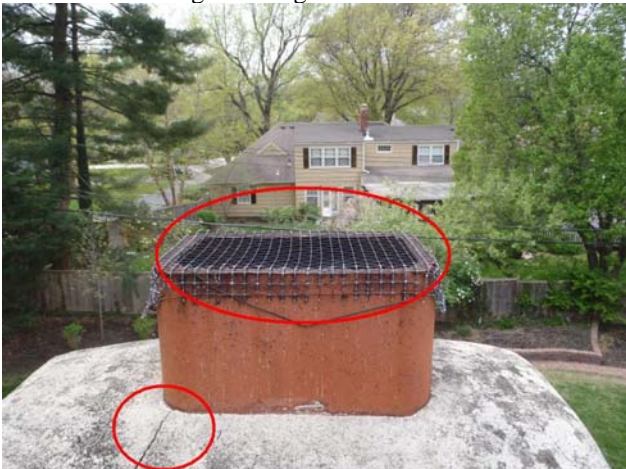
- **Monitor, Repair:** The cap of the masonry chimney is cracked. These cracks should be sealed or caulked before winter to prevent damage from freezing water.
- **Repair:** A rain cap and vermin screen should be installed on the masonry chimney and the chimney flue should be checked for damage. Damaged flues can be unsafe.

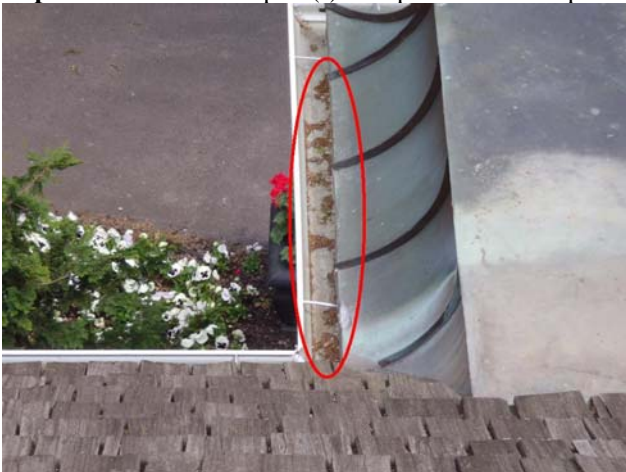
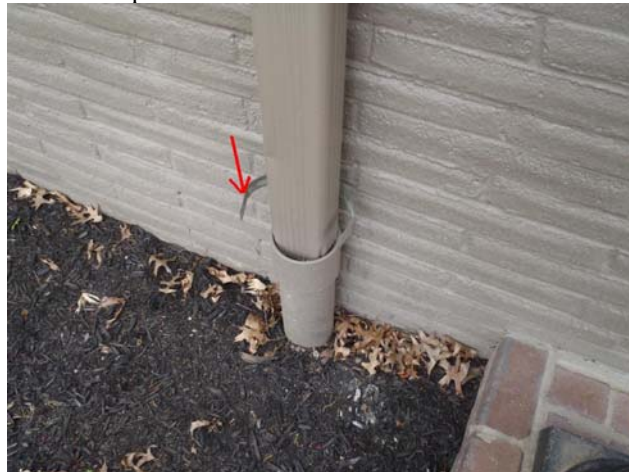
- **Repair:** The gutters require cleaning to avoid spilling roof runoff around the building – a potential source of water entry or water damage.
- **Improve:** Loose downspout(s) clamp near the front porch should be improved.

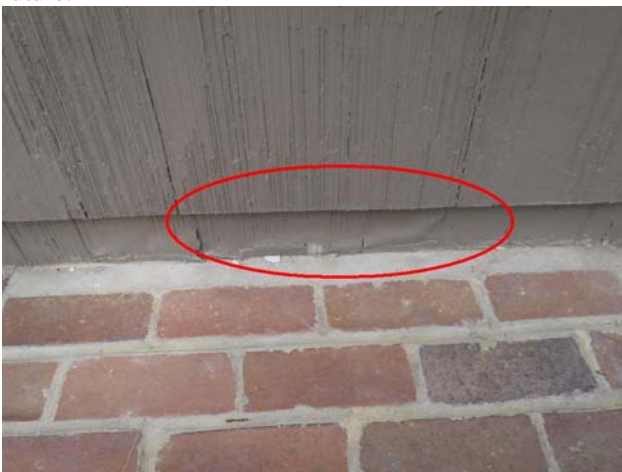
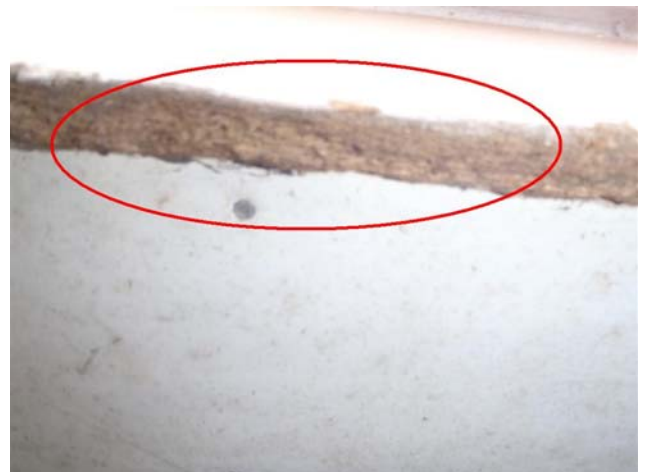
- **Repair:** The exterior siding paint is peeling and/or worn thin in localized areas (i.e. near master bedroom sliding glass door and at lower edge of front bay windows.) These areas should be painted to prevent water damage or rot in the future.

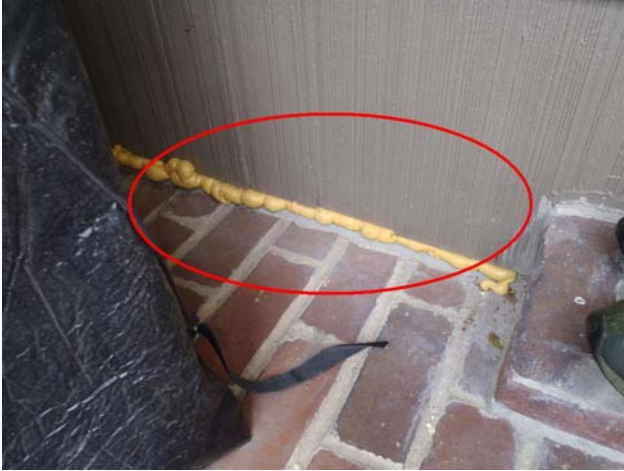
- **Repair:** Localized rot was observed in the siding (i.e. near the master bedroom sliding glass door.) Following repair of the damaged areas (which should be combined with exterior painting/maintenance) proper maintenance of the siding and control of water from roof or surface runoff can avoid further damage.
- **Monitor:** Insulation noted below lower edge of siding near back slider.

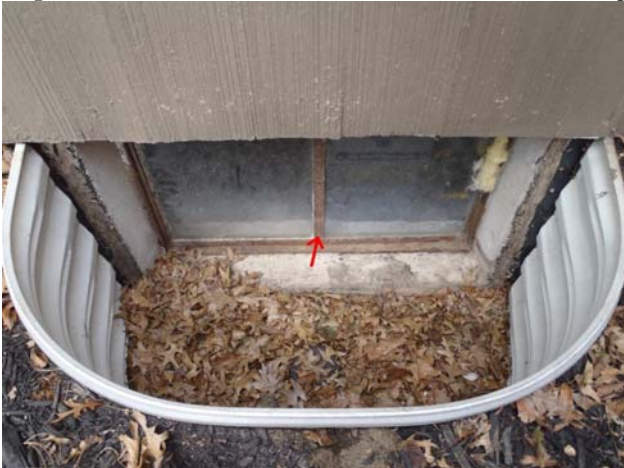
- **Improve:** The metal basement window frames are rusting noticeably. Painting may be desirable.

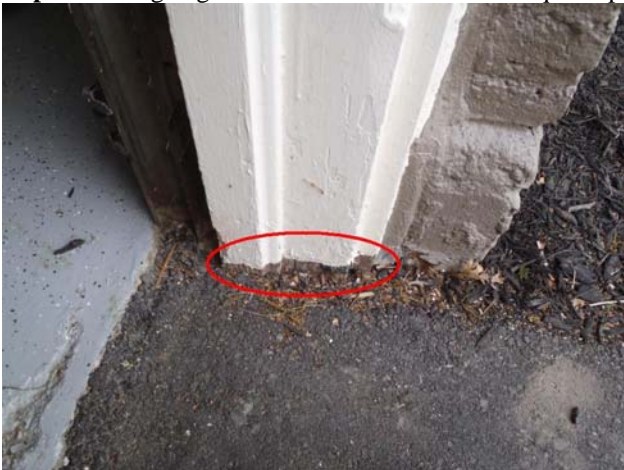
- **Repair:** The garage overhead door frame/ trim requires painting.

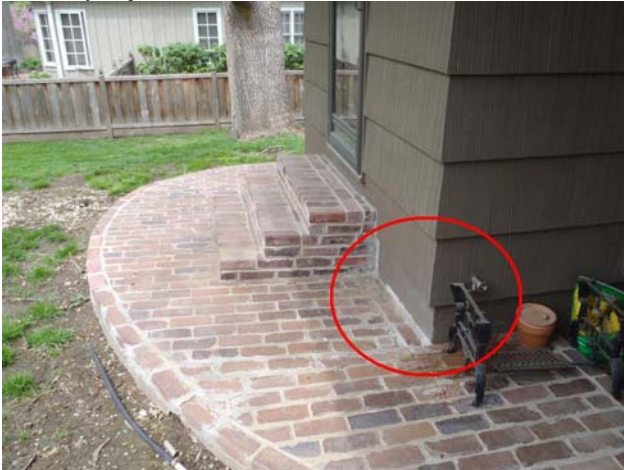
- **Recommend:** Cover should be provided for the basement window well to keep storm water out of the well.
- **Possible Major Concern, Monitor:** The back northwest patio porch step entry appears to slope towards the house. This condition can cause water entry in the building. It is difficult to improve this situation without re-grading the porch and walkway adjacent to the foundation.

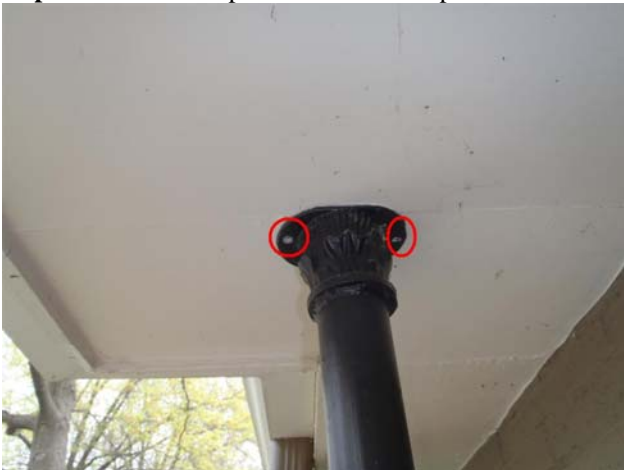
- **Improve:** The front porch cover should posts could be better secured to the house to reduce risk of falling.

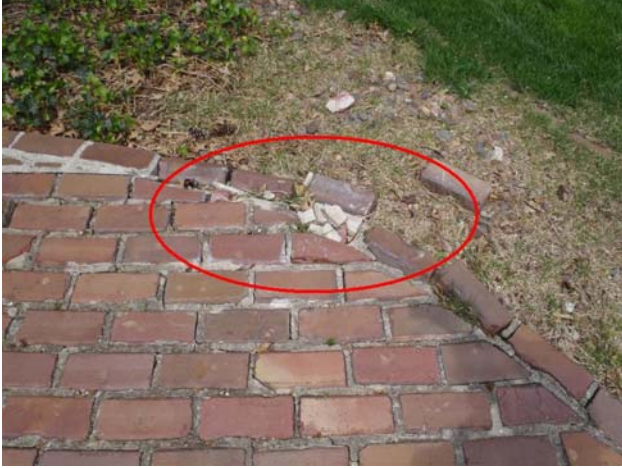
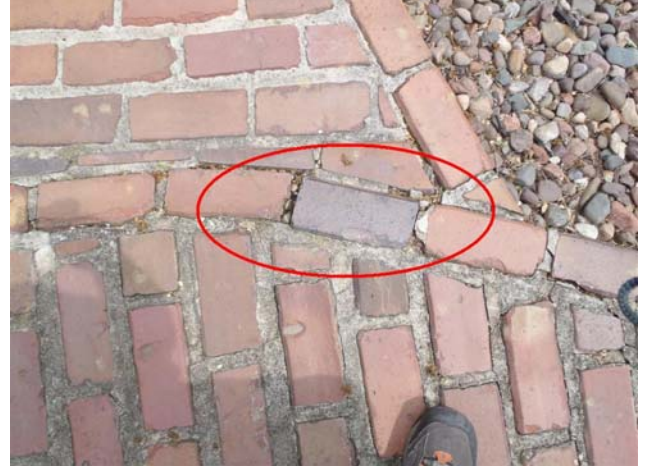
- **Repair:** The exterior brickwork on the back patio and walkway should be re-pointed (replacement of the mortar between the bricks) to prevent further deterioration. Cracked, deteriorated or missing bricks should be replaced.

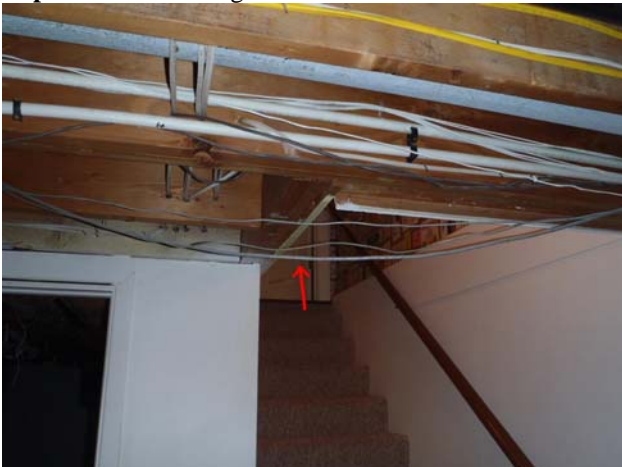
- **Repair:** Loose wiring in the basement should be secured.

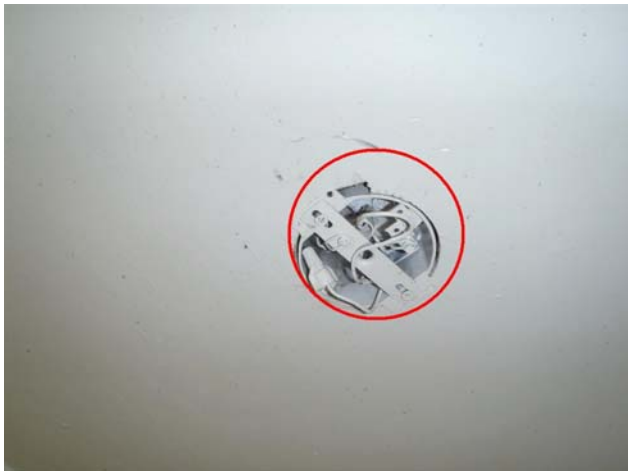
- **Repair:** The light is inoperative (i.e. front porch, basement and garage.) If the bulbs are not blown, the circuit should be repaired.
- **Repair, Safety Issue:** The missing light fixture on the northwest corner of the exterior should be repaired or replaced. Exposed wiring represents a safety concern. This wiring is controlled by the middle switch near the laundry room back door.

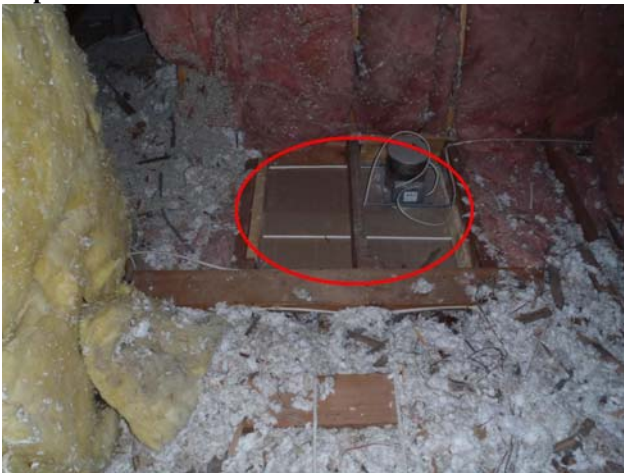
- **Repair:** Insulation should be evened out.

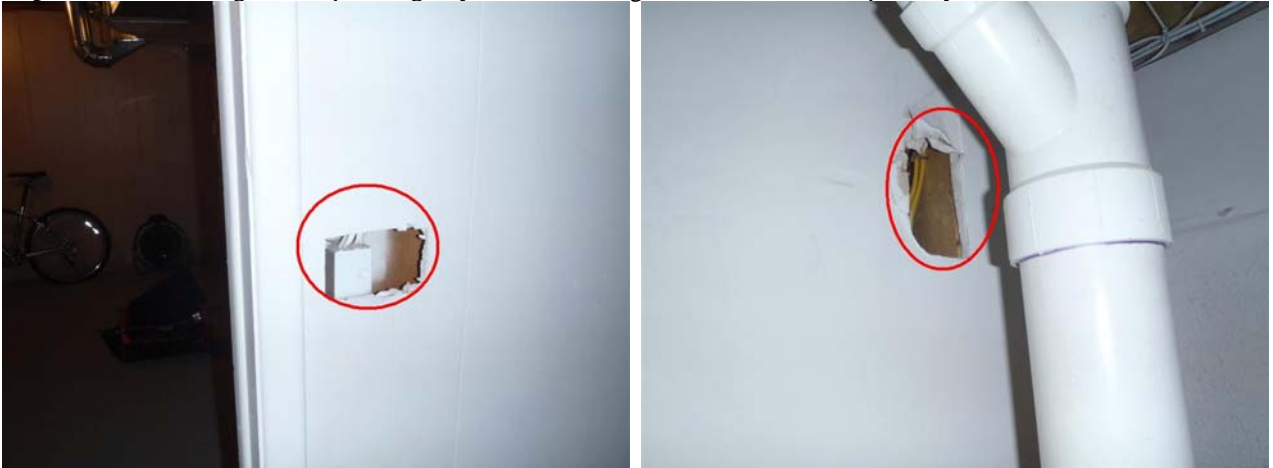
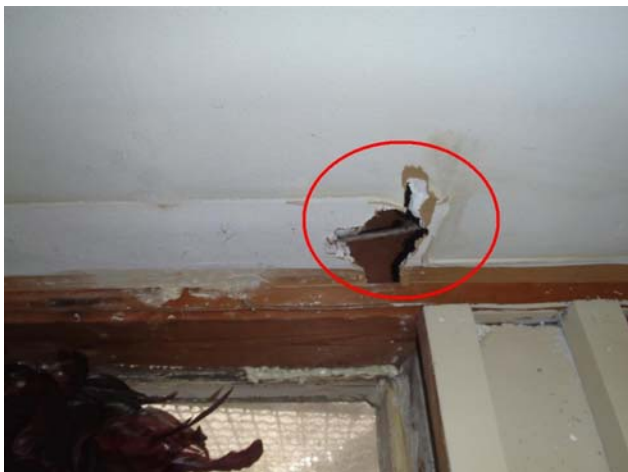
- **Repair:** Minor damage to the paneling, drywall and ceiling was observed in the partially finished basement.

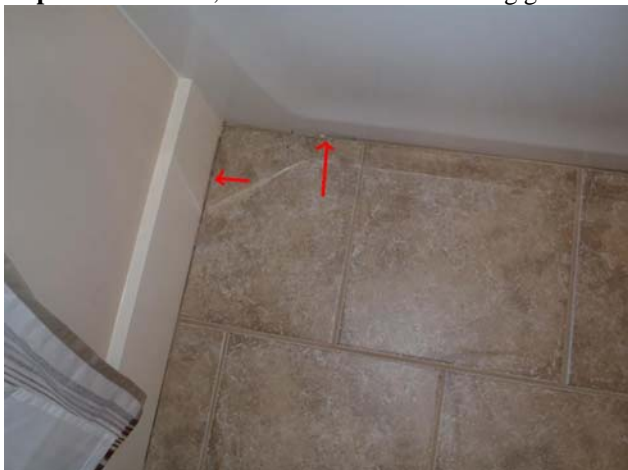
- **Improve:** Cracked, deteriorated and/or missing grout in the upstairs northwest bath flooring should be replaced.
