**Star  
Home  
Inspection Services**

*Home Inspection Report*

**6731 Roe Ave Prairie Village, KS 66208**

**Inspection Date: 05/24/2011**

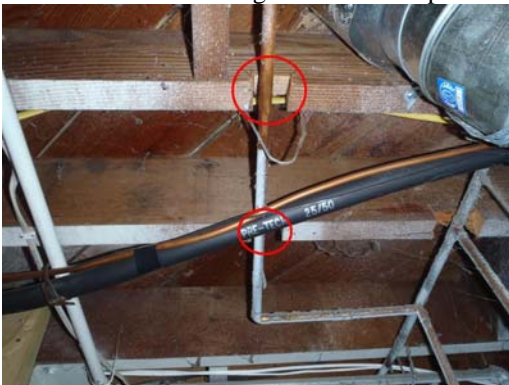
- **Monitor:** Floor joists are notched and or cut. This weakens the joist and risks structural damage; if any further movement is or cracking is observed repairs or additional support will be needed.

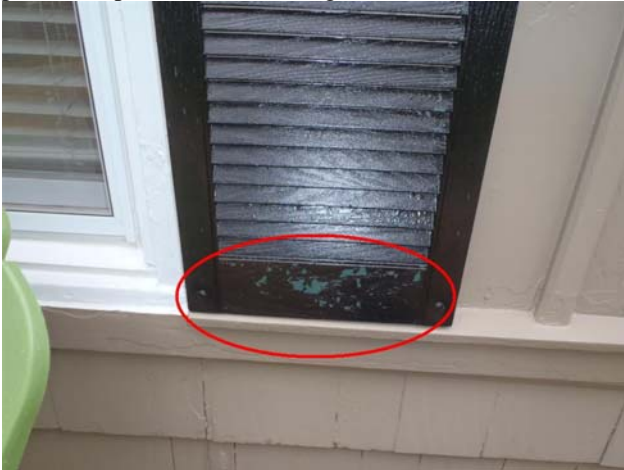
- **Repair:** The exterior of the outbuilding needs to be painted.
- **Repair:** The exterior window shutters paint is peeling and/or worn thin in localized areas. These areas should be painted to prevent water damage or rot in the future. **REPAIRED**

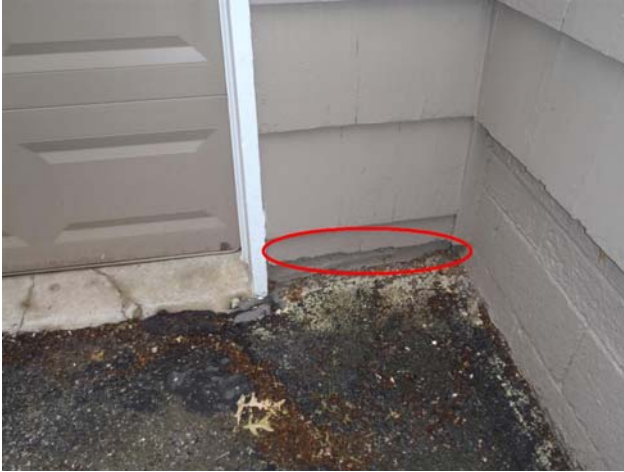
- **Repair:** Localized rot was observed in the outbuilding siding. Following repair of the damaged areas (which should be combined with exterior painting/maintenance) proper maintenance of the siding and control of water from roof or surface runoff can avoid further damage.
- **Monitor, Repair:** Localized damage of the exterior siding was noted. Following repair of the damaged areas (which should be combined with exterior painting/maintenance) proper maintenance of the siding and control of water from roof or surface runoff can avoid further damage.

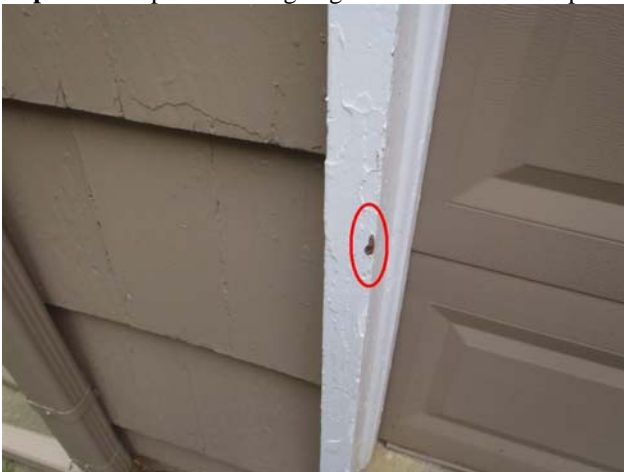
- **Repair:** The paint on the garage door frame/ trim is peeling and requires minor painting. **REPAIRED**

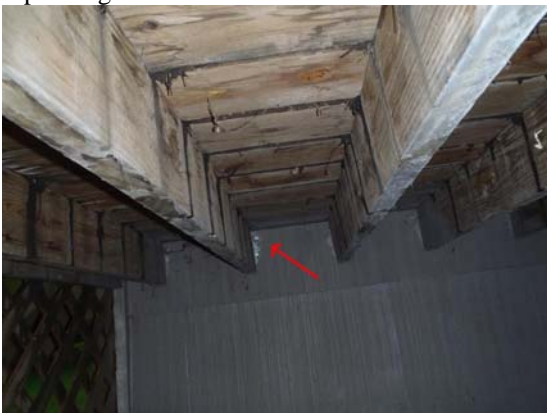
- **Monitor, Repair:** The deck should be better secured to the house using lag bolts and a header board to reduce risk of separating from the house.

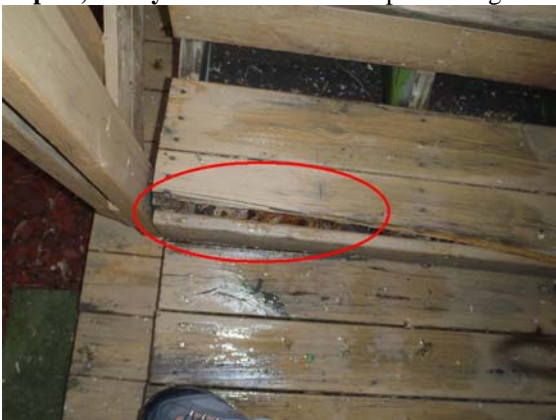
- **Repair:** The deck shows evidence of rot (i.e. bottom of deck steps.)
- **Monitor, Repair:** The support posts for the deck are below the soil. This configuration is prone to rot. Raising above soil level is recommended. The potential of rot could already be present.
- **Repair, Safety Issue:** The deck step is damaged and should be replaced as it is unsafe. **REPAIRED**

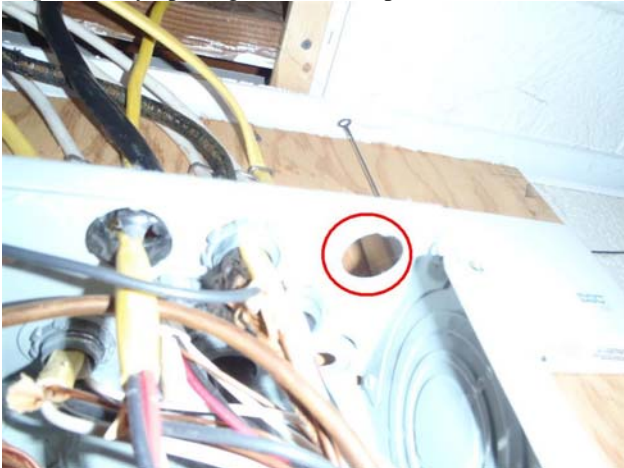
- **Repair:** Any openings in the main panel should be covered. **REPAIRED**

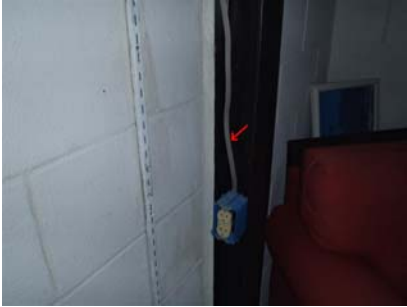
- **Repair:** Extension cords should not be used as permanent wiring. This wiring in the garage should be removed and replaced with permanent wiring and an outlet(s). **REPAIRED**
- **Repair:** Wiring exposed on interior finishes in the basement should be relocated or protected by a rigid conduit. **REPAIRED**

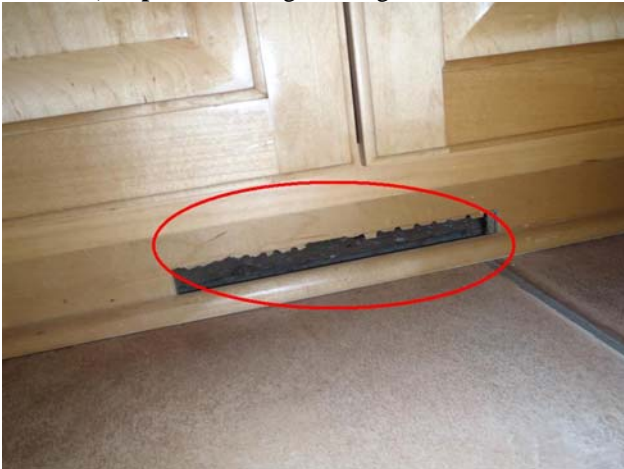
- **Monitor, Repair:** Missing vent register cover at the base of the cabinets in the kitchen was observed.

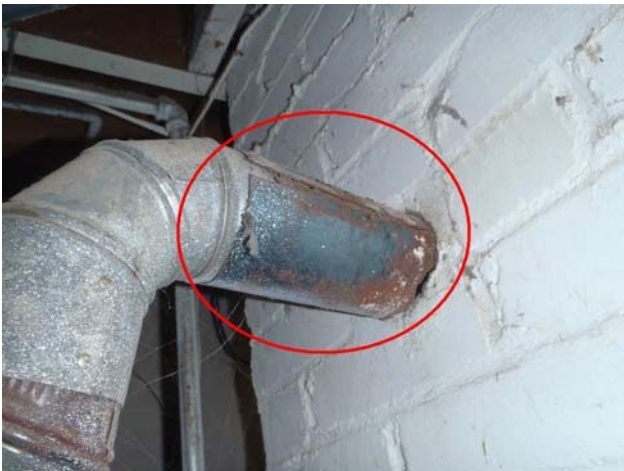
- **Monitor:** Water heaters have a typical life expectancy of 7 to 12 years. The existing unit is approaching or has exceeded this age range. One cannot predict with certainty when replacement will become necessary.
- **Repair:** The water heater burner is dirty. It should be cleaned and adjusted. **REPAIRED**
- **Repair, Safety Issue:** The water heater venting system shows evidence of exhaust "spillage". *This is a serious condition that could be a health threat to the occupants of the home.* This condition should be addressed promptly. **REPAIRED**

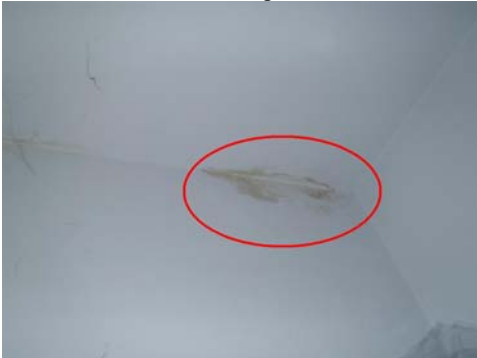
- **Monitor:** Water staining was noted in the southeast bedroom closet ceiling and basement ceiling. **REPAIRED**

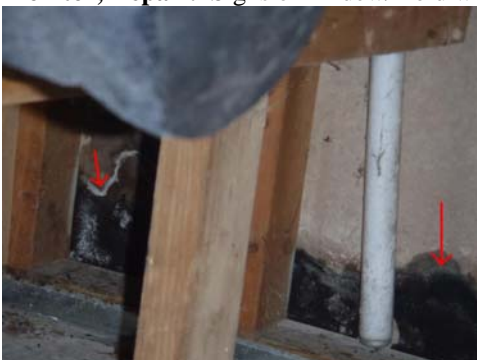
- **Monitor, Repair:** Damage to the laundry room ceiling was observed.
- **Monitor:** Minor cracks were noted (i.e. living room.)
- **Monitor:** Typical drywall and/or plaster flaws were observed that could include loose tape, minor cracks, rough seams, peeling paper, nail popping, minor patching, loose or bulging plaster, etc. Any repairs would be discretionary.
- **Monitor, Repair:** Signs of mildew/mold were observed in the outbuilding.
