Star Home Inspection Services

Home Inspection Report

7 NW Walnut St Lees Summit, MO 64063

Inspection Date: 02/23/2010

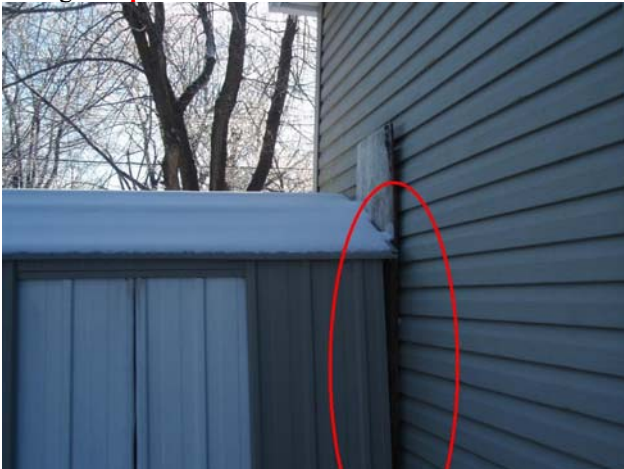
- **Repair:** Wood/soil contact at the base of the siding and where plywood is stored at north side of the home should be eliminated. Rotted or damaged siding that is uncovered should be repaired. These areas are at risk of additional hidden damage. **Repaired**

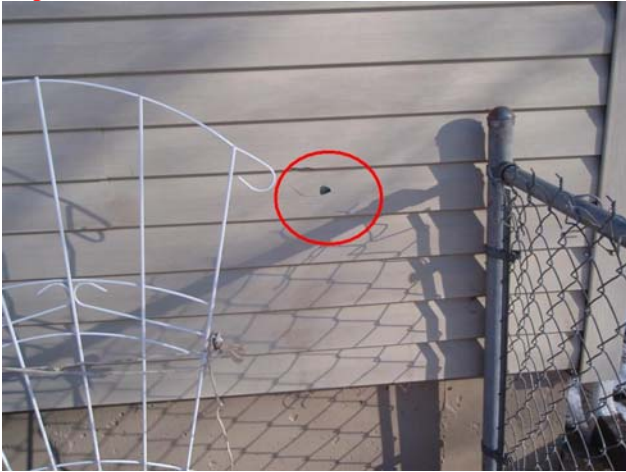
- **Repair:** Localized damage of the vinyl siding should be repaired. There is extra risk of hidden damage in such areas.
Repaired

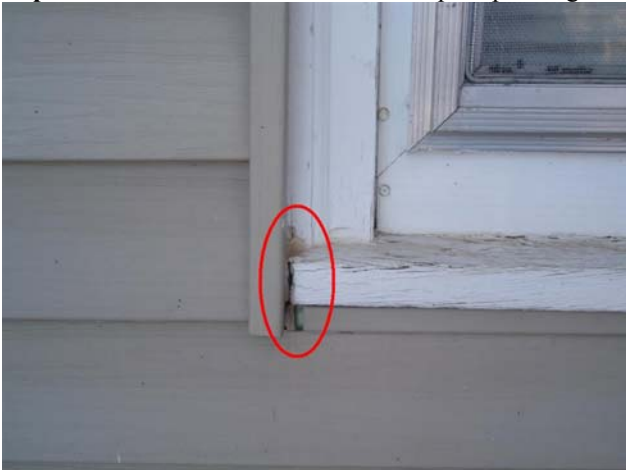
- **Repair:** Some of the window frames require painting and caulking.

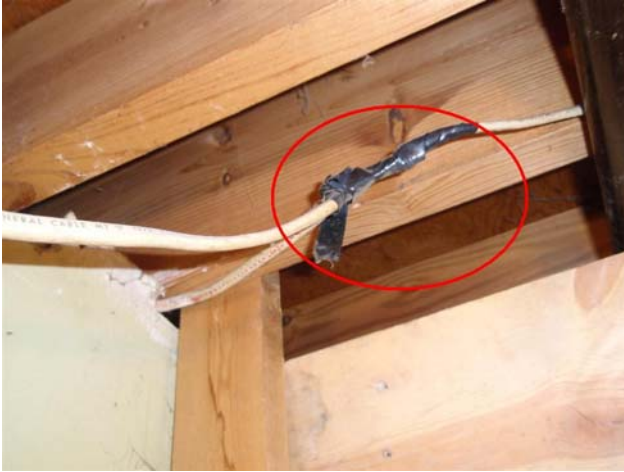
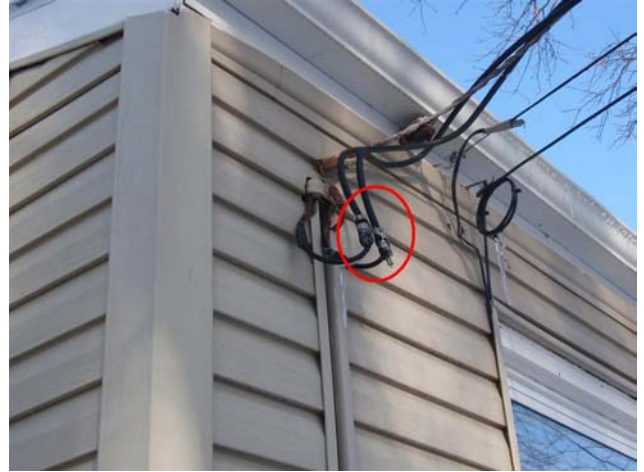
- **Repair:** Extension cords should not be used as permanent wiring. This wiring in the garage and furnace room should be removed and replaced with permanent wiring and an outlet(s). **Repaired**
- **Repair:** Improper electrical connections should be repaired (i.e. furnace room and exterior service connection.) All electrical connections should be made inside junction boxes fitted with cover plates. The exterior connection should be sealed. **Repaired**

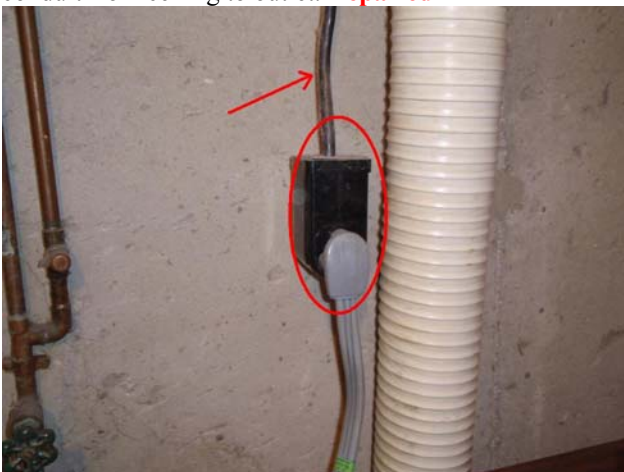
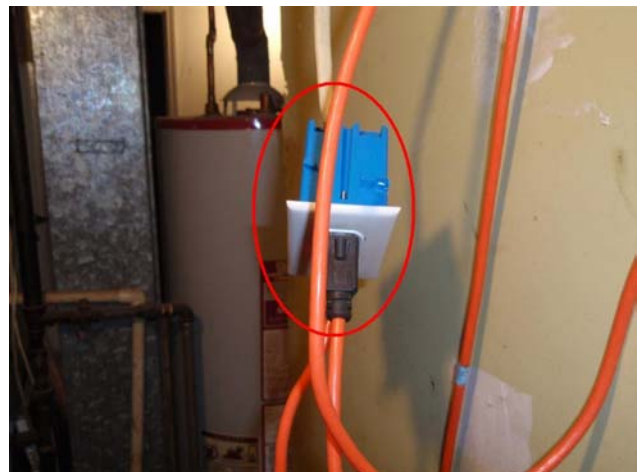
- **Repair:** An outlet is loose (i.e. furnace room and dryer outlet. It should be secured and the dryer outlet should be in conduit from ceiling to outlet. **Repaired**

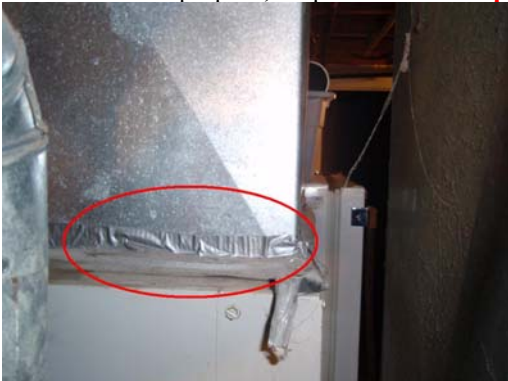
- **Repair:** Loose fitting joints and/or openings in the ductwork should be improved Duct tape is not the appropriate material for this purpose, despite its name. **Repaired**

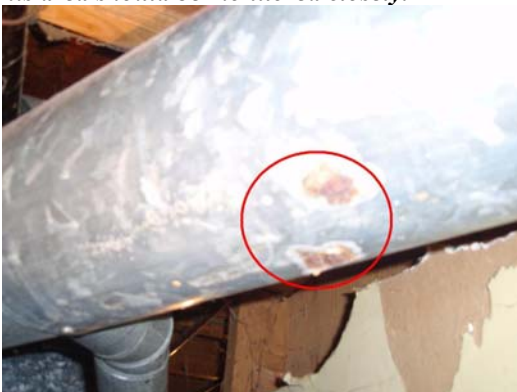
- **Monitor:** *Rust was observed at furnace exhaust flue in the furnace room. Repairs are not necessary at present but his area should be monitored closely.*

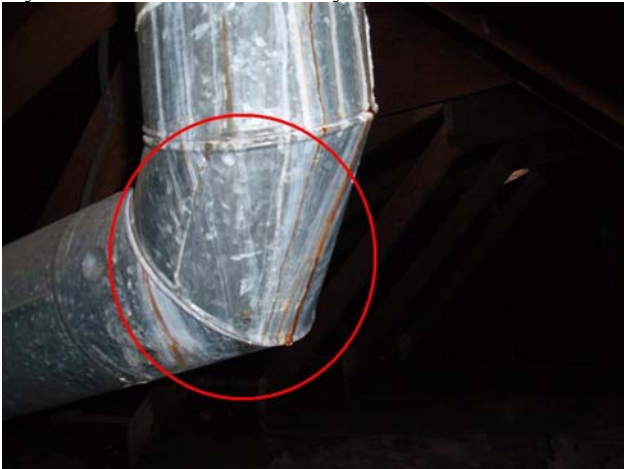
- **Monitor:** While in the attic water stains were observed on the lower sections of the furnace flue. The insulation below the elbow also showed signs of past moisture. It appears that rain blew in under the rain cap and came down the interior of the flue until it got to the first joint where it then transferred to the outside surface and dripped off the elbow. This is a common condition in 80% of homes but very seldom is enough to penetrate completely through the insulation to the drywall below. Monitor for any additional wetness after rains.

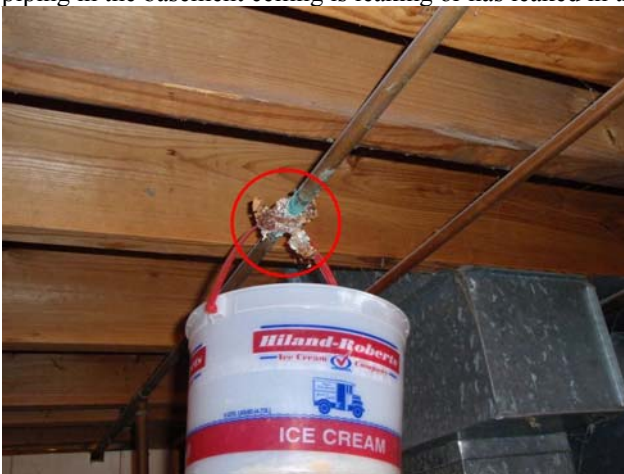
- **Monitor, Repair:** Corrosion on the exterior of the supply piping was observed. The saddle valve connection at the piping in the basement ceiling is leaking or has leaked in the past.

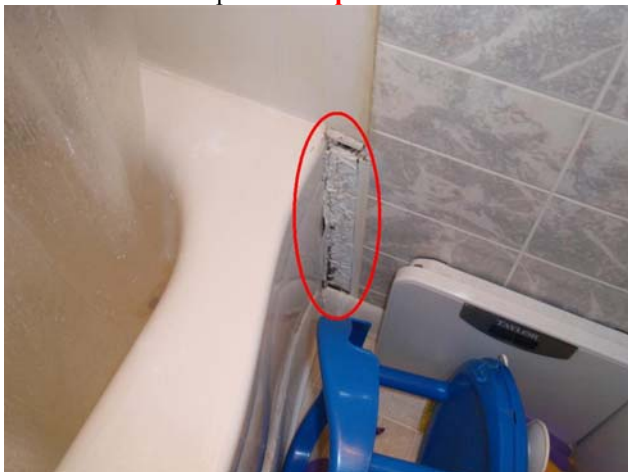
- **Repair:** The faucet handles at the basement shower are leaking.
- **Repair:** Cracked, deteriorated and/or missing bathtub enclosure caulk and damage to the wall at the corner of the bathtub could be improved. **Repaired**
