**Star  
Home  
Inspection Services**

*Home Inspection Report*

**7001 Antioch Rd Overland Park, KS 66204**

**Report Number: 01132010-2A**

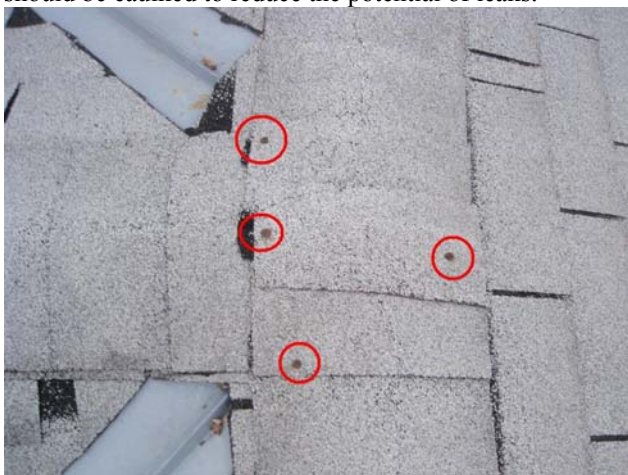
- **Recommend:** Exposed nail heads were observed in the roofing shingles and/or ridge caps. All exposed nail heads should be caulked to reduce the potential of leaks.

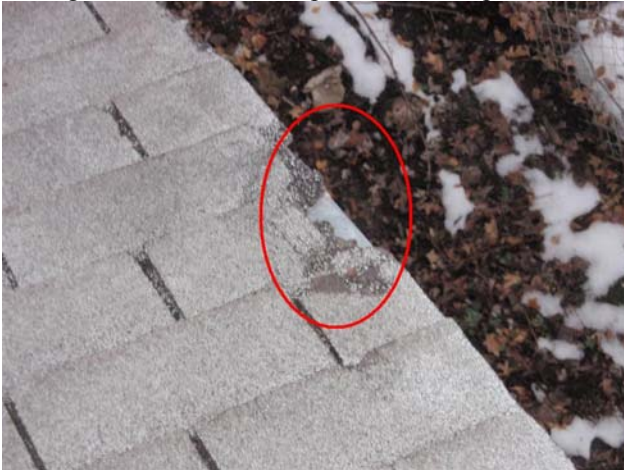
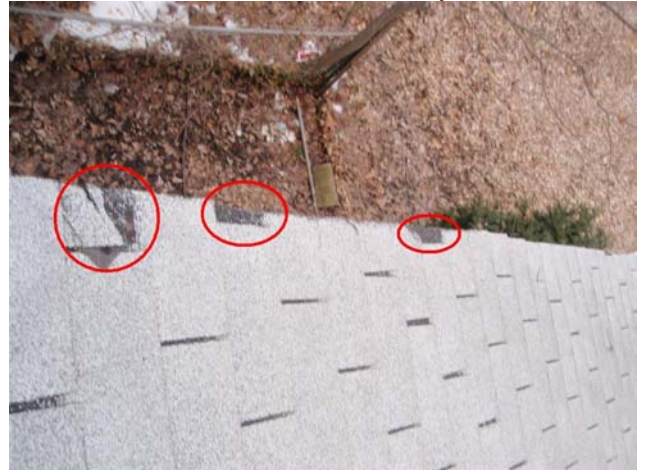
- **Repair:** Minor repairs to the roofing are needed (i.e. south edge where metal flashing is exposed). Damaged or missing roofing material should be repaired. All roof penetrations should be examined and sealed as necessary.

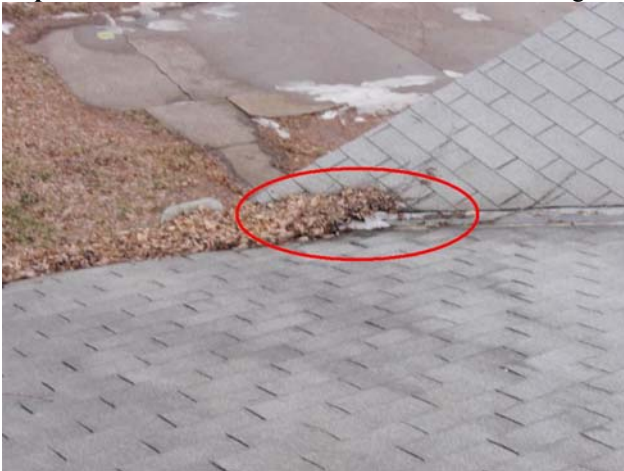
- **Improve:** Debris should be removed from the roofing to reduce risk of leaks and early roof wear.

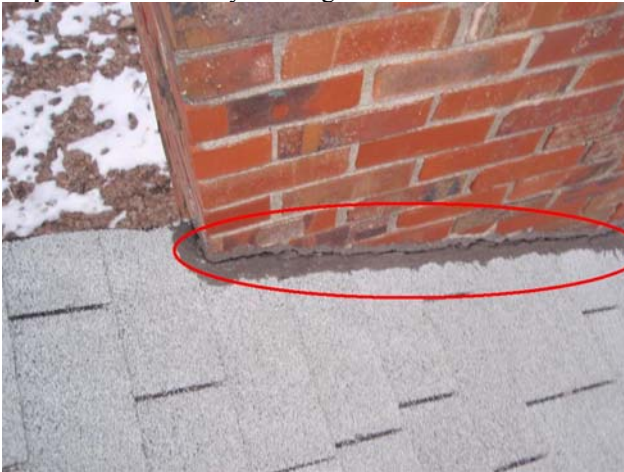
- **Repair:** The chimney flashing should be caulked to avoid leaks.

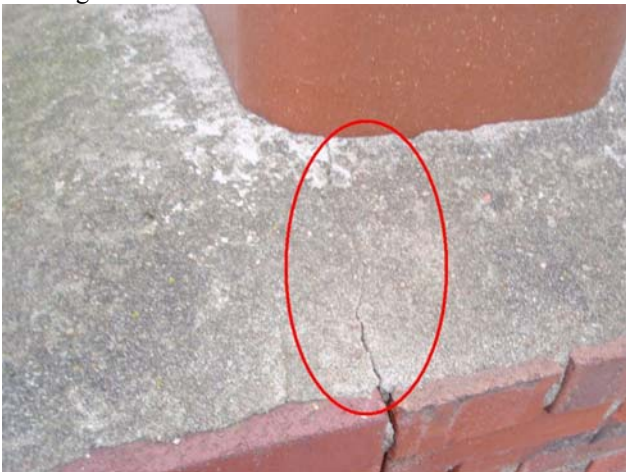
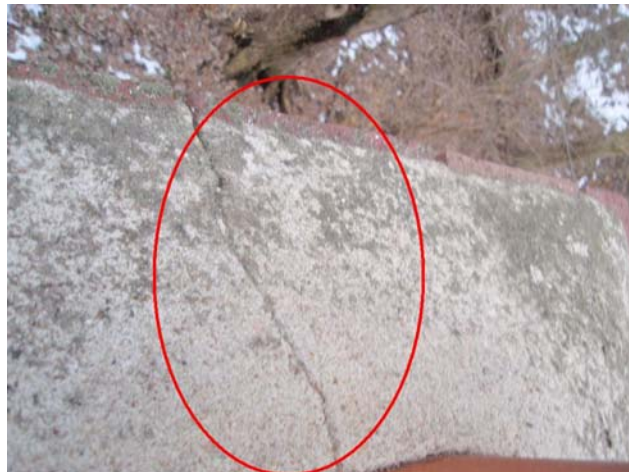
- **Repair:** The cap of the masonry chimney is cracked. These cracks should be sealed or caulked to prevent damage from freezing water.

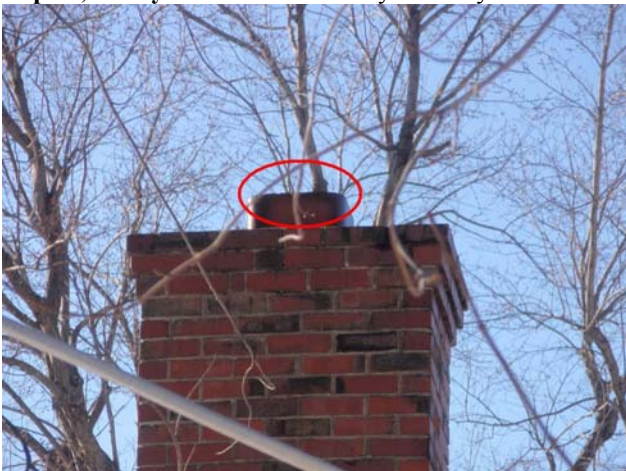
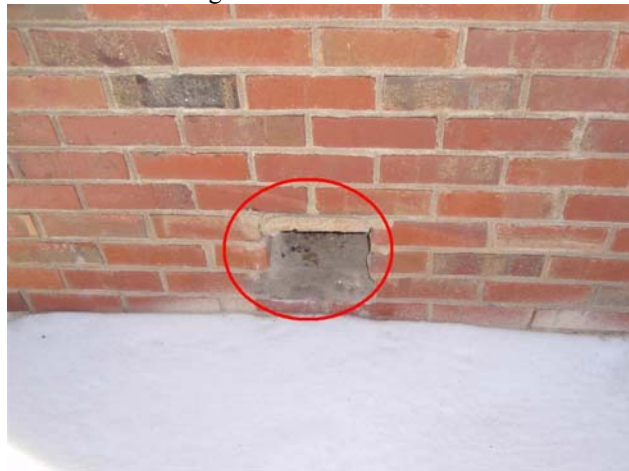
- **Repair:** A rain cap and vermin screen should be installed on the masonry chimney and the chimney flue should be checked for damage. Damaged flues can be unsafe.
- **Repair, Safety Issue:** The masonry chimney exterior clean out cover is missing

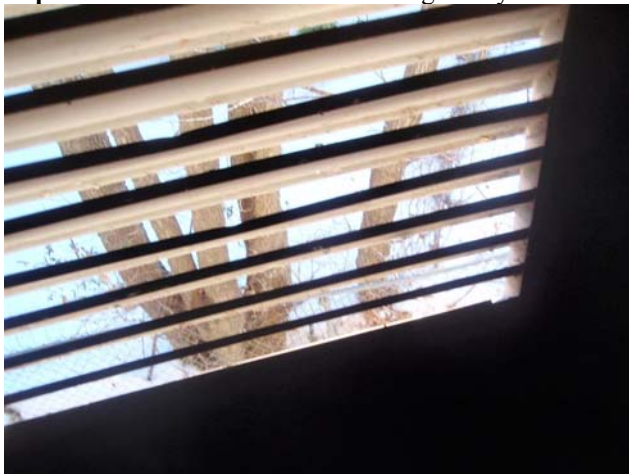
- **Repair:** Gable vent screens are missing. They should be repaired or replaced to prevent vermin activity.
