**Star
Home
Inspection Services**

Home Inspection Report

7020 Walmer, Overland Park, KS 66204

Inspection Date: 09/22/2009

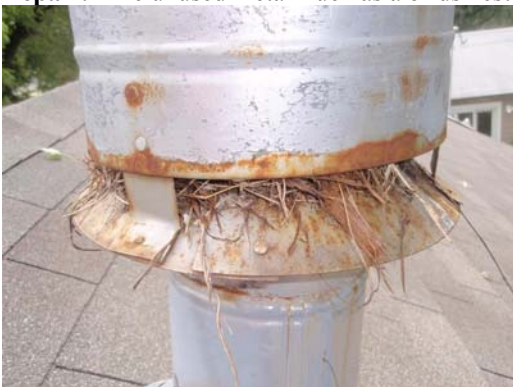
- **Repair:** The unused metal flue has a birds nest in it. This should be capped off to prevent bird and/or vermin entry.

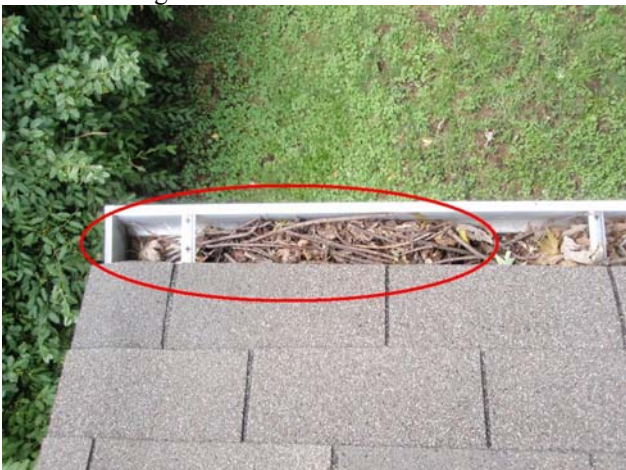
- **Repair:** The gutters require cleaning to avoid spilling roof runoff around the building – a potential source of water entry or water damage.

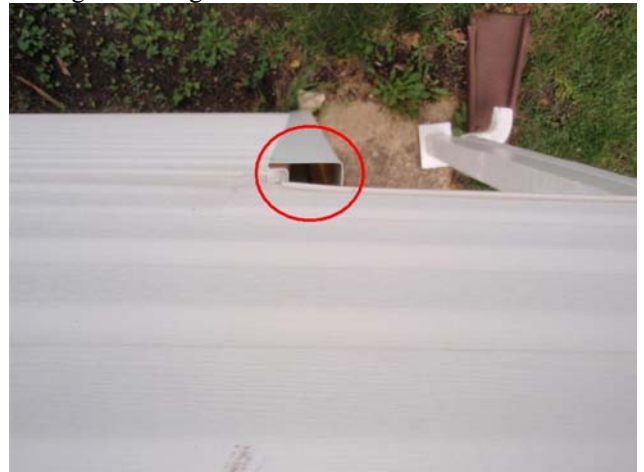
- **Repair:** Any openings in the exterior siding should be sealed. An example is where the air conditioner refrigerant lines enter the house and at top northeast and southwest corners of siding. Caulking is needed.

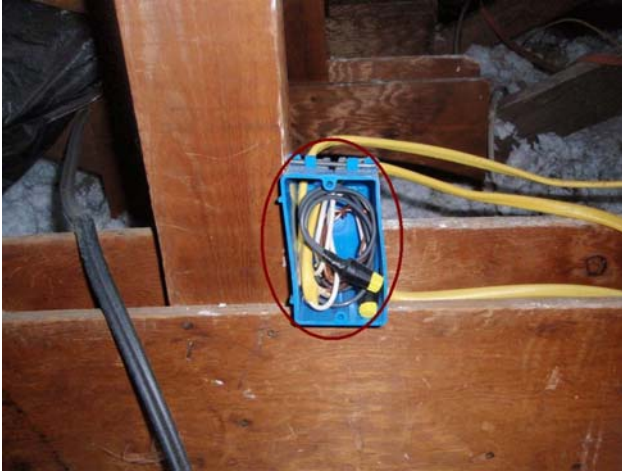
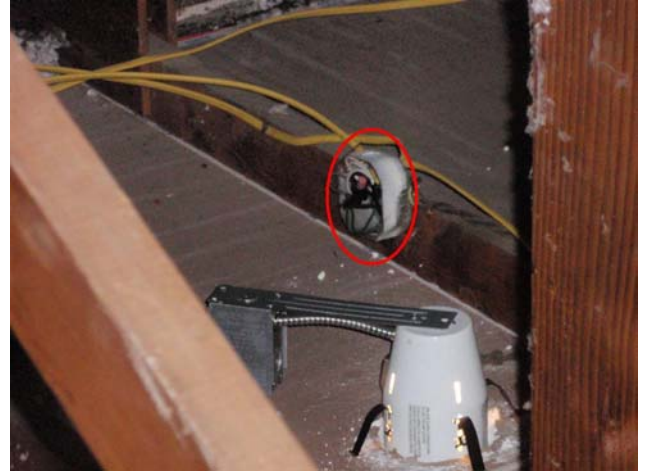
- **Repair:** All junction boxes should be fitted with cover plates, in order to protect the wire connections (i.e. attic).

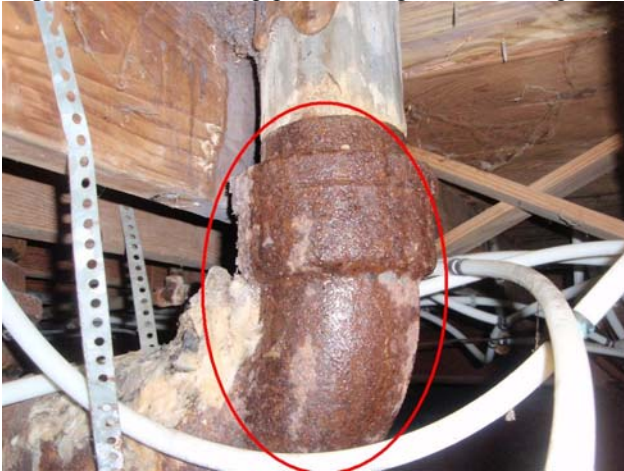
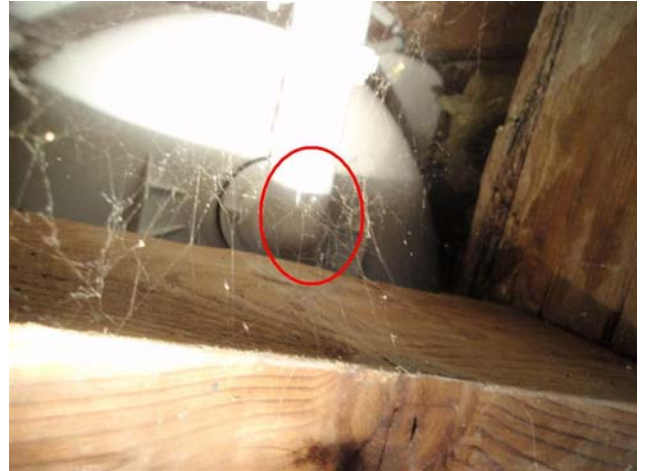
- **Repair:** The waste drain pipe in the crawl space is leaking.
- **Repair:** The tub drain pipe is leaking in the crawl space.
