Star Home Inspection Services

Home Inspection Report

7020 Walmer, Overland Park, KS 66204

Inspection Date: 09/22/2009

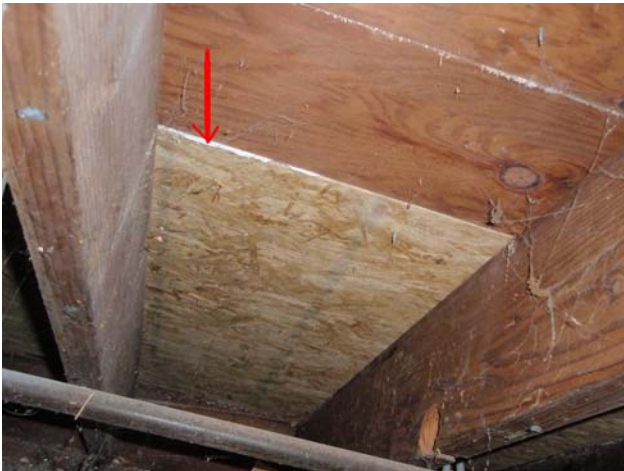
- **Monitor:** Prior repairs to the subflooring below the kitchen was observed. The repairs appear to have been properly installed.

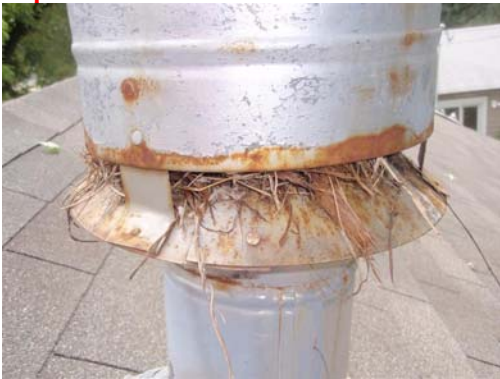
- **Repair:** The unused metal flue has a birds nest in it. This should be capped off to prevent bird and/or vermin entry.

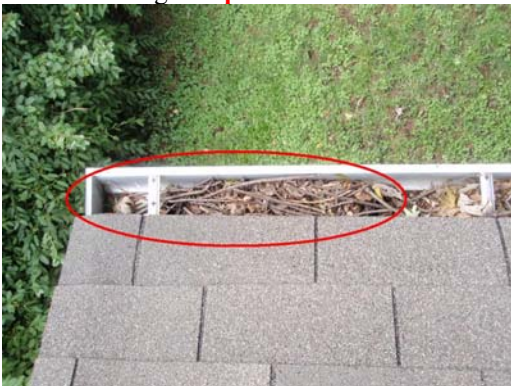
- **Repair:** The gutters require cleaning to avoid spilling roof runoff around the building – a potential source of water entry or water damage. **Repaired**

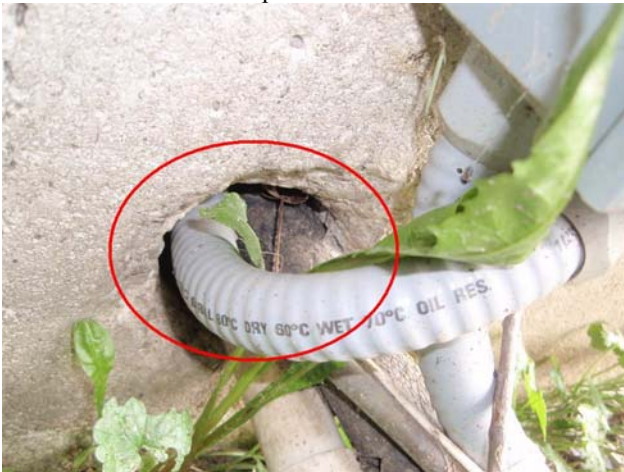
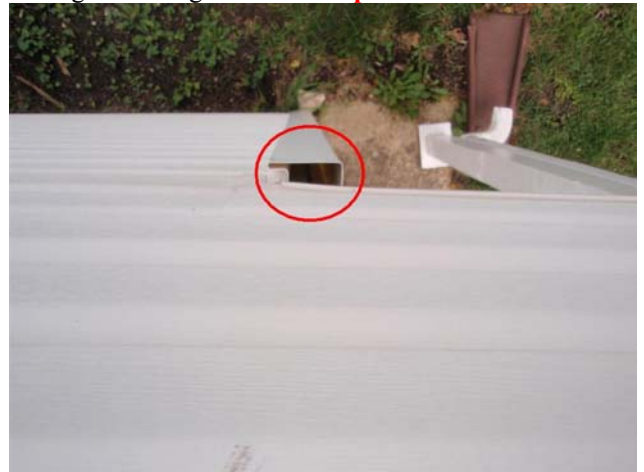
- **Repair:** Any openings in the exterior siding should be sealed. An example is where the air conditioner refrigerant lines enter the house and at top northeast and southwest corners of siding. Caulking is needed. **Repaired**

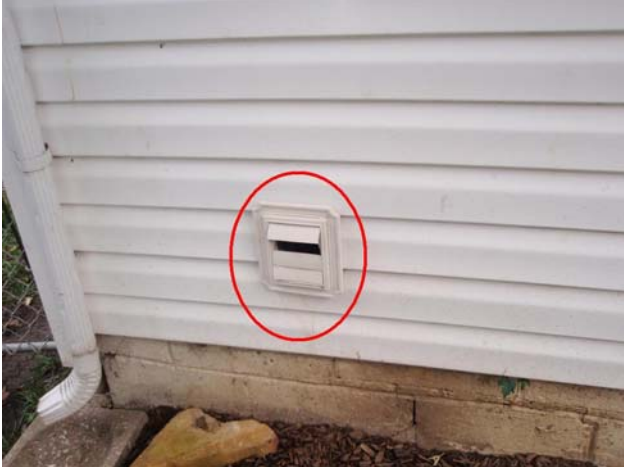
- **Improve:** Damage to the dryer vent cover louvers was observed.

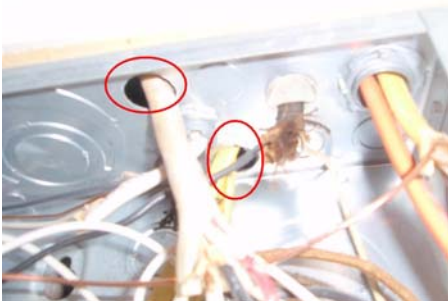
- **Repair:** Oversized breaker within the main distribution panel for the air condition should be replaced. The data plate on the unit specifies a maximum breaker size of 20 Amps and the one in the panel is 30 Amps. **Repaired**
- **Repair:** Cable clamps (sometimes referred to as bushings or grommets) are required where wiring passes into the main distribution panel. Cable clamps serve to protect the wiring from the metal edges of the panel openings. **Repaired**

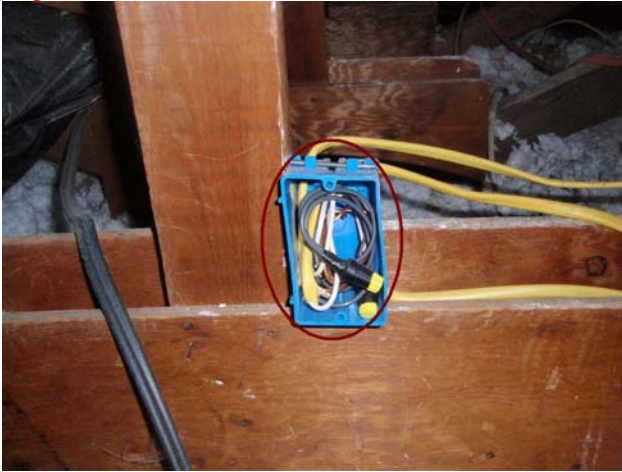
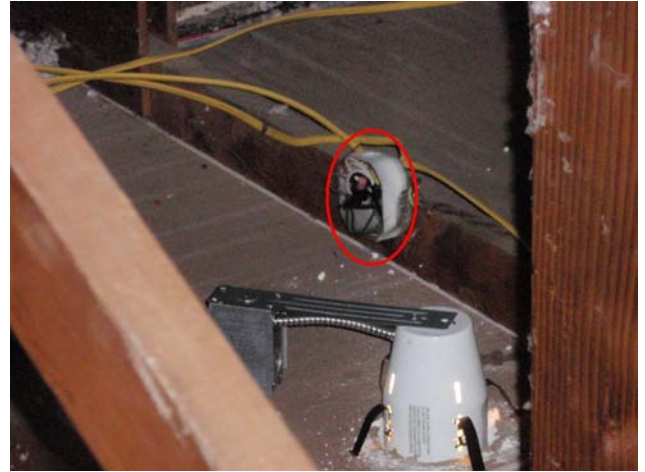
- **Repair:** All junction boxes should be fitted with cover plates, in order to protect the wire connections (i.e. attic).
Repaired

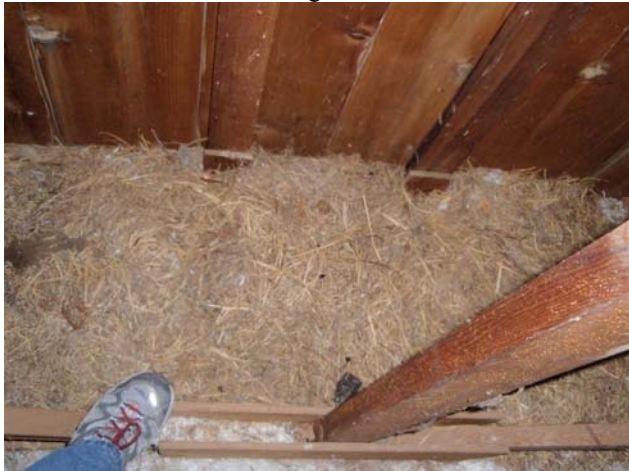
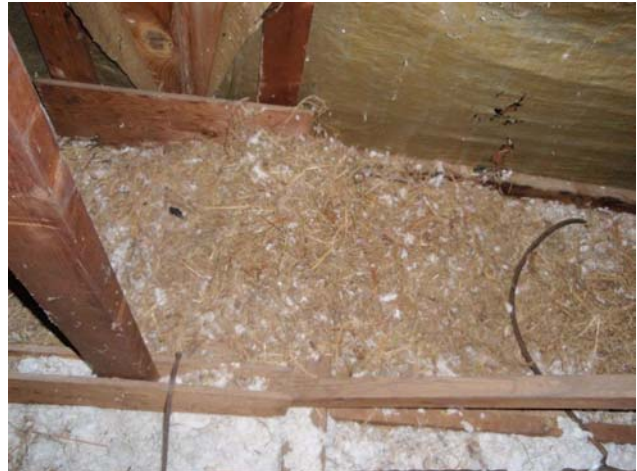
Recommend: There is a large bird nest at both ends of the attic. It's recommended these be removed.

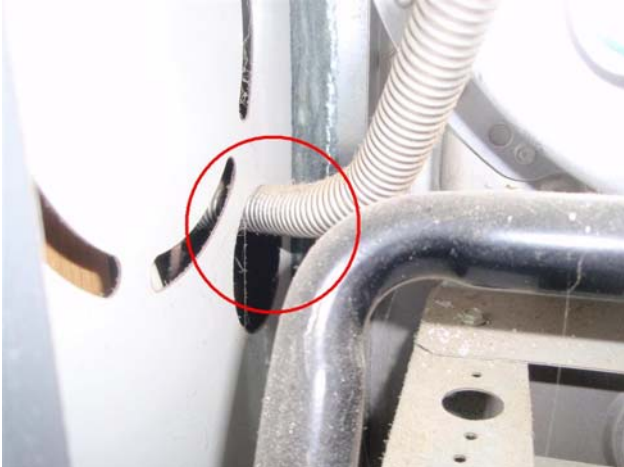
- **Repair:** Flexible gas appliance connections should not pass through walls, floors or the appliance housing as is the case of the furnace. This connector should be replaced with one of suitable solid gas piping. **Repaired**

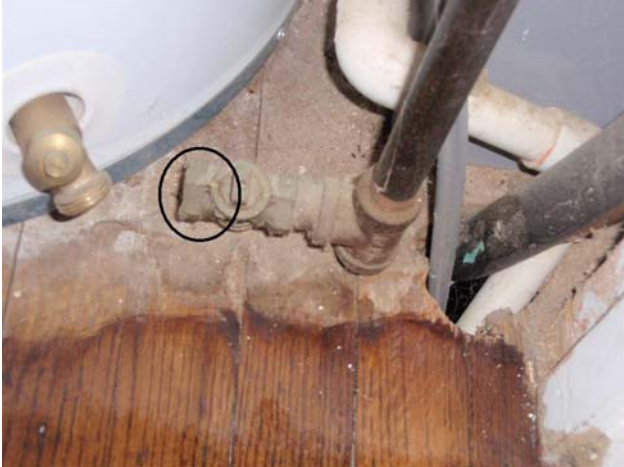
- **Repair:** The gas pipe in the furnace room should be capped when not in use. **Repaired**

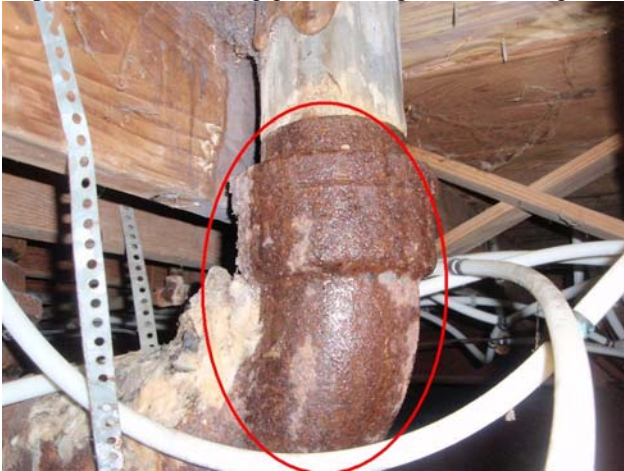
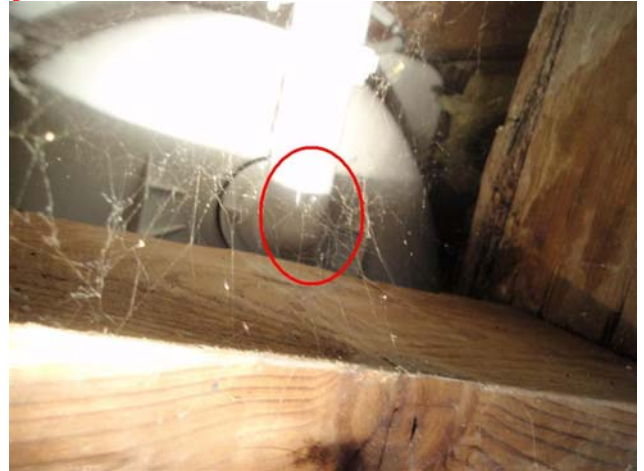
- **Repair:** The waste drain pipe in the crawl space is leaking. **Repaired**
- **Repair:** The tub drain pipe is leaking in the crawl space. **Repaired**
