Star Home Inspection Services

Home Inspection Report

7035 Russell St, Overland Park, KS 66204

Inspection Date: 11/26/2008

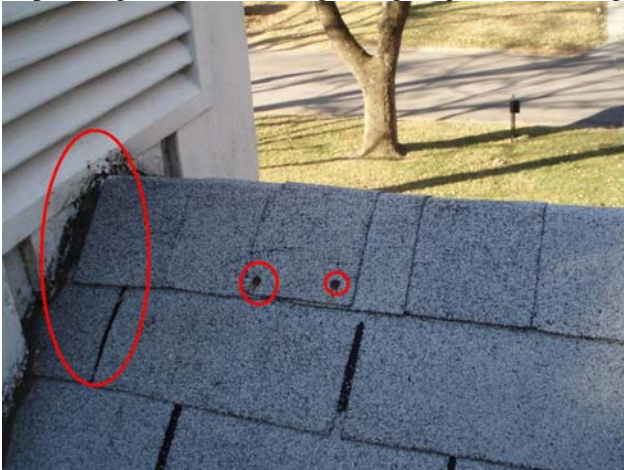
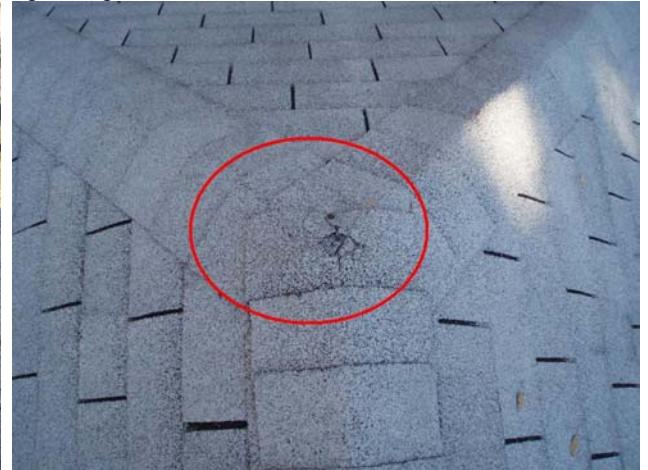
Sloped Roofing

- **Repair:** Minor repairs to the roofing are needed. Damaged or missing roofing material should be repaired. All roof penetrations should be examined and sealed as necessary. Older roofs are, by their nature, a high maintenance roof. Annual inspection and repair should be anticipated. In addition, the older flashings should be monitored. In some cases, a deteriorated flashing can result in expensive repairs, because sections of the roofing have to be removed. As a rule of thumb, replacement of the entire roof covering may be logical if more than ten percent of the roof requires repair.
- **Repair:** Split, loose or damaged ridge caps of the roofing require repair.

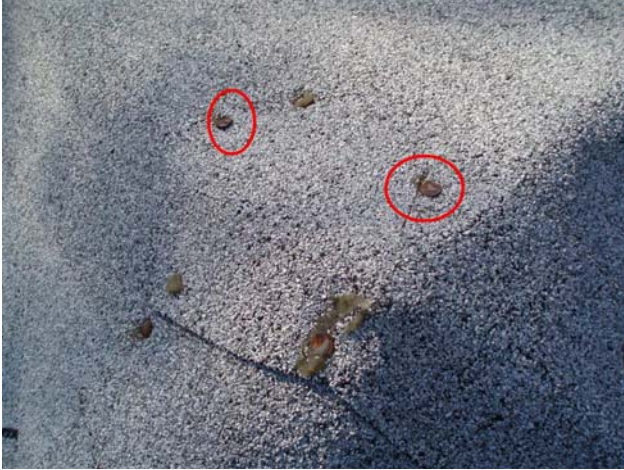
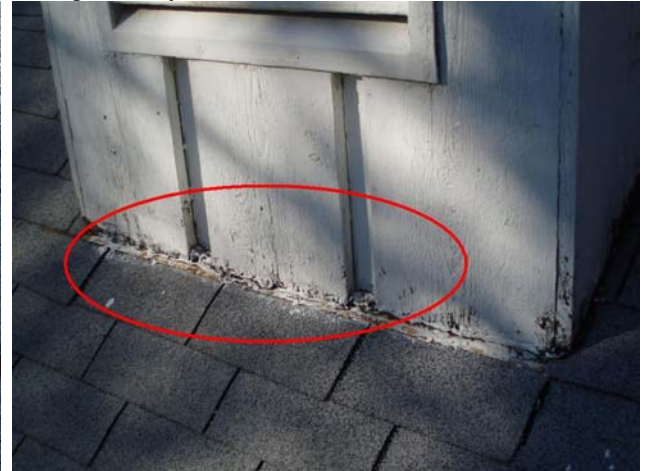
Flashings

- **Repair:** The flashing is rusting. It should be painted to extend its life.
- **Repair:** The flashing at the roof parapet vent should be caulked to avoid leaks.
- **Repair:** Nail heads are exposed at the flashing and on some shingles. They should be sealed to reduce risk of leaks.

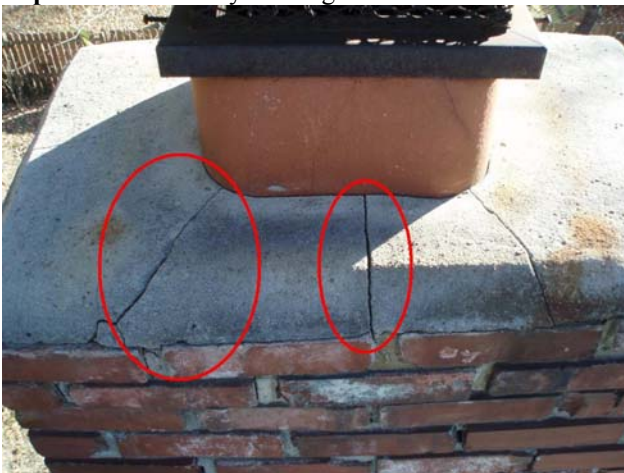
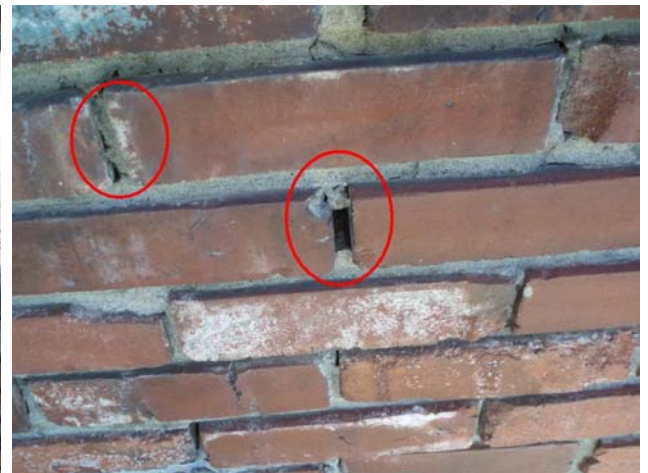
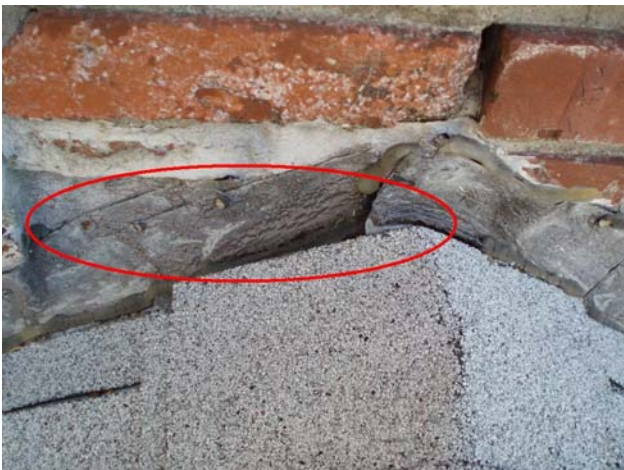
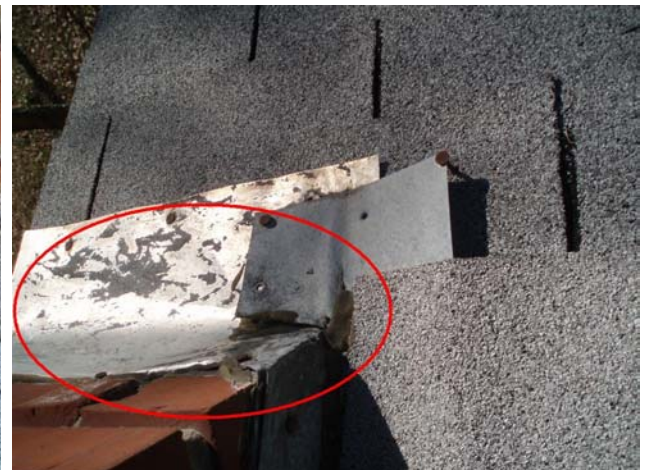
Chimneys

- **Repair:** The masonry chimney needs re-pointing (replacing the mortar between the bricks) to avoid water damage.
- **Repair:** The cap of the masonry chimney is cracked. These cracks should be sealed or caulked to prevent damage from freezing water.
- **Repair:** The chimney flashing should be caulked to avoid leaks.

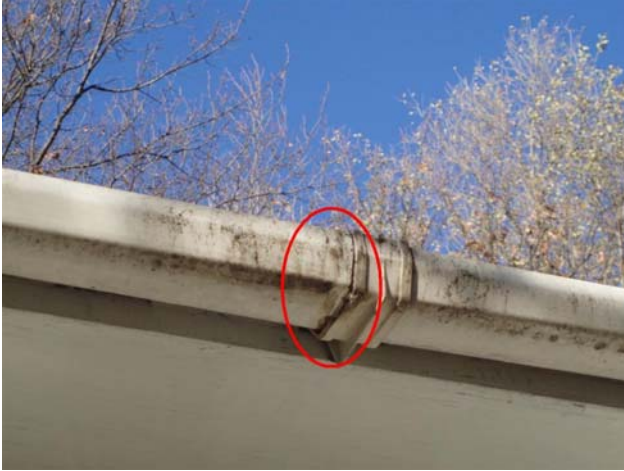
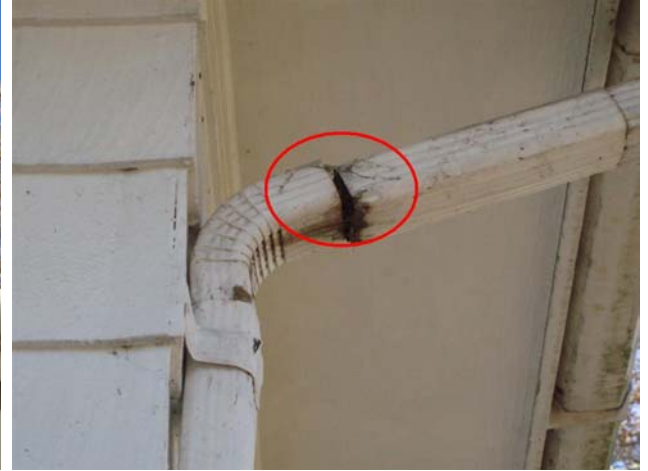
Gutters & Downspouts

- **Repair:** The gutters require cleaning to avoid spilling roof runoff around the building – a potential source of water entry or water damage.
- **Repair:** Minor leaks in the gutters should be repaired and disconnected downspouts should be repaired.

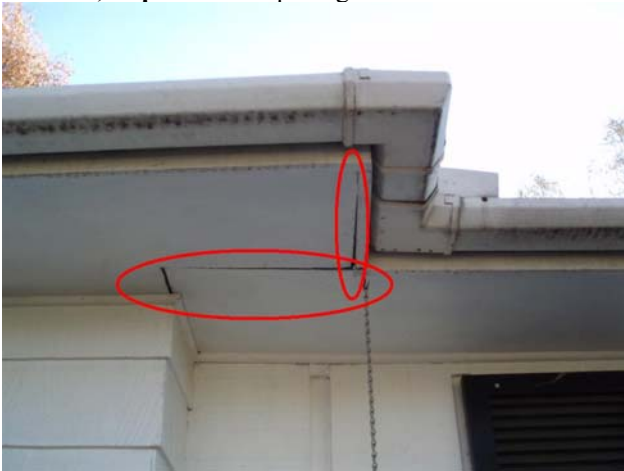
Exterior/Eaves

- **Monitor, Repair:** Seal openings at the front soffit near the garage door and at siding near garage door trim.

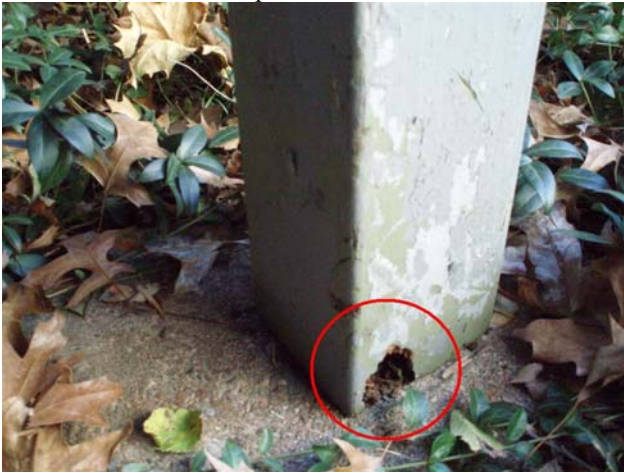
Deck

- **Repair, Safety Issue:** Nail pops in the deck floor were observed. This is a safety issue and the nails should be hammered flush.
- **Monitor:** The deck shows evidence of rot on some boards and deck posts. Replacement may eventually be desired. In the interim, localized repairs could be undertaken.

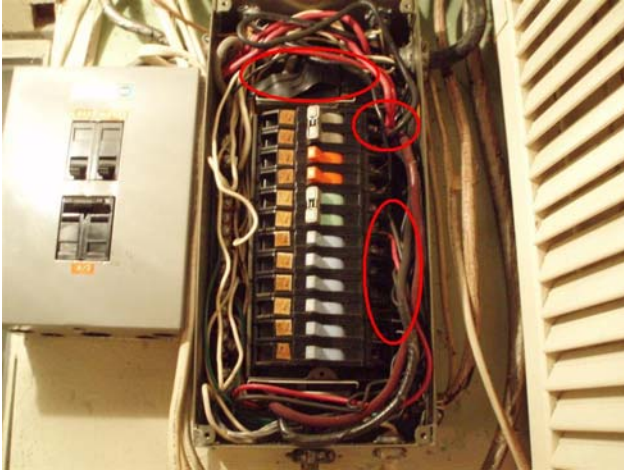
Main Panel

- **Repair:** The main distribution panel does not contain enough circuits to properly serve the home. A larger panel or an auxiliary would be desirable. Panel may be better suited at location further from water source.
- **Repair:** Circuits within the main distribution panel that are doubled up (referred to as “double taps”) should be separated. Each circuit should be served by a separate fuse or breaker.

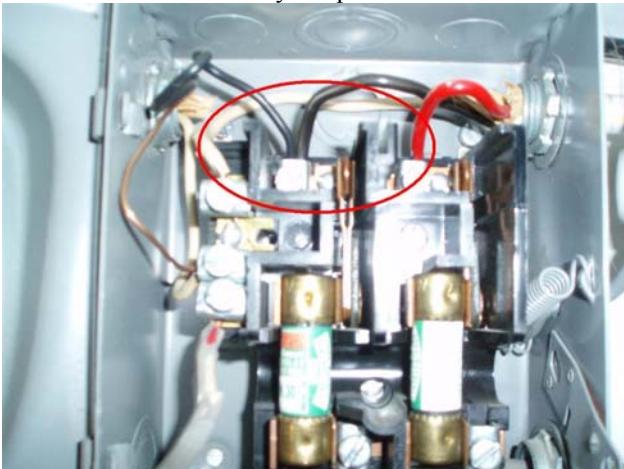
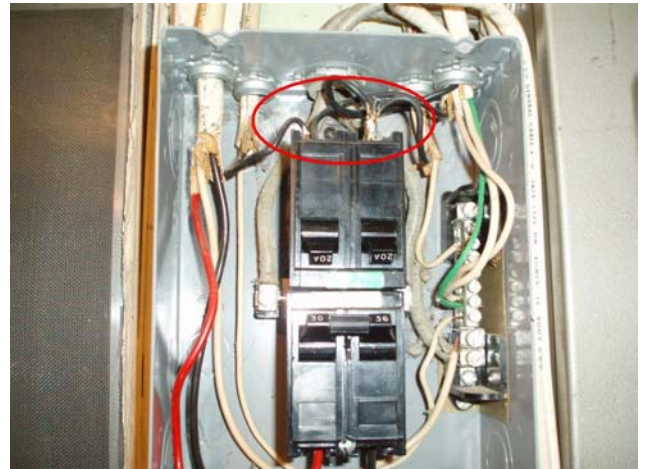
Auxiliary Panel(s)

- **Repair:** Any openings in the auxiliary panel should be covered.
- **Repair:** Circuits within the auxiliary panels that are doubled up (referred to as “double taps”) should be separated. Each circuit should be served by a separate fuse or breaker.
