**Star
Home
Inspection Services**

Home Inspection Report

705 NE Ashmont Pl, Lees Summit, MO 64064

Report Number: 04172009-1A

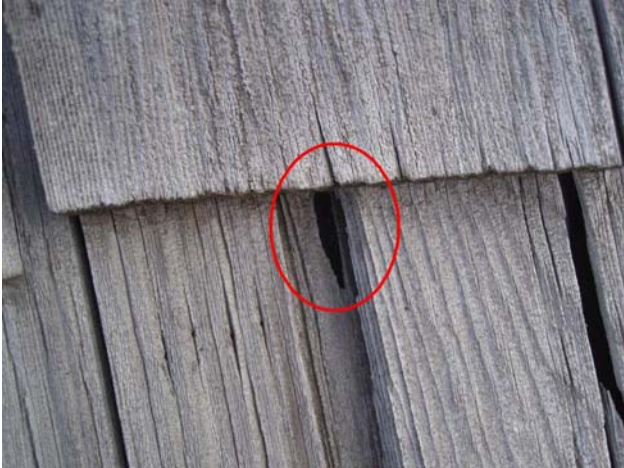
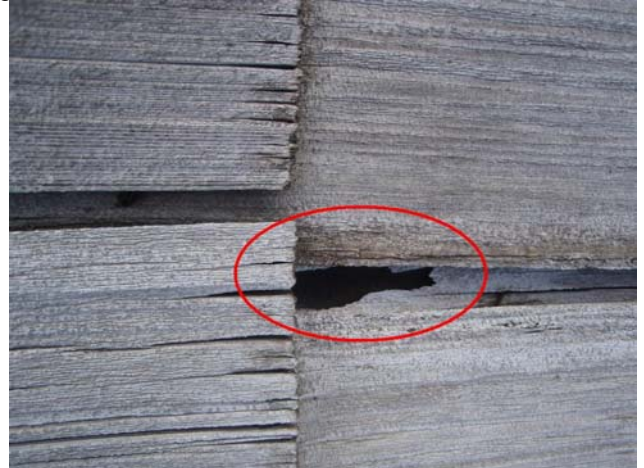
- **Repair:** Minor repairs to the roofing are needed. Exposed sheathing is visible where the roofing is damaged. Damaged or missing roofing material should be repaired. The life expectancy of wood roofs is generally 15 to 20 years. This will depend on several factors such as the quality of shingle or shake, the slope of the roof (steeper is better), the amount of exposed shingle, and the amount of sun or shade. As with all roofs, annual maintenance is needed. Cracked, curled, or displaced shingles or shakes should be repaired. As a rule of thumb, replacement of the entire roof covering may be logical if more than ten percent of the wood roof requires repair. **Repaired**

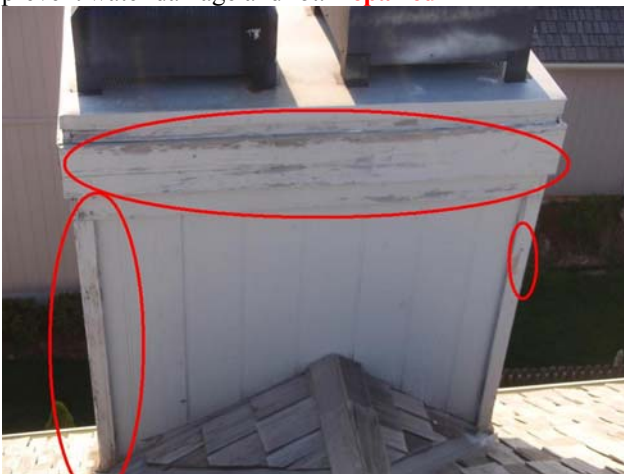
- **Repair:** The paint on the trim around the chimney siding at the back side is peeling. These areas should be painted to prevent water damage and rot. **Repaired**

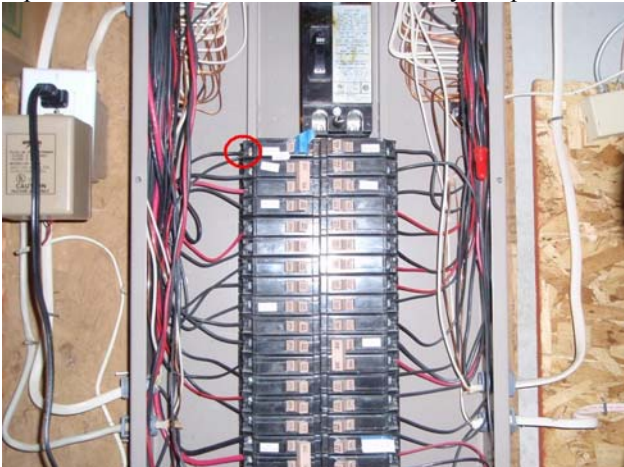
- **Repair:** Circuits within the main distribution panel that are doubled up (referred to as "double taps") should be separated. Each circuit should be served by a separate fuse or breaker. **Repaired**
