**Star  
Home  
Inspection Services**

*Home Inspection Report*

**7125 Grand Ave Kansas City, MO 64114**

**Inspection Date: 08/05/2010**

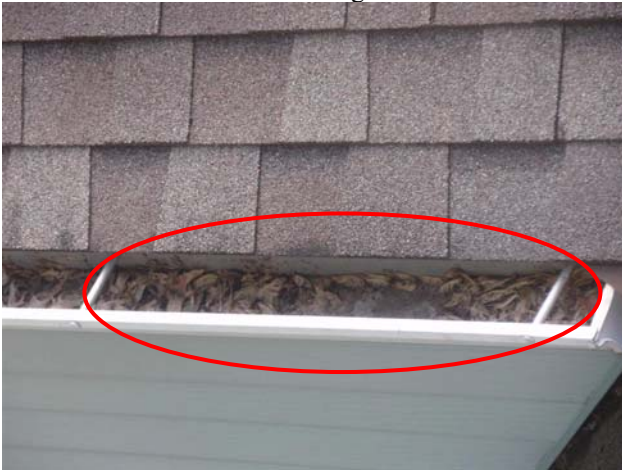
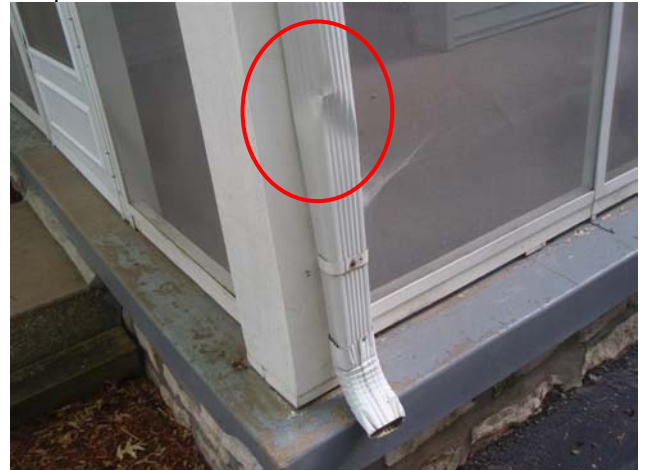
- **Repair:** The gutters require cleaning to avoid spilling roof runoff around the building – a potential source of water entry or water damage.
- **Monitor:** Minor cosmetic damage to the front southwest downspout was observed.

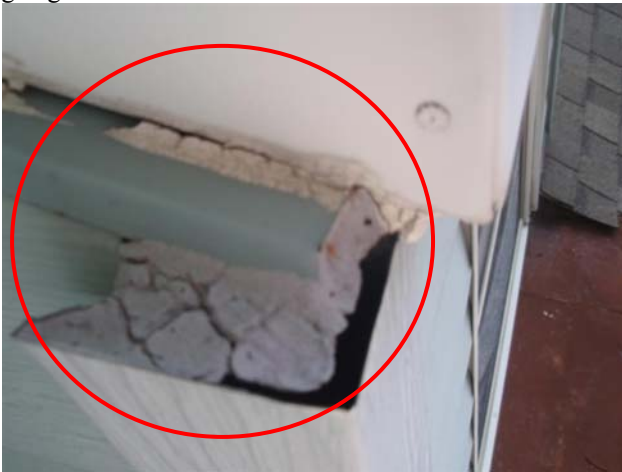
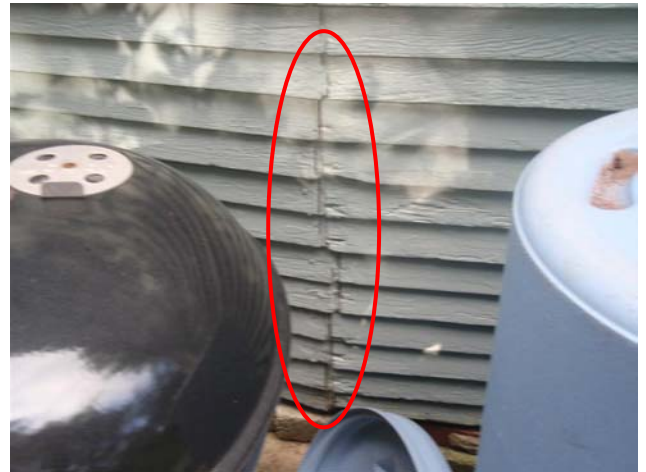
- **Repair:** Any openings in the exterior siding should be sealed. An example is at the top corners of metal siding and at the garage.

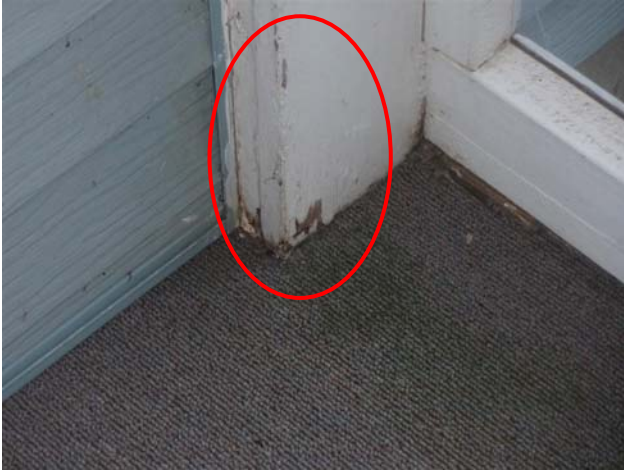
- **Repair:** Localized rot was observed in the garage siding. Following repair of the damaged areas (which should be combined with exterior painting/maintenance) proper maintenance of the siding and control of water from roof or surface runoff can avoid further damage.
- **Repair:** The paint on the trim around the siding at the front porch is peeling. These areas should be painted to prevent water damage and rot.

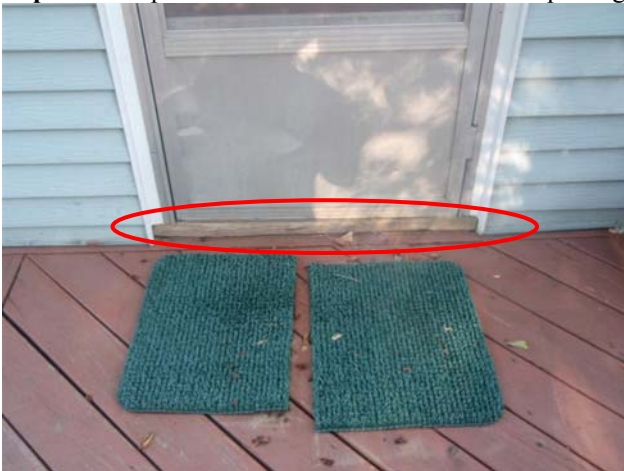
- **Repair:** The paint on the back door frame/ trim is peeling and requires painting and caulking.

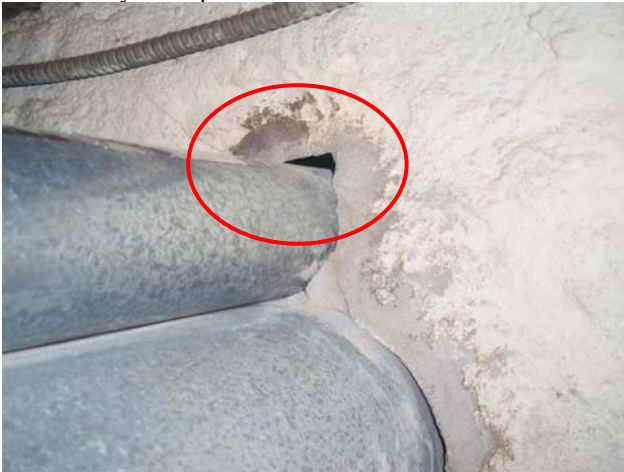
- **Monitor:** The water heater is an old unit that may be approaching the end of its useful life. It would be wise to budget for a new unit. One cannot predict with certainty when replacement will become necessary.
- **Repair:** For enhanced safety, it is recommended that the connections of the water heater and furnace venting system at the chimney be improved.

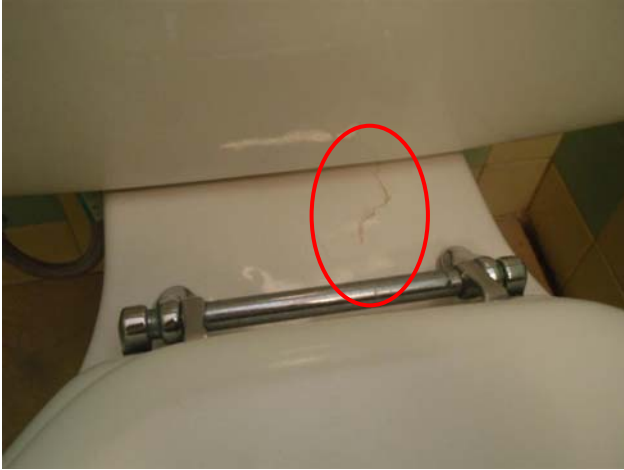
- **Repair:** The toilet in the main floor hall bath is loose. **REPAIRED**
- **Monitor, Repair:** The upstairs bath toilet is cracked.
