Star Home Inspection Services

Home Inspection Report

7129 Long Ave Shawnee, KS 66216

Inspection Date: 03/01/2010

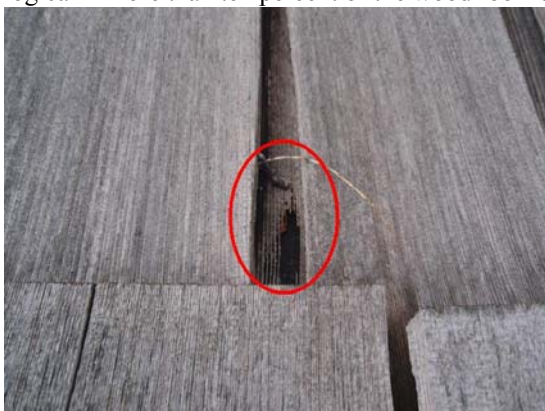
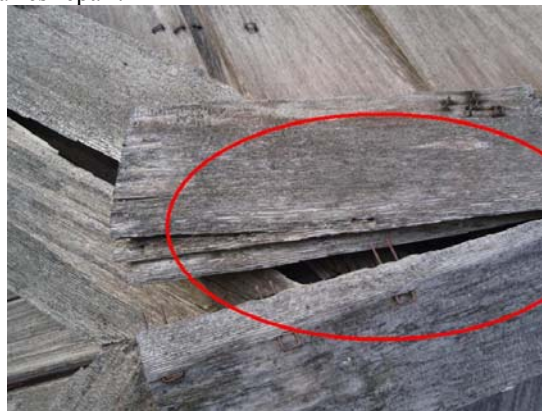
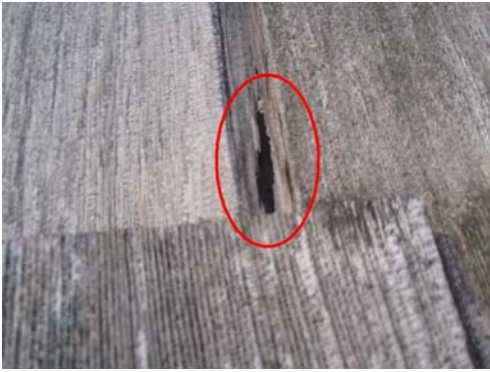
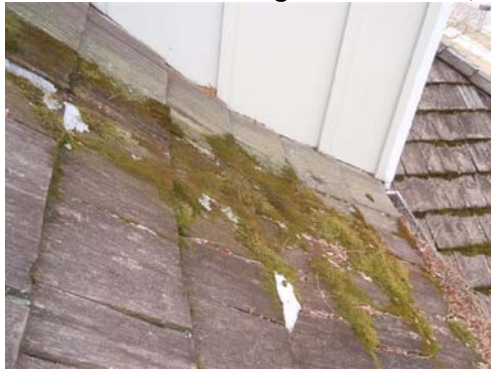
Repair: Minor repairs might be possible to extend the roof life and to defer leaks. Damaged or missing roofing material should be repaired. Split, loose or damaged ridge caps of the roofing require repair. All roof penetrations should be examined and sealed as necessary. The roofing shows evidence of moss and organic build up in shaded areas. This condition may reduce the life expectancy of the roofing. Trimming or removing trees could improve this condition. Older roofs are, by their nature, a high maintenance roof. Annual inspection and repair should be anticipated. As a rule of thumb, replacement of the entire roof covering may be logical if more than ten percent of the roof requires repair. The life expectancy of wood roofs is generally 15 to 20 years with tune-ups normally needed around the 10th year. This will depend on several factors such as the quality of shingle or shake, the slope of the roof (steeper is better), the amount of exposed shingle, and the amount of sun or shade. As with all roofs, annual maintenance is needed. Cracked, curled, or displaced shingles or shakes should be repaired. As a rule of thumb, replacement of the entire roof covering may be logical if more than ten percent of the wood roof requires repair.

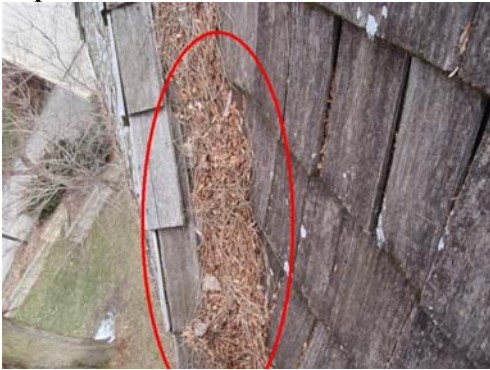
- **Improve:** Debris should be removed from the roofing to reduce risk of leaks and early roof wear.

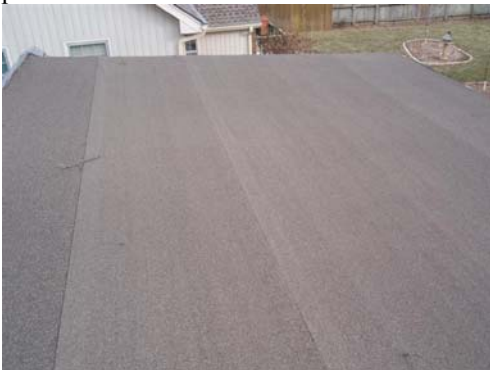
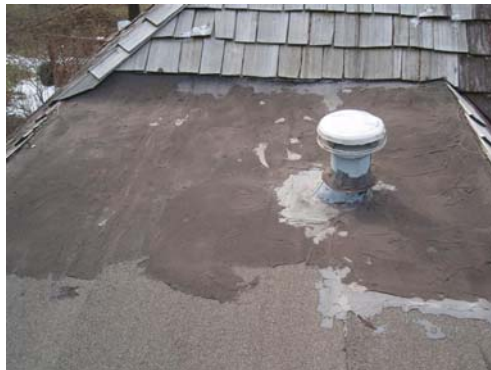
- **Note:** Rolled roofing is prone to leaking and requires close monitoring and higher than normal maintenance.
- **Monitor:** Prior repairs to the rolled roofing are evident. This would suggest that problems have been experienced in the past. This area should be monitored.

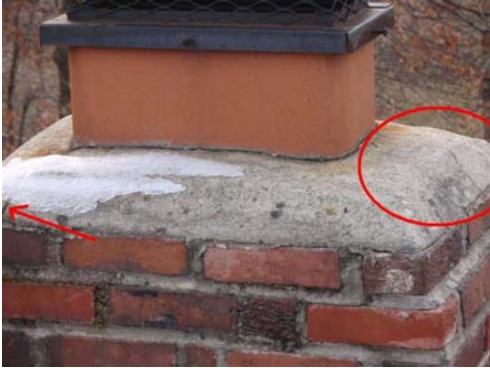
- **Monitor, Repair:** The cap of the masonry chimney is cracked. These cracks should be sealed or caulked before winter to prevent damage from freezing water.

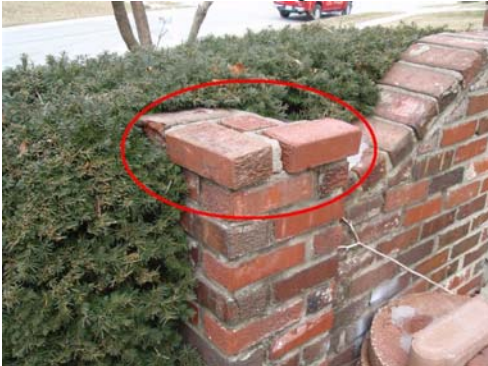
- **Repair:** Localized pointing of deteriorated mortar between the bricks of the front exterior wall extension on the corner of the house is advisable to prevent further deterioration.

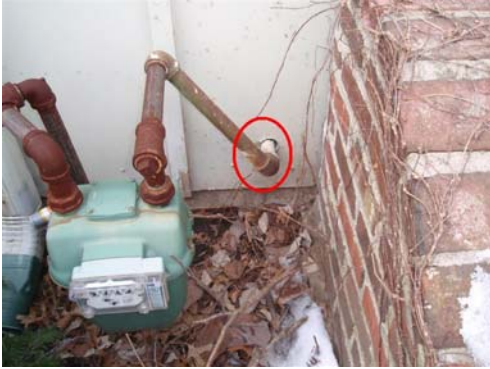
- **Repair:** Any openings in the exterior siding should be sealed. An example is where the gas line enter the house. Caulking is needed.

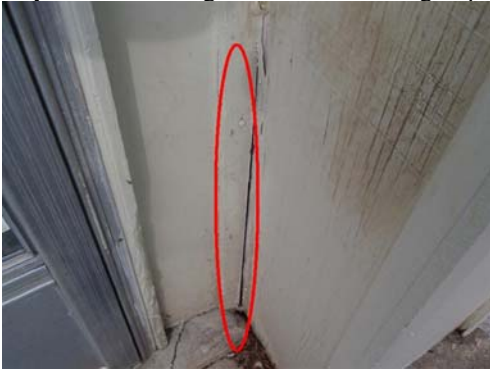
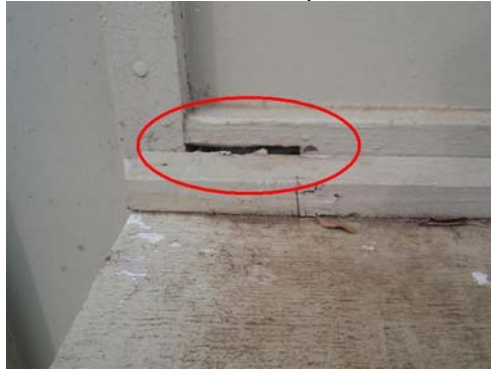
- **Repair:** Localized rot was observed in the siding. Following repair of the damaged areas (which should be combined with exterior painting/maintenance) proper maintenance of the siding and control of water from roof or surface runoff can avoid further damage.
- **Repair:** The siding trim needs caulking improvements in localized areas to prevent water damage and rot.

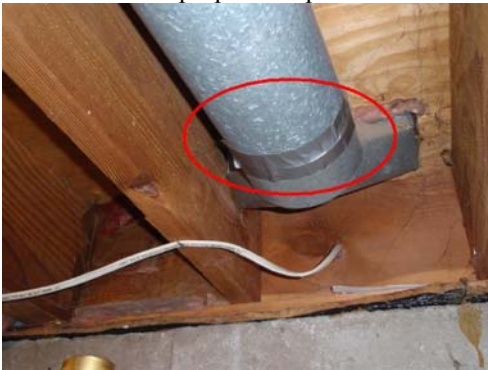
- **Monitor:** No heat supply was found in the finished basement. If this area proves to be cool, a heat supply or some form of supplemental heat should be provided.
- **Repair:** Loose fitting joints and/or openings in the ductwork should be improved. Duct tape is not the appropriate material for this purpose despite its name.

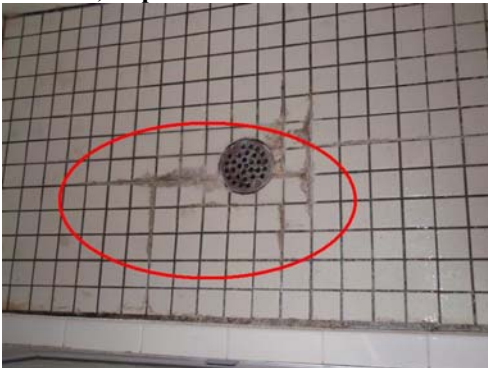
- **Monitor, Repair:** The shower stall tile floor in the master bath was observed to have grouting caulked at the tile floor.
