**Star
Home
Inspection Services**

Home Inspection Report

7212 Canterbury St Prairie Village, KS 66208

Report Number: 10082009-2A

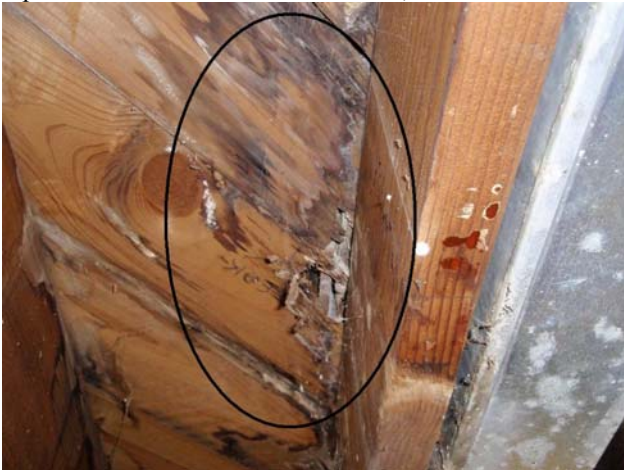
- **Monitor:** Minor unevenness was observed in the floor structure. This condition is common. It may be the result of the materials, framing design, installation methods and aging of the building. There was not evidence of need for immediate, costly repair.
- **Monitor** The subflooring shows evidence of minor water damage/rot (supporting layer of flooring atop floor joists and below finish flooring or carpeting) below the hall bath. The amount of visible damage does not appear to need immediate repair. This area should be monitored, if further deterioration and or damage is observed, repairs may be required.

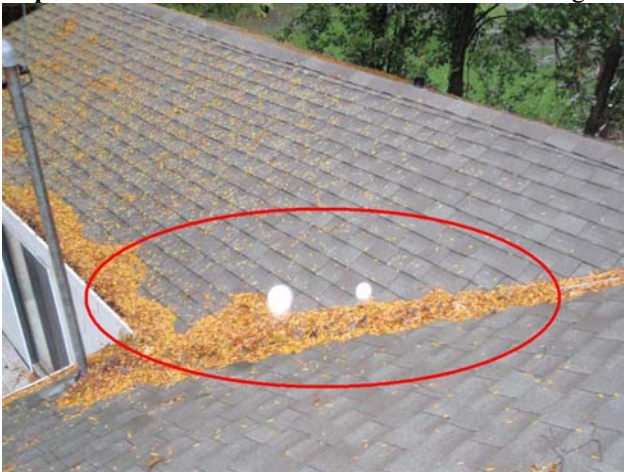
- **Improve:** Debris should be removed from the roofing to reduce risk of leaks and early roof wear.

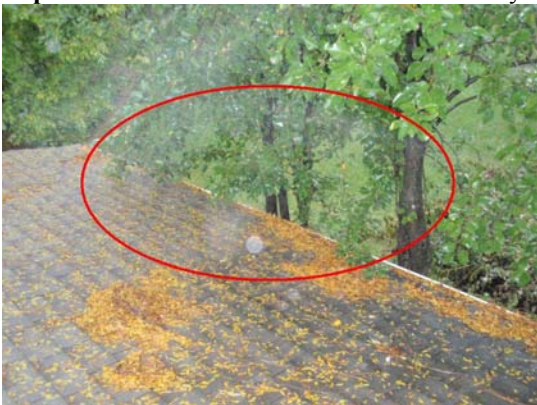
- **Repair:** Tree branches should be trimmed away from the house to avoid damage to the building.

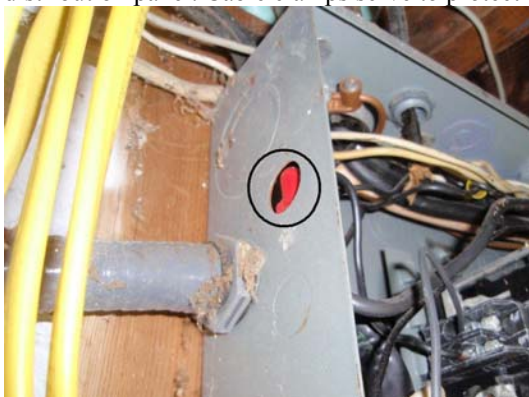
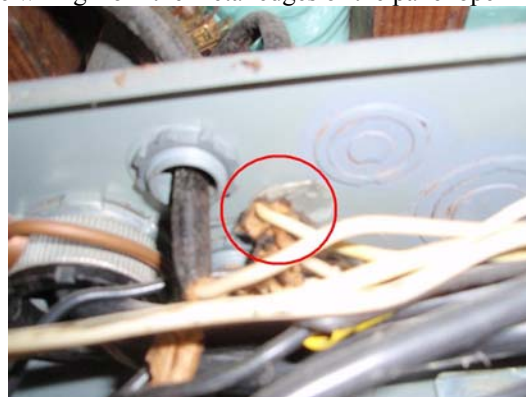
- **Repair:** Oversized breaker within the main distribution panel for the air condition should be replaced. The data plate on the unit specifies a maximum breaker size of 25 Amps and the one in the panel is 30 Amps.
- **Repair:** Any openings in the main panel should be covered.
- **Repair:** Cable clamps (sometimes referred to as bushings or grommets) are required where wiring passes into the main distribution panel. Cable clamps serve to protect the wiring from the metal edges of the panel openings.

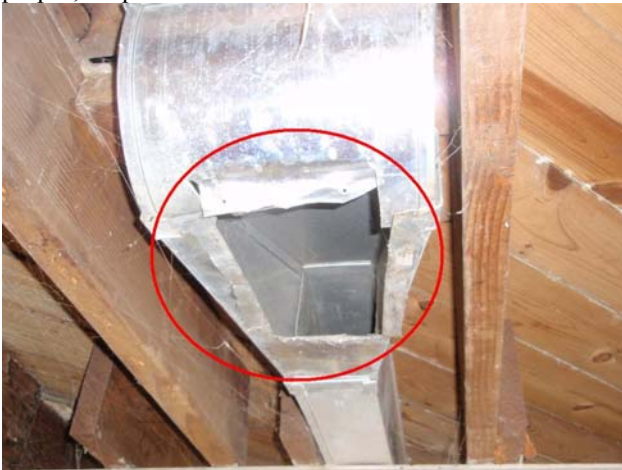
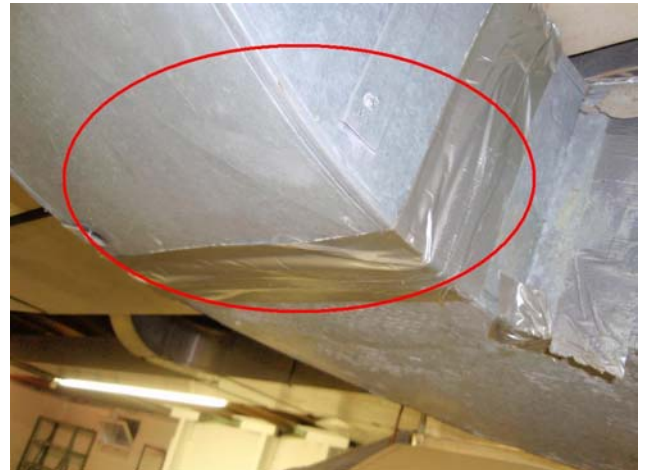
- **Repair:** Missing vent register cover at the basement ceiling should be replaced.
- **Repair:** Duct taped openings in the ductwork should be improved; duct tape is not the appropriate material for this purpose, despite its name.

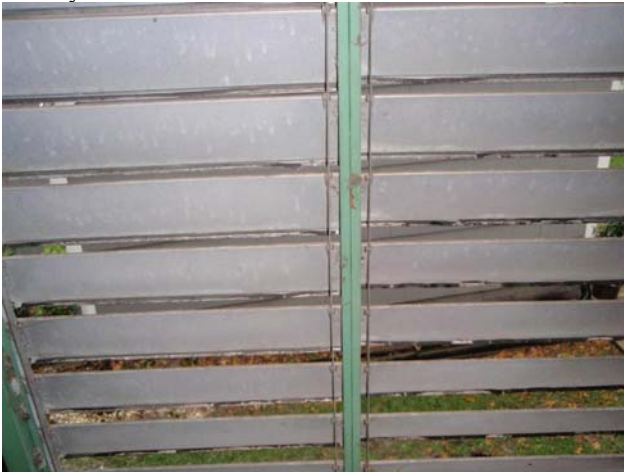
- **Repair:** Gable vent screen(s) is missing (i.e. west side). Gable vent screen(s) should be repaired to prevent vermin activity.

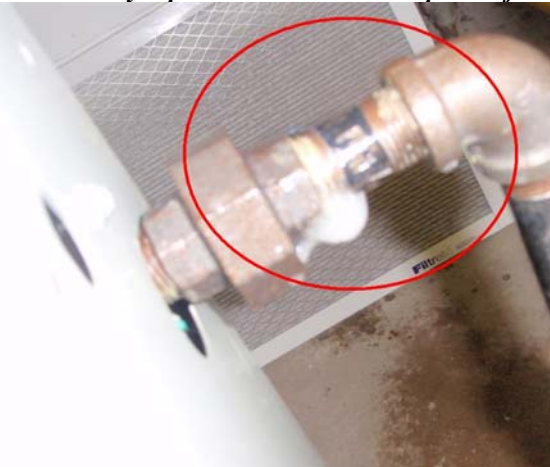
- **Repair, Safety Issue:** *A gas leak was detected (at the gas supply line beside the furnace and marked "GAS LEAK" with blue tape) with a TIF 8800 gas/carbon monoxide detector and confirmed with soapy water. This is a serious safety concern. It is recommended that the gas utility, HVAC company or plumber be engaged as soon as possible to make the necessary repairs. The current occupants of the home should also be notified.*

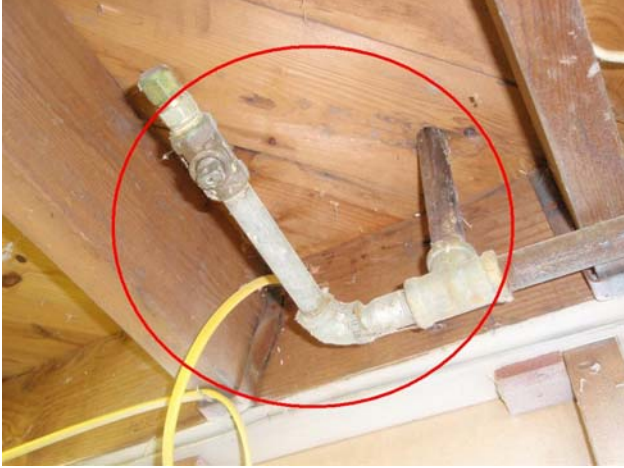
- **Monitor, Repair:** Galvanized steel pipe at the ceiling in front of the washer/dryer marked with blue tape is no longer suitable for gas piping by most gas utility companies. This should be confirmed or verified with the local gas company and if confirmed it's recommended this pipe be replaced with one of suitable material.

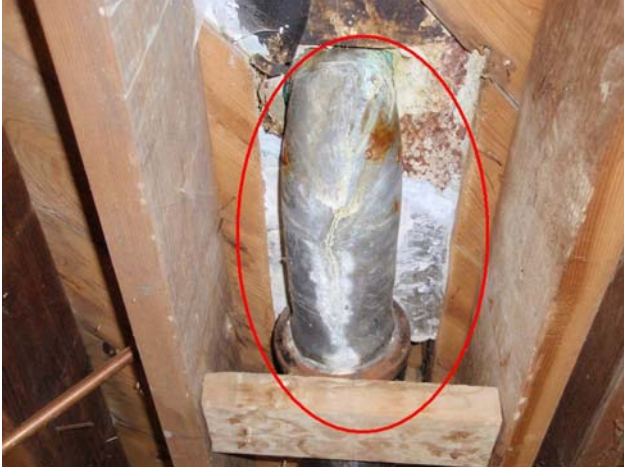
- **Monitor:** The lead waste piping below the hall bath is old and prone to leakage at the connections.
