Star Home Inspection Services

Home Inspection Report

723 Ash, Lawrence, KS 66044

Report Number: 10012009-1A

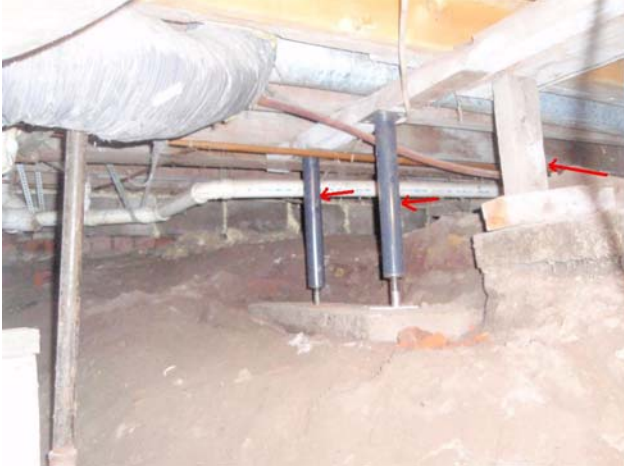
- **Monitor:** Metal and wood support posts have been added in the crawl space. These areas should be monitored. If additional movement and/or sagging are observed additional repairs may be necessary.

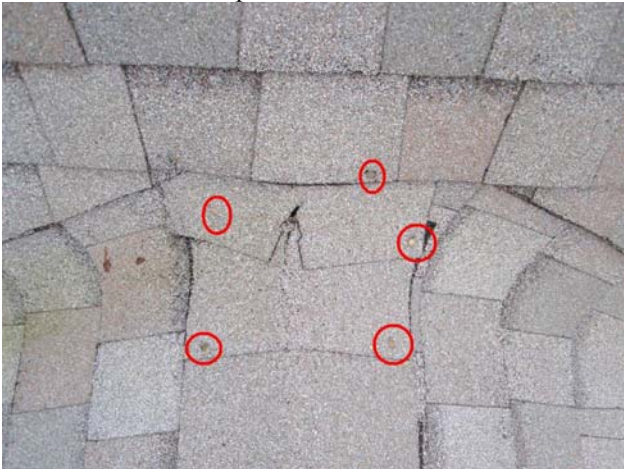
- **Repair:** Exposed nail heads were observed in the roofing shingles and/or ridge caps. All exposed nail heads should be caulked to reduce the potential of leaks. **Roofer looked at roof and said no repairs are needed.**

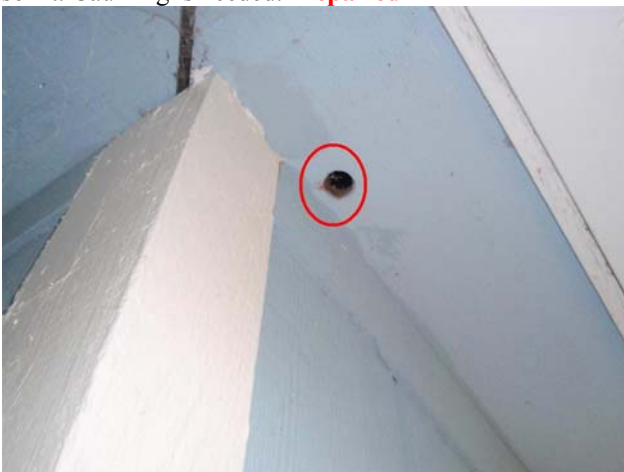
- this type of siding.
- **Repair:** Any openings in the exterior siding, soffits and fascia should be sealed. An example is at the northeast back soffit. Caulking is needed. **Repaired**

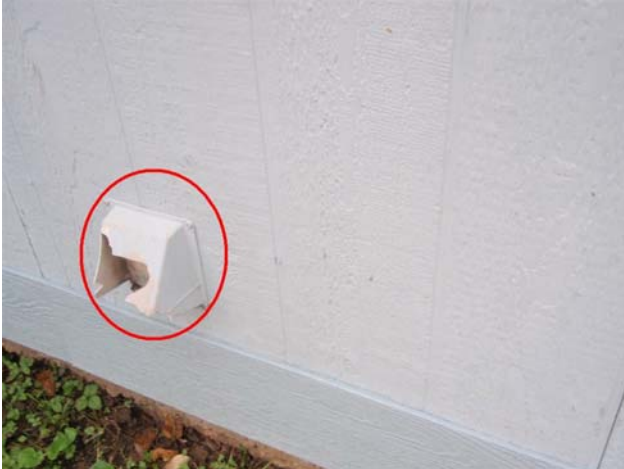
- **Improve:** Damage to the dryer vent cover was observed. **Repaired**

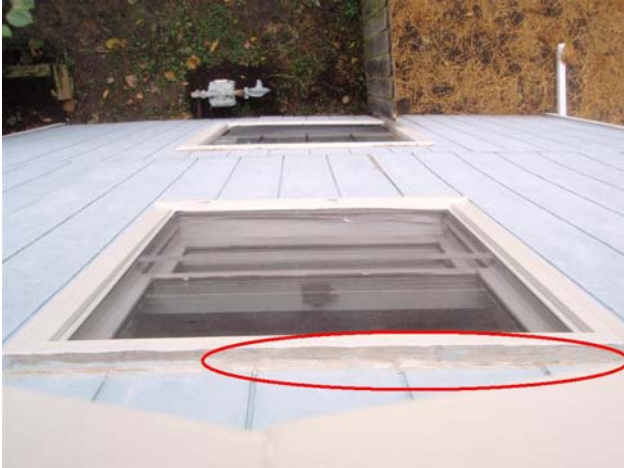
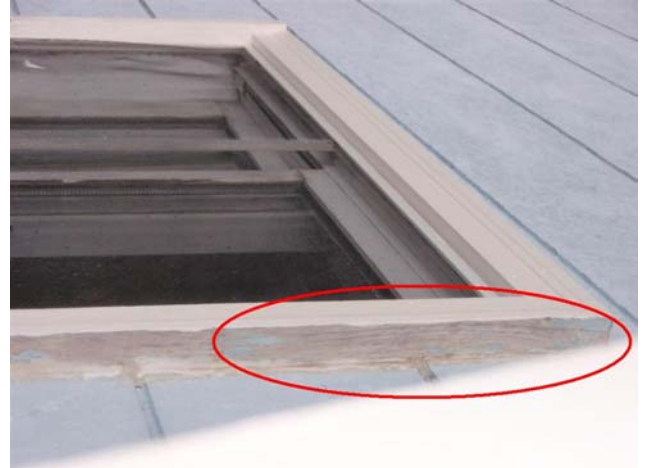
- **Repair:** The window frames require painting (top edge of trim) and caulking. **Repaired**

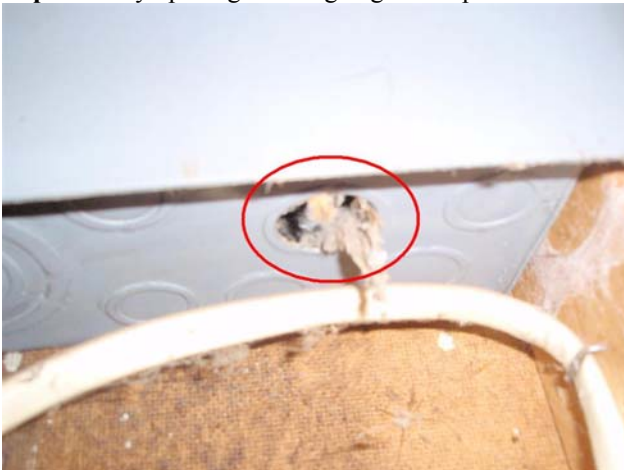
- **Repair:** Any openings in the garage main panel should be covered. **Repaired**

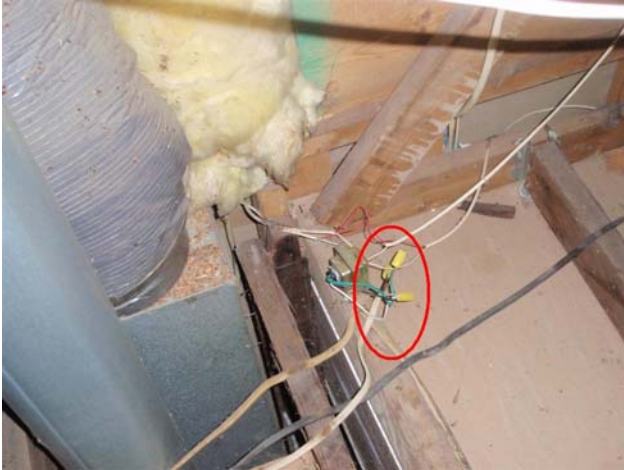
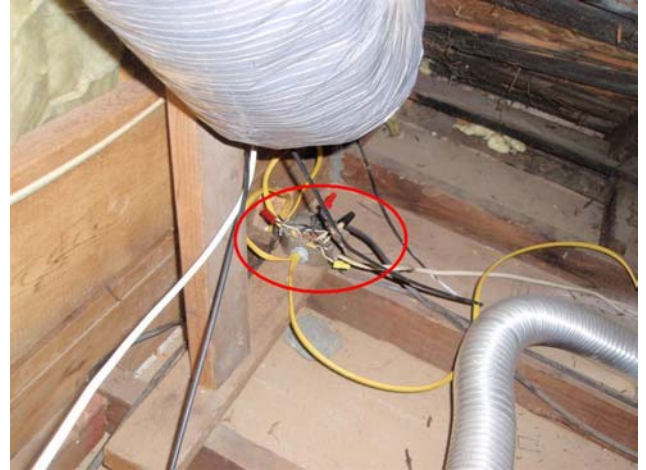
- **Repair:** Improper electrical connections in the attic should be repaired. All electrical connections should be made inside junction boxes fitted with cover plates. **Repaired**
- **Repair:** All junction boxes should be fitted with cover plates, in order to protect the wire connections (i.e. attic). **Repaired**

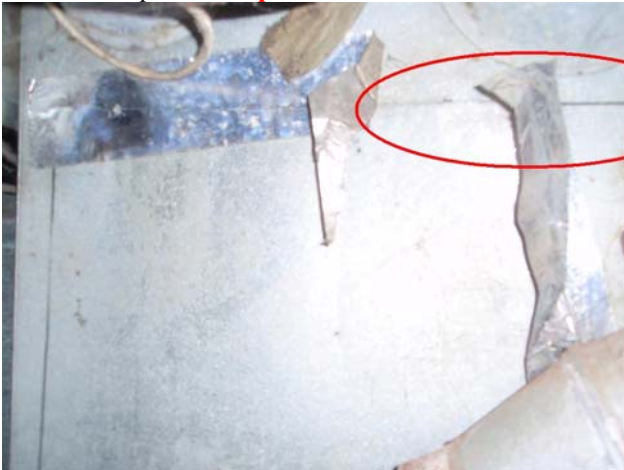
- **Repair:** Loose fitting joints and/or openings in the ductwork (i.e. near the furnace where foil tape has come loose) should be improved. **Repaired**

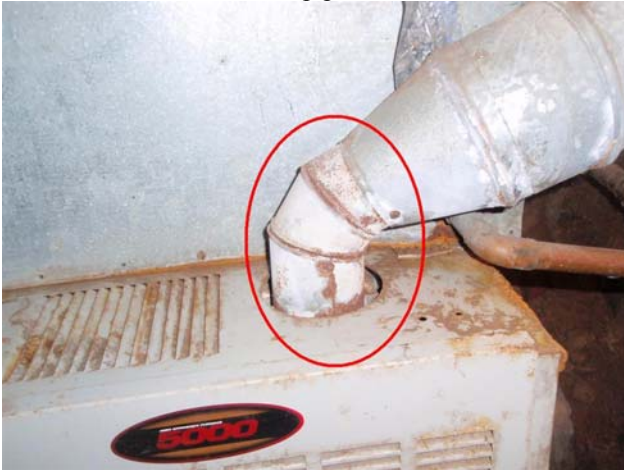
- **Monitor:** The exhaust flue pipe for the furnace shows evidence of surface rust.

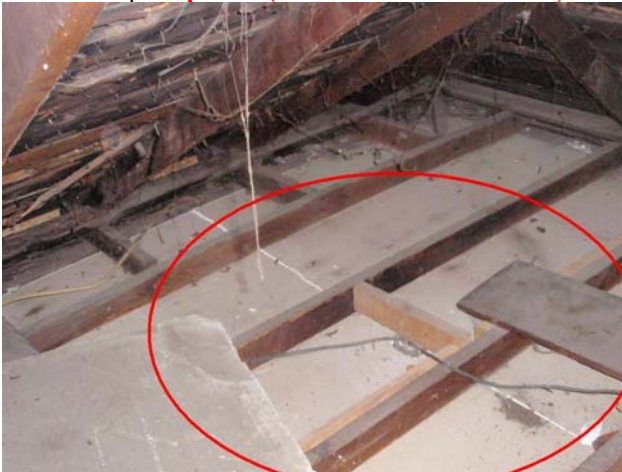
- **Repair:** Insulation improvements may be cost effective at the north end of the home, depending on the anticipated term of ownership. **Repaired (Added insulation in attic)**

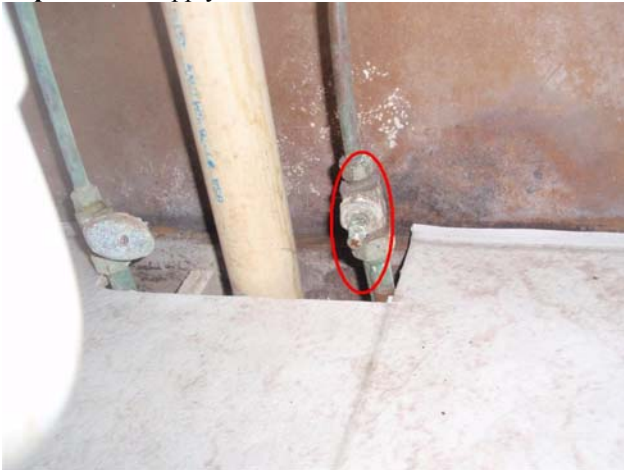
- **Improve:** A supply valve handle under the kitchen sink is missing.
