# Star Home Inspection Services

## *Home Inspection Report*

**7237 Marty, Overland Park, KS 66204**

**Report Number: 01062009-2A**

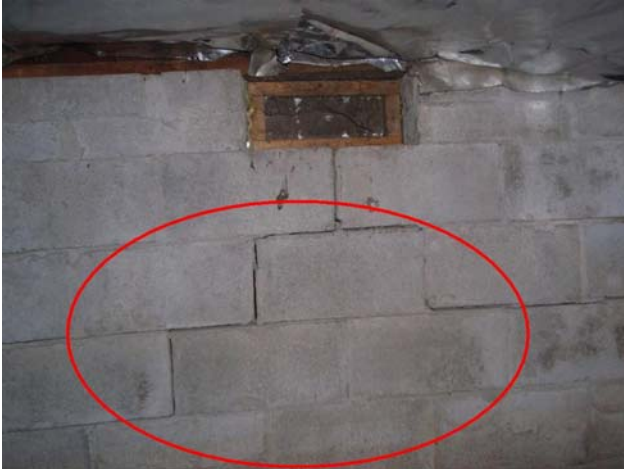
#### Foundation

- **Monitor:** Minor horizontal cracking was observed in the foundation. Cracks of this nature are usually the result of soil or frost pressure. The size, pattern, and location of these cracks does not suggest a serious problem at present. Keep water away from the foundation: review the lot and roof drainage improvements in the Exterior and Roofing sections of this report. If these cracks should worsen, repairs may be necessary.

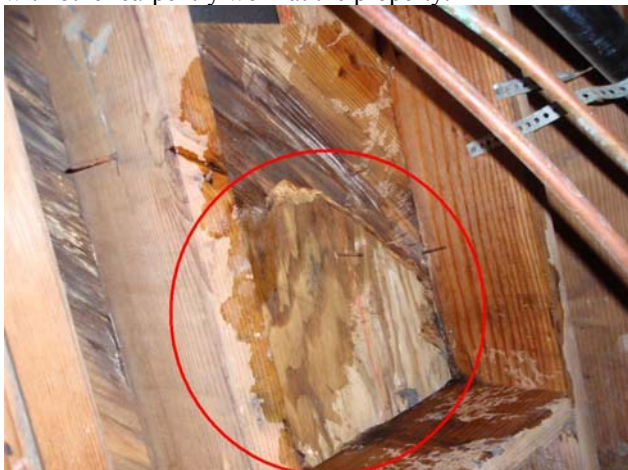
## Floors

- **Monitor:** Damaged subflooring (supporting layer of flooring atop floor joists and below finish flooring or carpeting) was found at area below hall bathroom floor. Limited areas of damage exist, this repair can be deferred until combined with other carpentry work at the property.

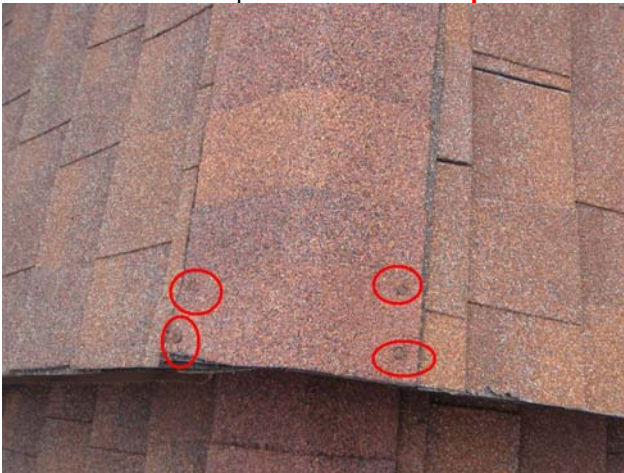
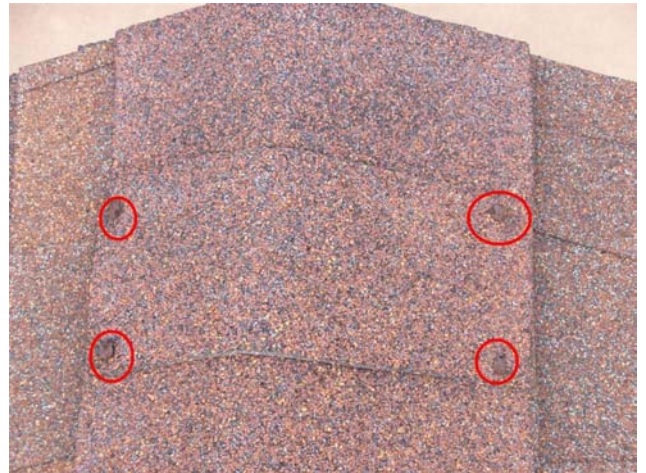
#### Sloped Roofing

- **Repair:** Exposed nail heads were observed in the roofing shingles and/or ridge caps. All exposed nail heads should be caulked to reduce the potential of leaks. **Repaired**

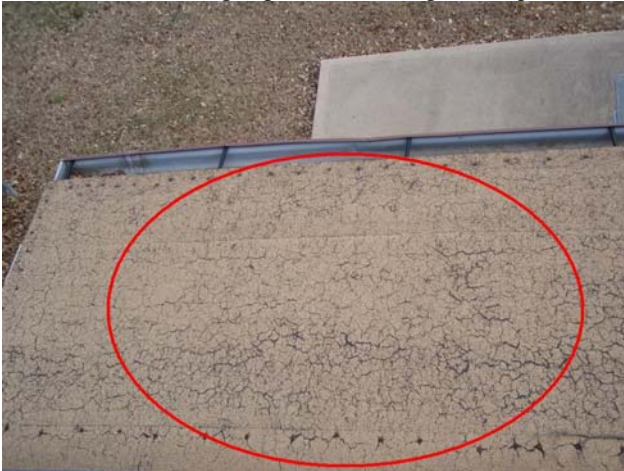
### Flat Roofing

- **Monitor, Repair:** The flat roofing over the back porch is near the end of its life. Watch for leaks and expect to replace the roof soon. All exposed nail heads should be caulked. **Repaired (Caulked)**
- **Note:** Rolled roofing is prone to leaking and requires close monitoring and higher than normal maintenance.

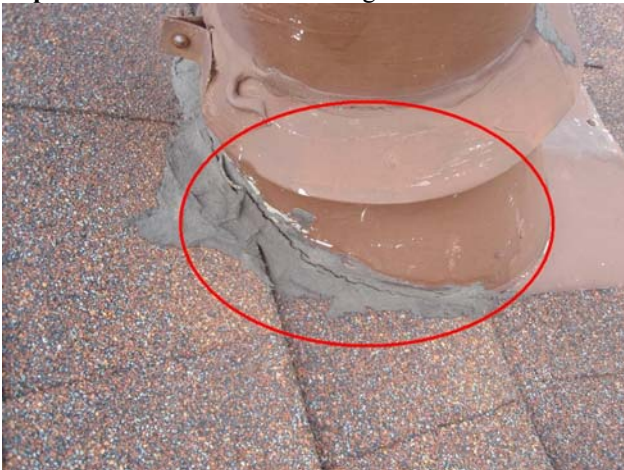
### Flashings

- **Repair:** The furnace vent flashing should be caulked to avoid leaks. **Repaired (Caulked)**

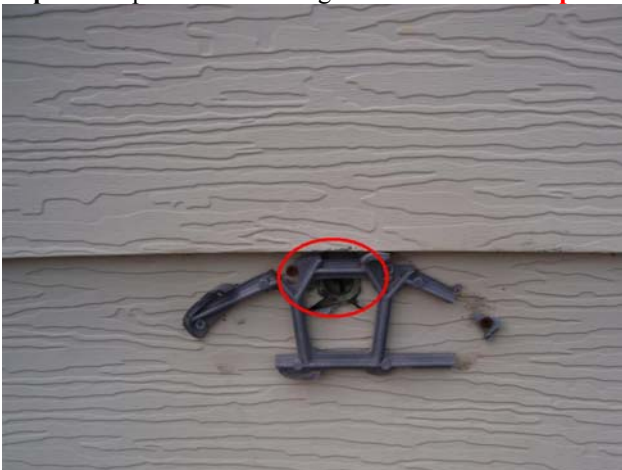
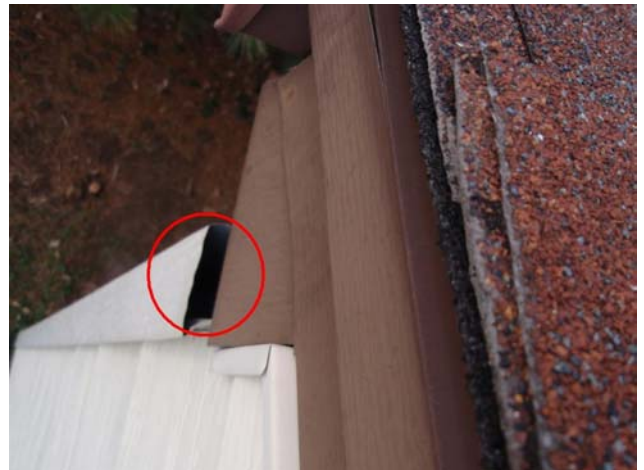
### Exterior Walls

- **Repair:** Hole in the siding where hose reel was removed should be sealed to prevent insect entry. **Repaired**
- **Repair:** Top corners of siding should be sealed. **Repaired**

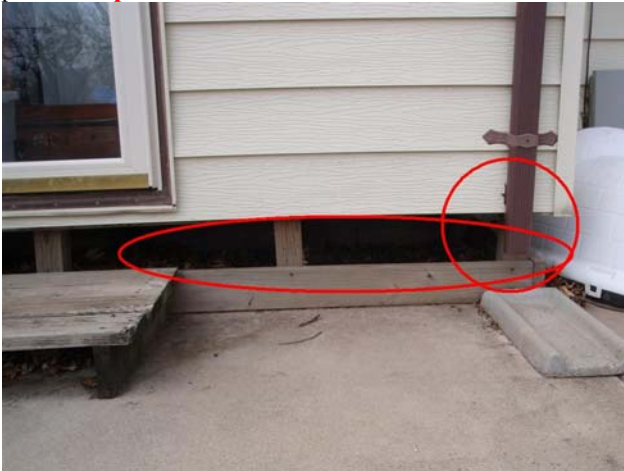
### Back step

- **Repair, Safety Issue:** Nail pops in the step floor were observed. This is a safety issue and the nails should be hammered flush.
- **Repair:** The area under back porch should be sealed to prevent debris/leaves from gathering and vermin activity under porch. **Repaired**

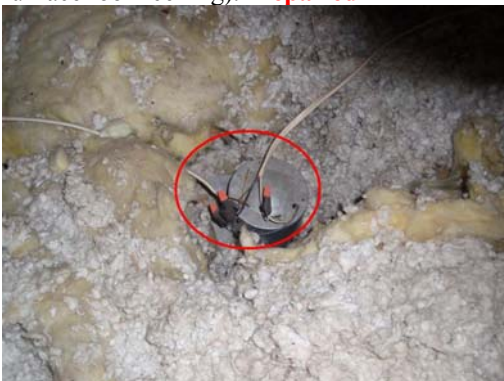
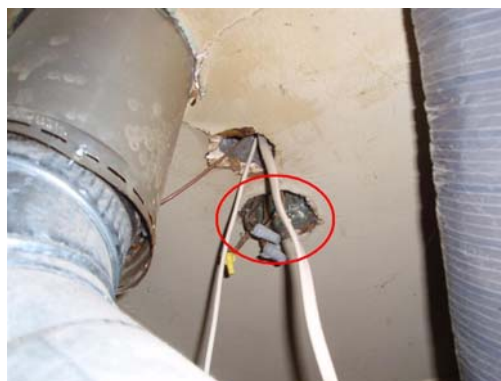
#### Distribution Wiring

- **Repair:** Improper electrical connections (example in attic) should be repaired. All electrical connections should be made inside junction boxes fitted with cover plates. **Repaired**
- **Repair:** All junction boxes should be fitted with cover plates, in order to protect the wire connections (example at furnace room ceiling). **Repaired**

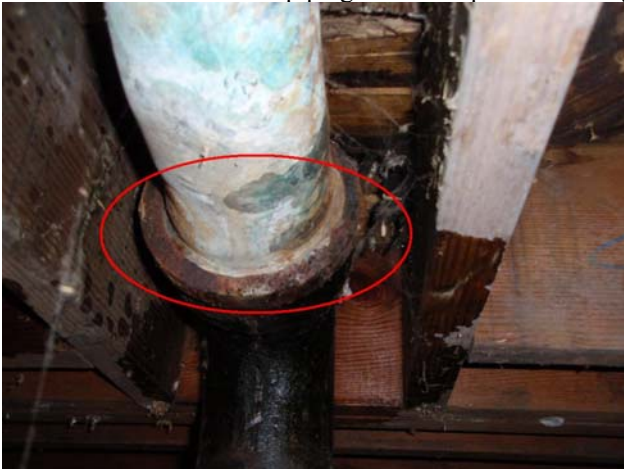
#### Waste / Vent

- **Monitor:** The lead waste piping is old and prone to leakage at the connections.
