**Star
Home
Inspection Services**

Home Inspection Report

7309 Nall Ave, Prairie Village, KS 66208

Report Number: 02022009-1A

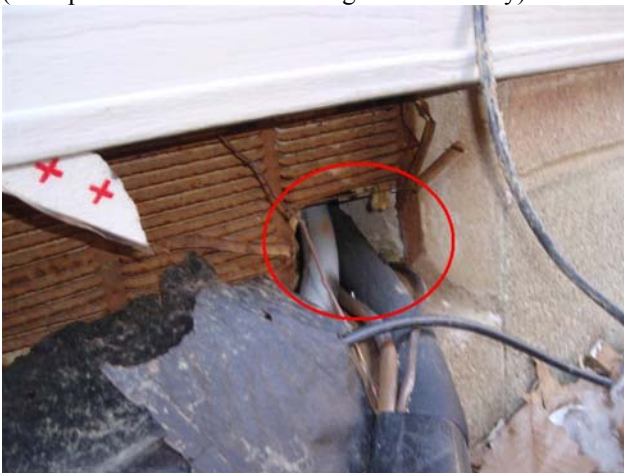
- **Improve:** All wood debris and/or trash should be removed from the crawl space. Organic debris around a property increases risk of insect or rot damage.
- **Improve:** All potential vermin entry points to the crawl space should be sealed to reduce risk of pest activity or damage (example at air conditioner refrigerant line entry).

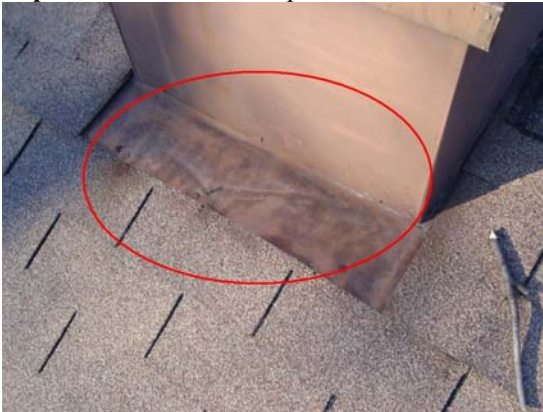
- **Repair:** The furnace vent flashing is loose and should be re-secured to avoid leaks.
- **Repair:** Nail heads are exposed at the furnace vent flashing. They should be sealed to reduce risk of leaks.

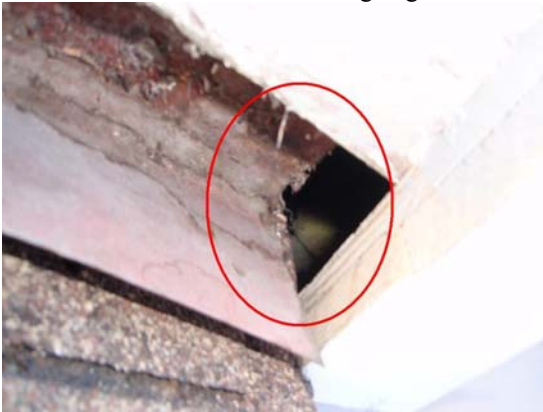
- **Monitor:** The skylight flashing should be carefully monitored. Skylight flashings are extremely vulnerable to leakage.
- **Repair:** The opening at eave where roof steps up from garage to main portion of the house should be sealed at corner eave area southeast corner above garage overhead door.

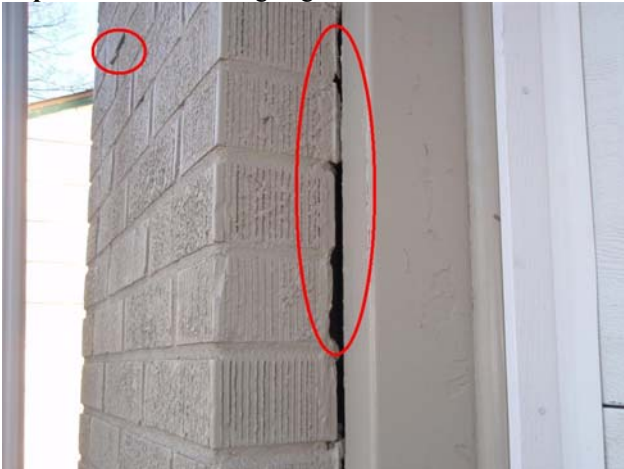
- **Improve:** Localized pointing of deteriorated mortar between the bricks of the exterior walls is advisable to prevent further deterioration (example near garage overhead door).
- **Repair:** The overhead garage door trim should be caulked/sealed where trim meets brick veneer siding.

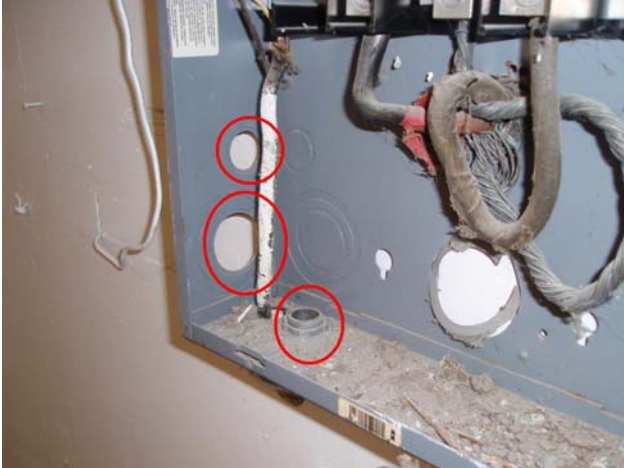
- **Repair:** Any openings in the main panel should be covered.

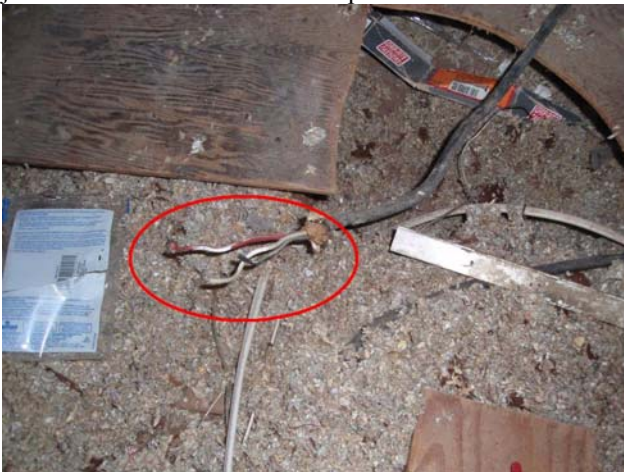
- **Repair:** Extension cords should not be used as permanent wiring. This wiring in the garage should be removed and replaced with permanent wiring and an outlet(s).
- **Repair:** Improper electrical connections in the attic should be repaired. All electrical connections should be made inside junction boxes fitted with cover plates.

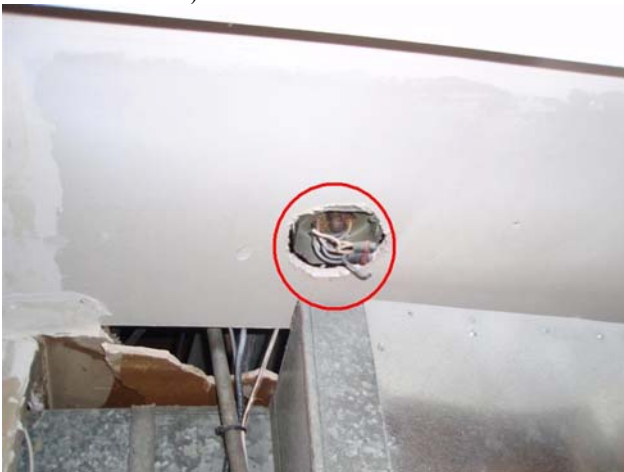
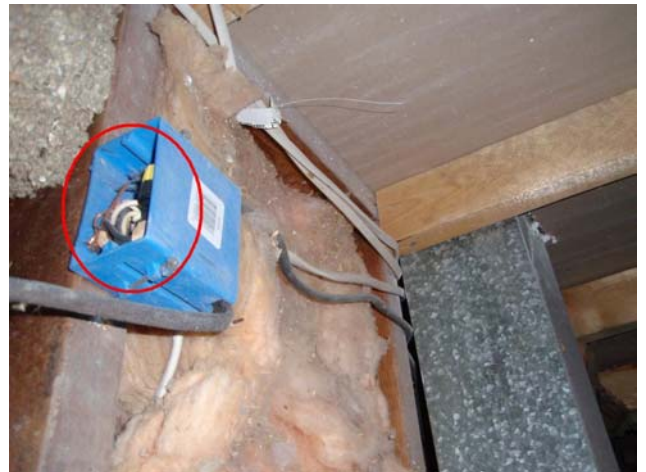
- **Repair:** All junction boxes should be fitted with cover plates, in order to protect the wire connections (examples in attic and furnace room).

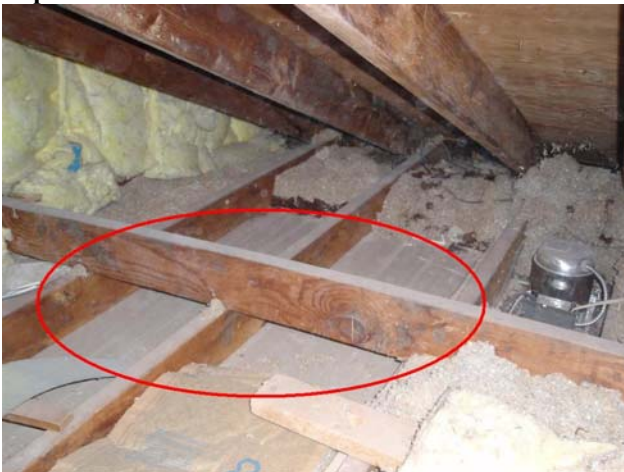
- **Repair:** Insulation should be evened out.

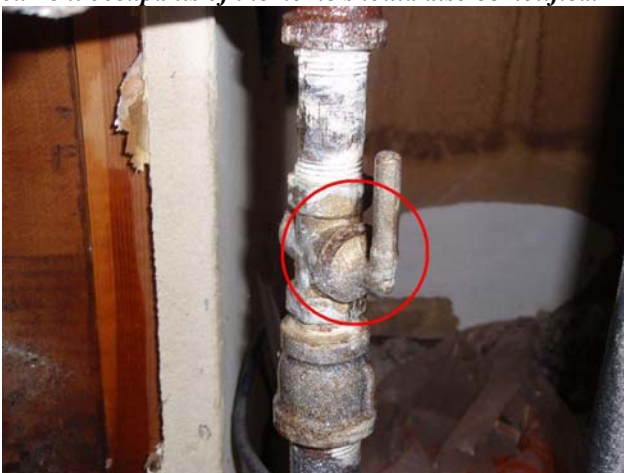
- **Repair, Safety Issue:** *A gas leak was detected in the furnace room (marked with blue tape) with a TIF 8800 gas/carbon monoxide detector and confirmed with soapy water. This is a serious safety concern. It is recommended that the gas utility, HVAC company or plumber be engaged as soon as possible to make the necessary repairs. The current occupants of the home should also be notified.*

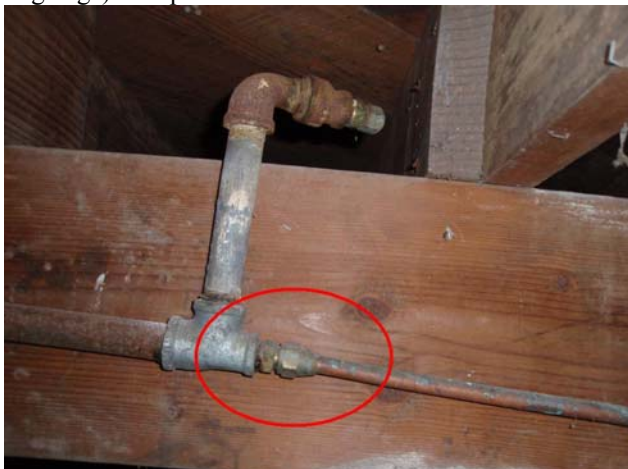
- **Repair:** Copper tubing is no longer suitable for gas piping. It's recommended this pipe servicing the dryer connection (in garage) be replaced with one of suitable material.
