**Star
Home
Inspection Services**

Home Inspection Report

7315 Marty, Overland Park, KS 66204

Inspection Date: 1/7/2009

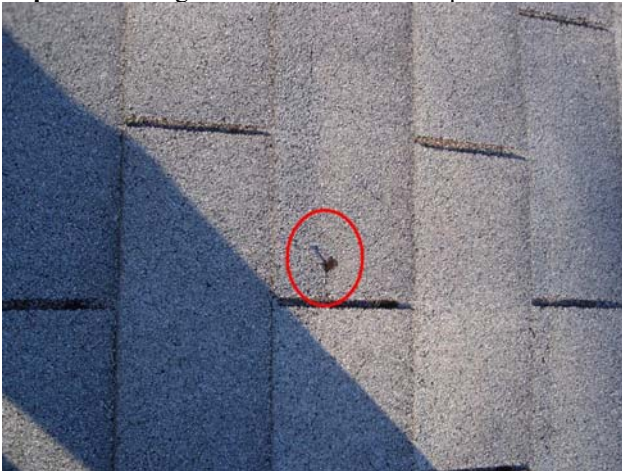
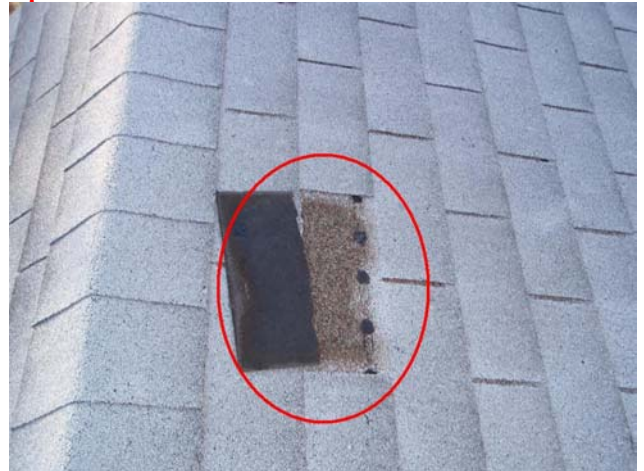
- **Repair:** Exposed nail head was observed in the roofing shingles. All exposed nail heads should be caulked to reduce the potential of leaks. **Repaired**
- **Repair:** Missing tabs were observed. Repairs are needed. **Repaired**

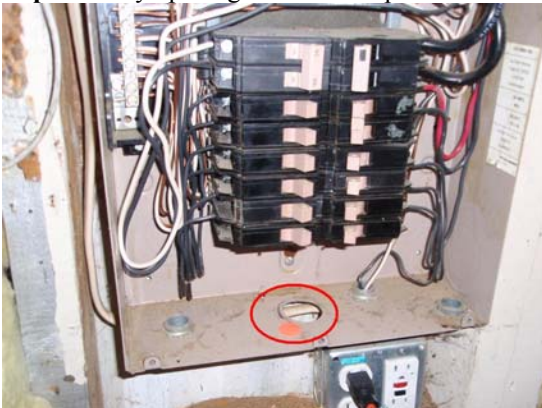
- **Repair:** Any openings in the main panel should be covered. **Repaired**

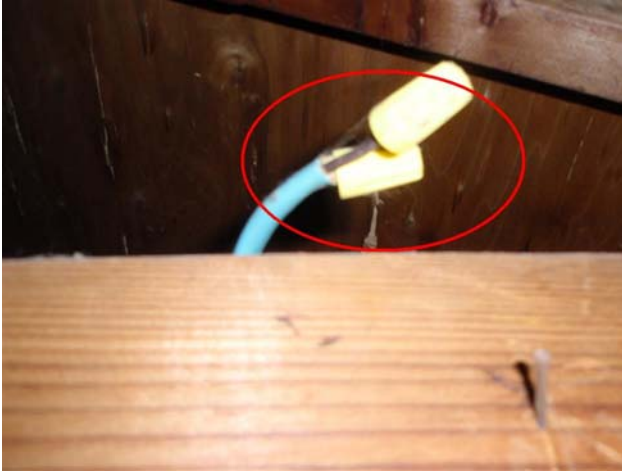
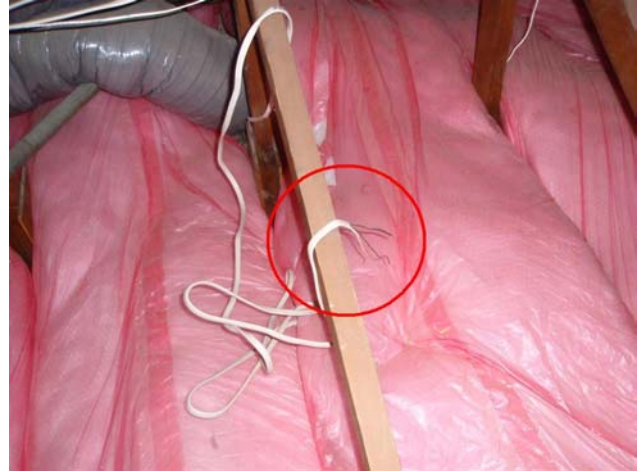
- **Repair:** Improper electrical connections should be repaired (examples at garage ceiling and in attic). All electrical connections should be made inside junction boxes fitted with cover plates. **Repaired**

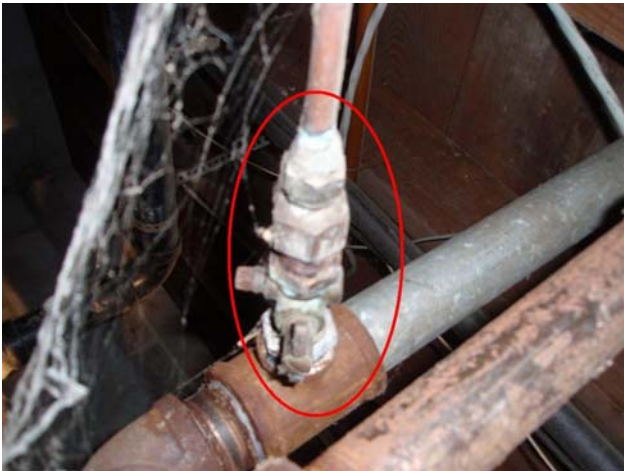
- **Repair:** Copper tubing is no longer suitable for gas piping. It's recommended this pipe in the crawl space servicing the gas range be replaced with one of suitable material. **Copper gas piping will be replaced with suitable material week of 0202/09**

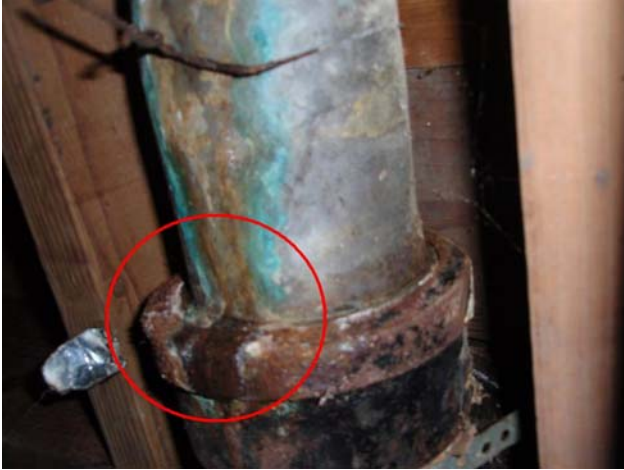
- **Repair:** The lead waste piping is leaking. **Caulked**
