# Star Home Inspection Services

## *Home Inspection Report*

**7427 Holmes Rd Kansas City, MO 64131**

**Report Number: 01262010-1A**

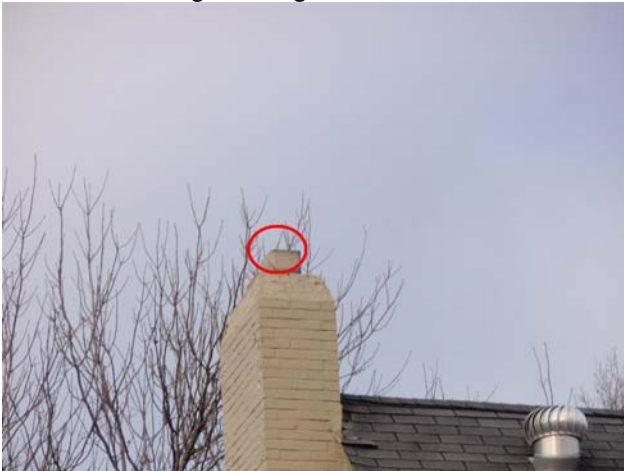
- **Repair:** A rain cap and vermin screen should be installed on the masonry chimney and the chimney flue should be checked for damage. Damaged flues can be unsafe.

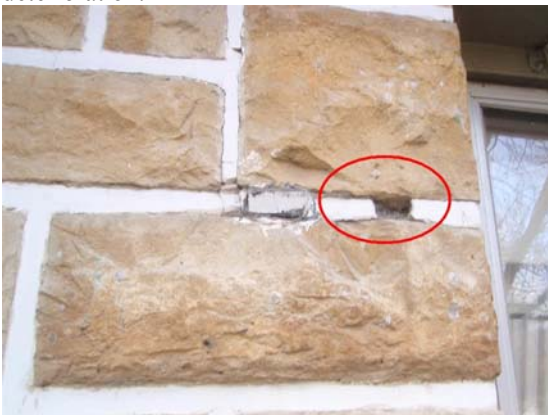
- **Repair:** Localized pointing of deteriorated mortar between the stones of the exterior walls is advisable to prevent further deterioration.

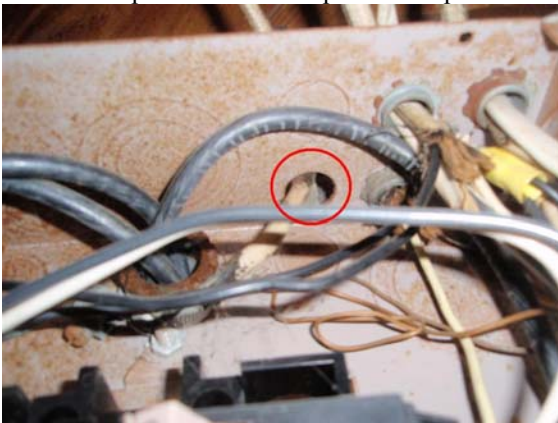
- **Monitor, Repair, Safety Issue:** The main distribution panel is in close proximity to the basement shower.
- **Repair:** Oversized breaker within the main distribution panel for the air condition should be replaced. The data plate on the unit specifies a maximum breaker size of 35 Amps and the one in the panel is 50 Amps.
- **Repair:** Cable clamps (sometimes referred to as bushings or grommets) are required where wiring passes into the main distribution panel. Cable clamps serve to protect the wiring from the metal edges of the panel openings.

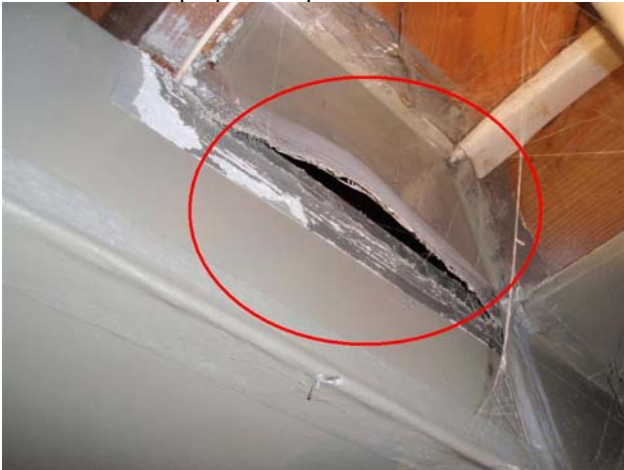
- **Repair:** Loose fitting joints and/or openings in the ductwork should be improved. Duct tape is not the appropriate material for this purpose despite its name.

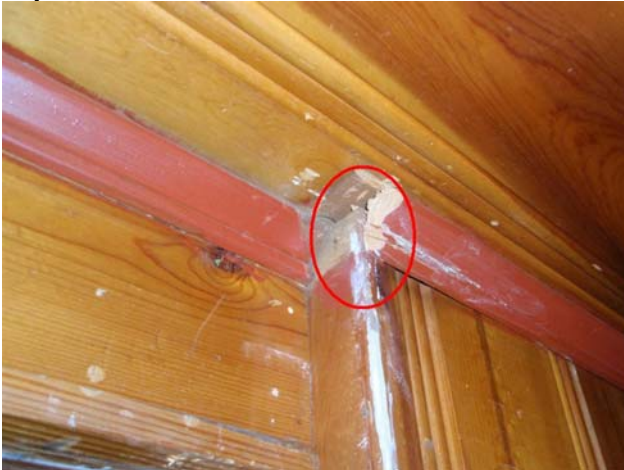
- **Monitor, Repair:** The vinyl flooring in the basement, kitchen and dining area is damaged
- **Repair:** The installation of the trim at the corner of the finished basement ceiling is incomplete.
