# Star Home Inspection Services

## *Home Inspection Report*

**7770 Chez La Terre Dr, Smithville, MO 64089**

**Report Number: 10272008-2A**

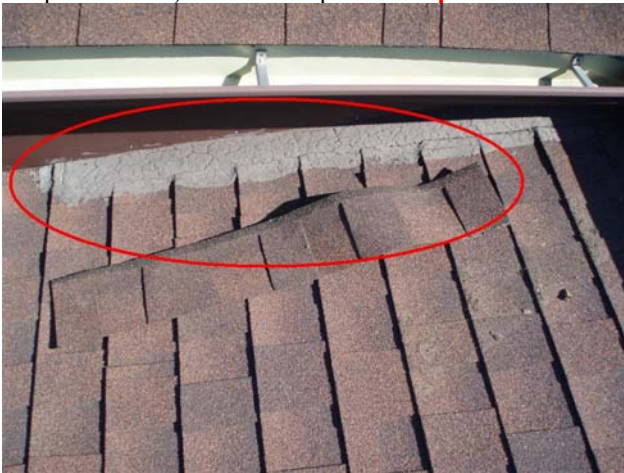
- **Repair:** Minor repairs to the roofing are needed. Damaged or missing roofing material (sunroom roof strip of roofing has pulled loose) should be repaired. **Repaired**

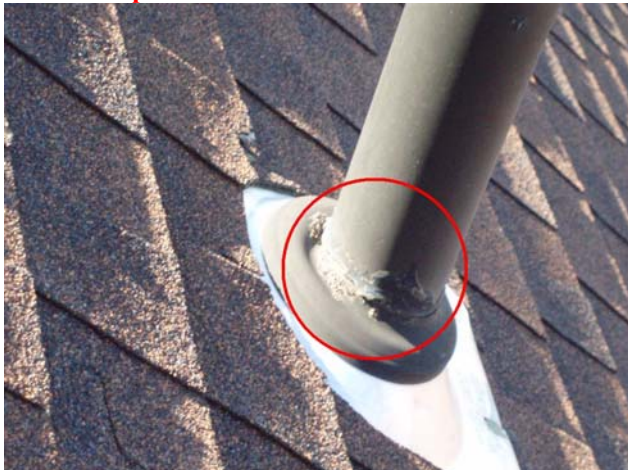
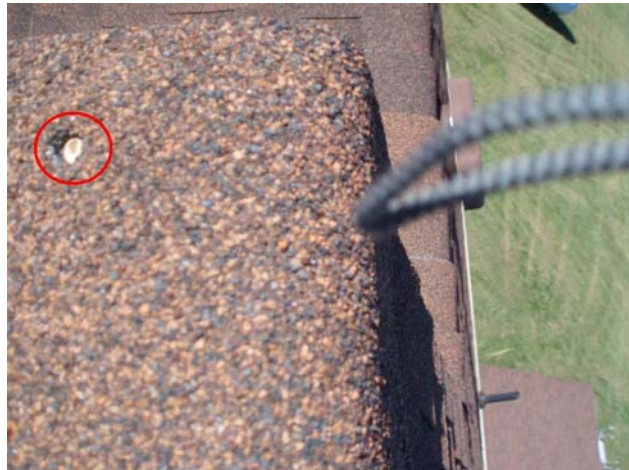
- **Monitor:** The plumbing vent boot has been previously repaired (caulked). This area should be monitored. **Repaired**
- **Repair:** Nail heads are exposed at the roofing at west ridge where roof steps down. They should be sealed to reduce risk of leaks. **Repaired**

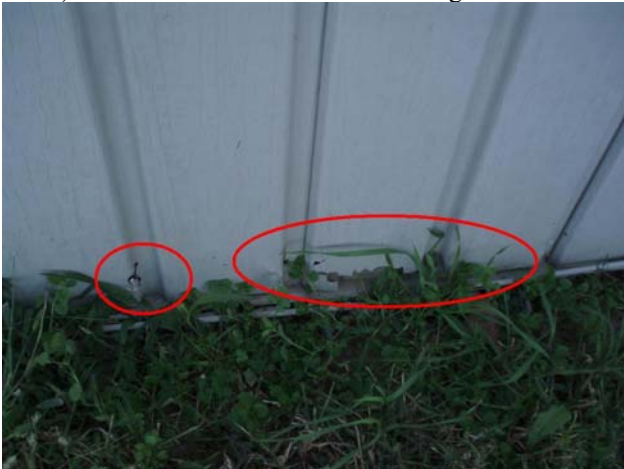
- **Monitor, Repair:** Localized damage of the vinyl exterior walls should be repaired (minor area near back sunroom noted). There is extra risk of hidden damage in such areas.

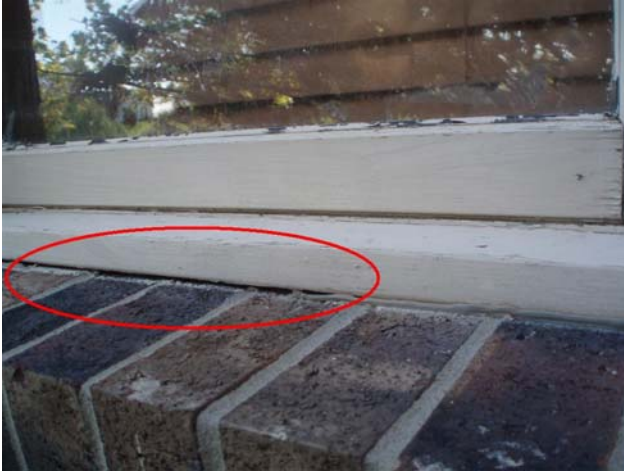
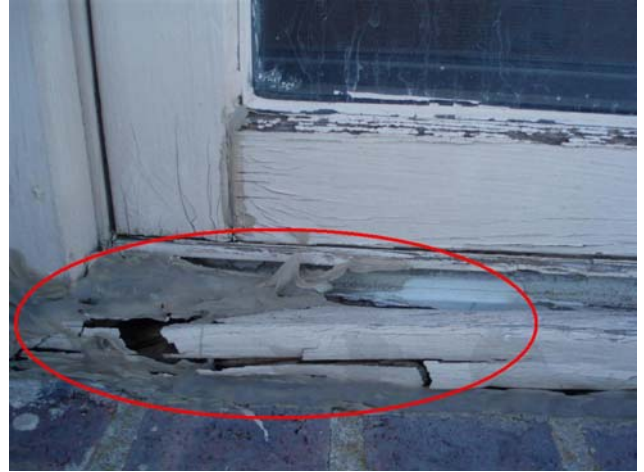
- **Repair:** The window frames require painting and caulking.
- **Repair:** Localized evidence of substantial rot was visible on some window trim/frames and sills. Repair to the window frames can usually be accomplished by a skilled carpenter. It's recommended that a thorough "inventory" be taken by a competent window repair technician to ascertain exactly how many areas will need to be repaired or replaced. Further evaluation by a specialist may well identify additional areas that require servicing. **Repaired/Replaced**

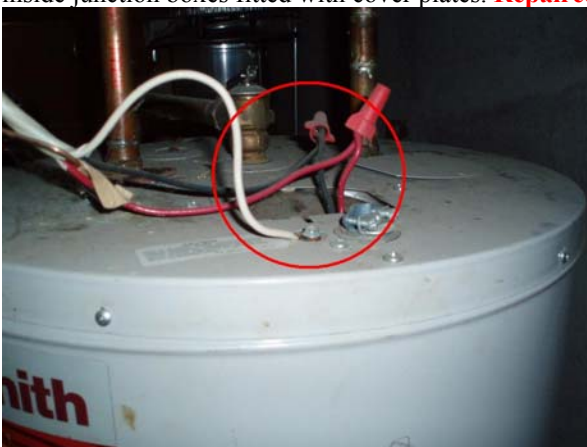
- **Repair:** Loose wiring at back basement wall should be secured. **Repaired**
- **Repair:** Improper electrical connections at water heater should be repaired. All electrical connections should be made inside junction boxes fitted with cover plates. **Repaired**

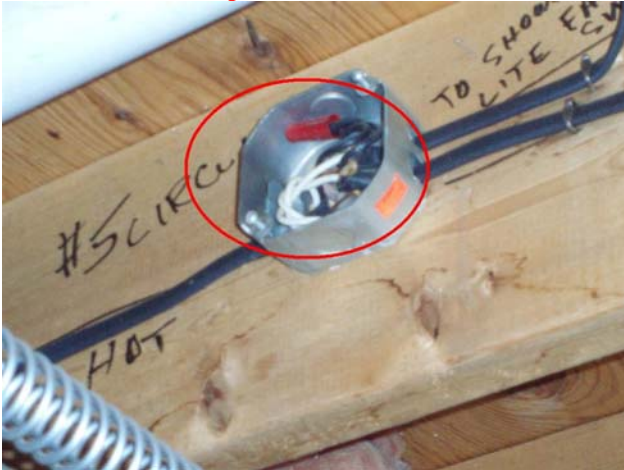
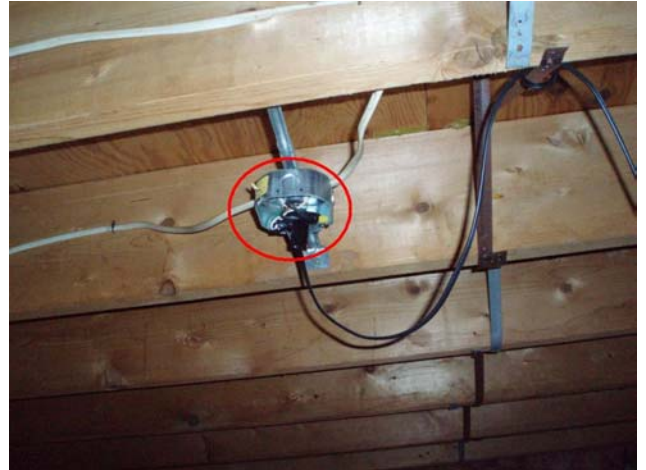
- **Repair:** All junction boxes should be fitted with cover plates (examples in basement ceiling), in order to protect the wire connections. **Repaired**

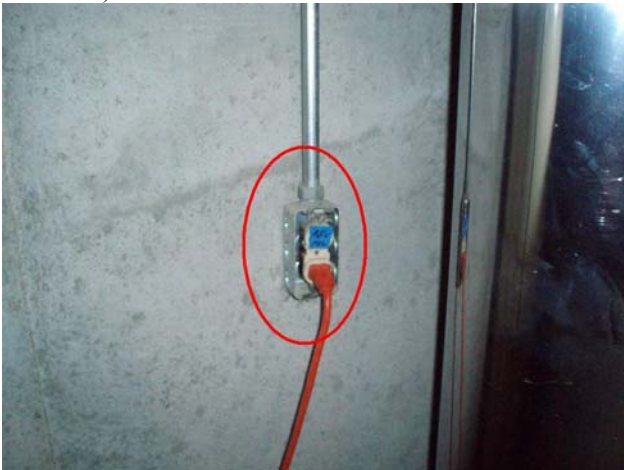
- **Repair:** An outlet has reversed polarity (i.e. it is wired backwards). These outlets and the circuits should be investigated and repaired as necessary (marked "Rev Pol" with blue tape, master bedroom bath, laundry, northeast bedroom and basement).

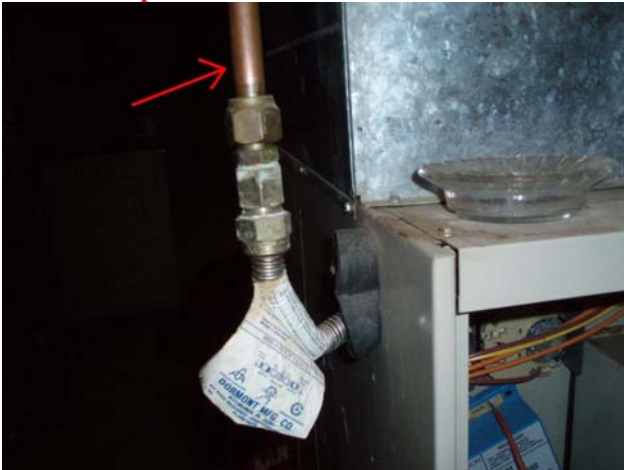
- **Repair:** Copper tubing is no longer suitable for gas piping. It's recommended this pipe be replaced with one of suitable material. **Repaired**

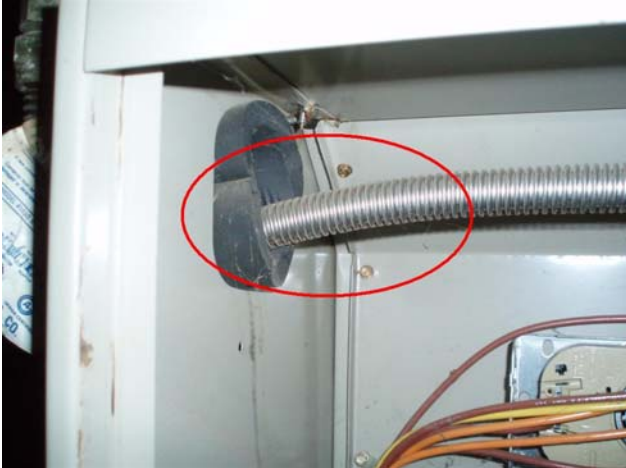
- **Repair:** The appliance gas connection for the furnace is unconventional. This condition should be corrected for improved safety. **Repaired**
